3-K-21-HZ
APPLICATION FOR CERTIFICATE OF APPROPRIATENESS

1319 Grainger Ave. 37912
Old North Knoxville H

Original Print Date: 5/5/2021
 Knoxville/Knox County Planning -- Historic Zoning Commission

Level 2 scope of work, for HZC review 5.20.2021: Proposed replacement of three porch columns: two corner columns on the first-story porch (east and west) and one leftmost (west) corner column on the second-story porch. Two-story porch features six round fluted columns on the first story and five round fluted columns on the second-story porch. Due to water intrusion from weather, failing gutters, and adjacent large trees, three corner columns have rotted. Applicant is proposing the installation of fiberglass reinforced polymer columns instead of wood. On the first-story porch, round fluted columns will measure 9' overall in height and 12" in diameter, with a slight taper to match the existing columns. On the second-story porch, columns will measure 8' overall in height and 10" in diameter. Columns will be smooth-finished on top of square base. Historic capitals to be retained, repaired, and installed on top of new columns. Historic wood railing to be retained.

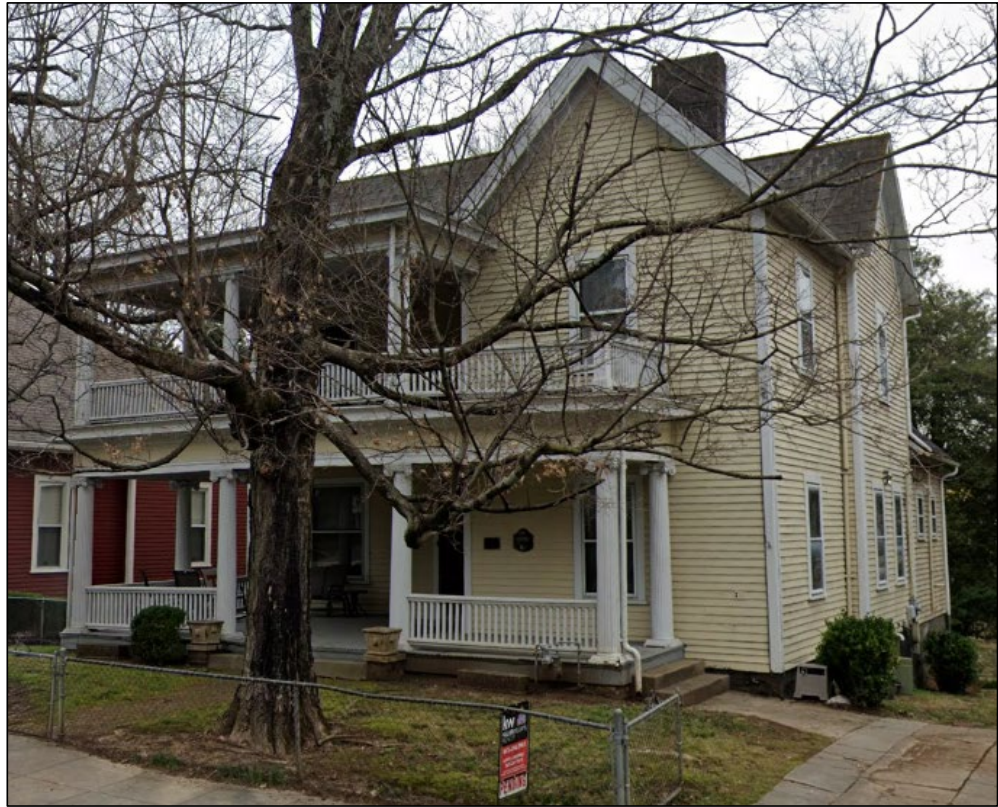
4. The applicant has provided several photos showing the columns' deterioration, especially the rot along the bottom, where the columns would attach to bases. Photos show the east first-story column leaning; the contractor has stated the column was approaching a point where it could not support the second-story porch. The columns were temporarily removed to move forward with porch flooring and gutter repairs.

Photo of columns submitted by applicant

5. Due to significant deterioration on the corner columns, the applicant is proposing replacement of the corner columns on the first story (east and west), and the west corner column on the second story. Due to the location of the corner columns and their exposure to the elements, the applicant is proposing an alternative material to hollow wood columns.

- 1) retain and reinstall existing railings; retain, repair, and reinstall original capitals; and install bases with placement, dimensions, and design to match existing;
- 2) replacement columns be confirmed to match size, taper proportions, fluting detail of wood columns;
- 3) confirmation of color, surface texture, and reflective surface to be compatible with the existing columns;
- 4) information to be provided to staff on column ventilation to minimize expansion/contraction issues which could negatively affect the original capitals.

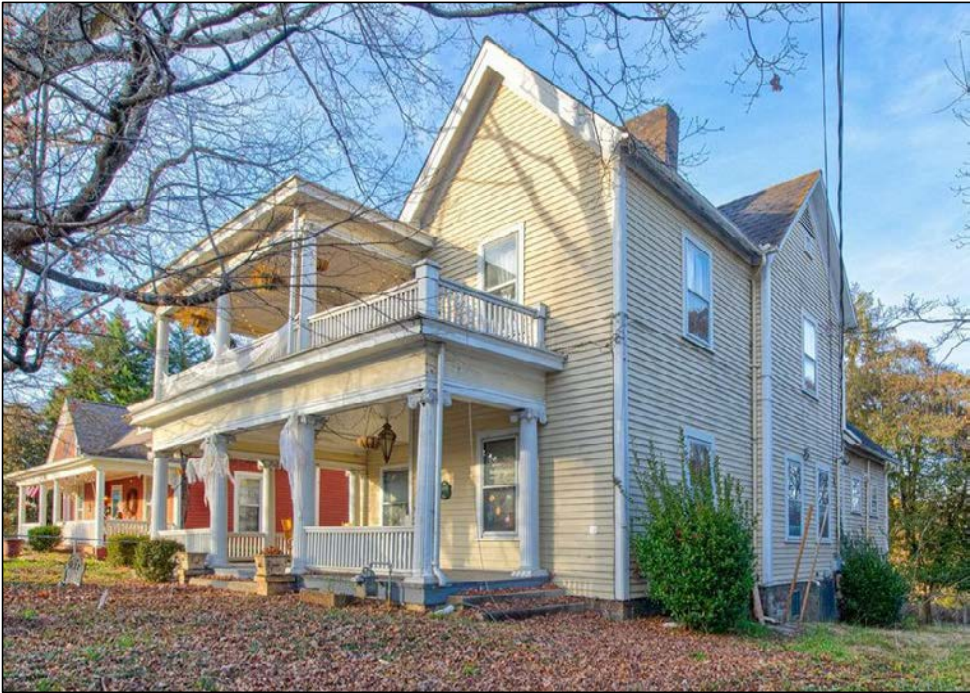
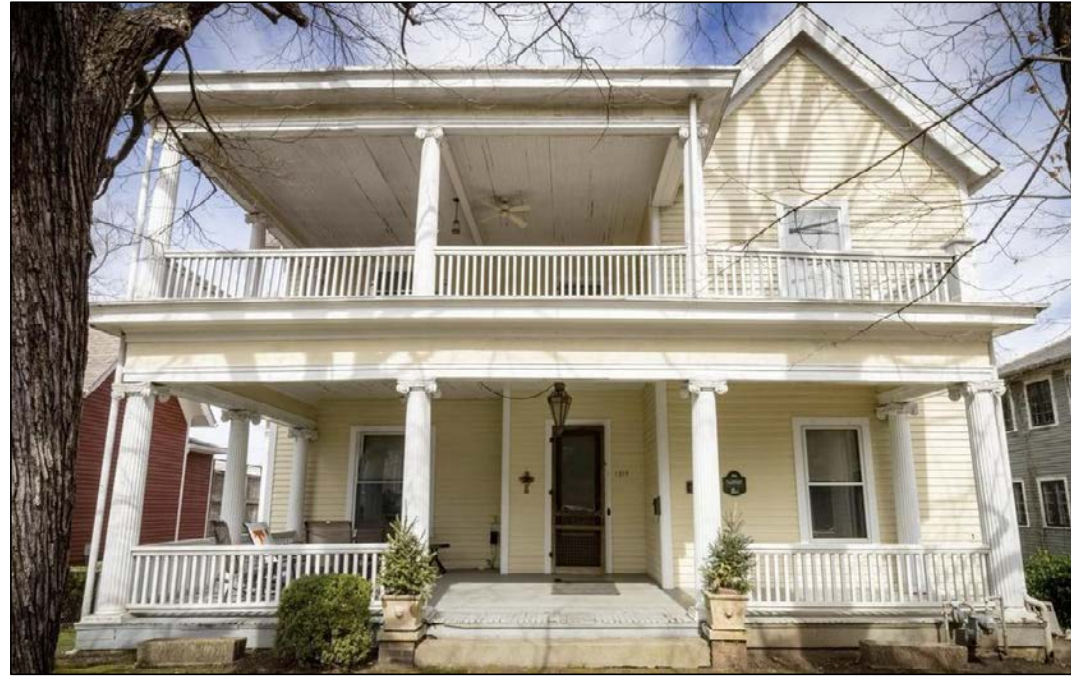
Overall photos from 2019 real estate listing
