4-E-23-HZ
APPLICATION FOR CERTIFICATE OF APPROPRIATENESS

1009 Gratz St. 37917
Fourth and Gill H

Staff Report

1009 Gratz St. COA Application

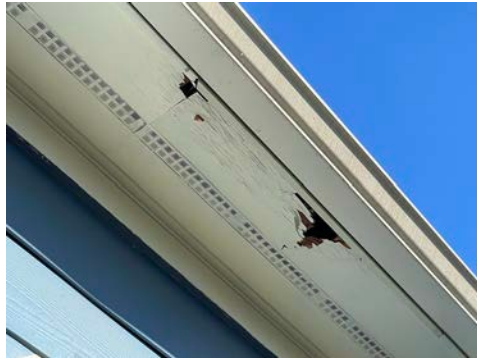
(14)

The current chimneys have entered a state of demolition by neglect (photos 01-05). This due on no part to the current owner as she has owned the property for five months. Previous owners are solely responsible for the neglect and deterioration of the chimneys and roof. Furthermore, this demolition by neglect is now affecting the health safety and welfare of the current owner, the property, and the tenant. The water damage caused by the complete deterioration of the chimneys and roof is causing damage in other parts of the structure (photos 14-16) which will lead to future repairs if left in its current state. It is also creating health and safety concerns for the tenant and the owner as the water is leaking into the residence, potentially creating mold or other hazardous living conditions (photos 9-13).
