5-J-24-HZ
APPLICATION FOR CERTIFICATE OF APPROPRIATENESS

1730 Jefferson Ave. 37917
Edgewood-Park City H

Staff Report

INSPECTION REPORT
1730 Jefferson Ave
Knoxville TN 37917

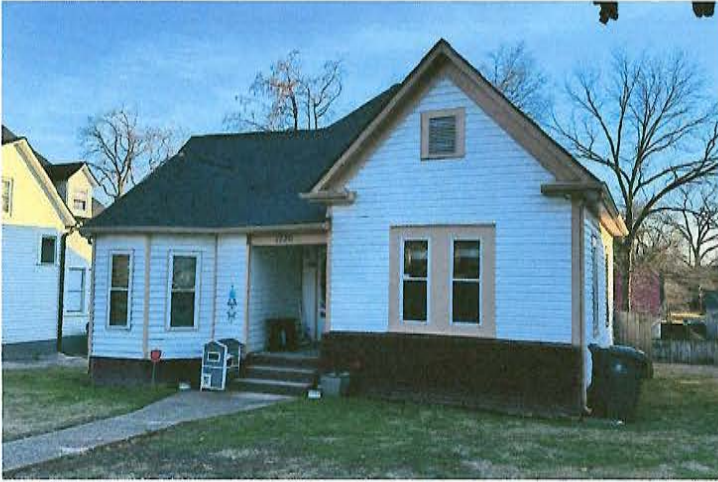
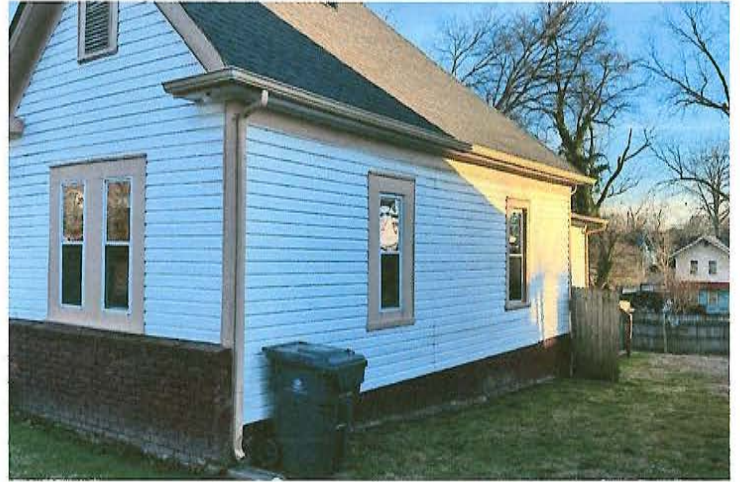
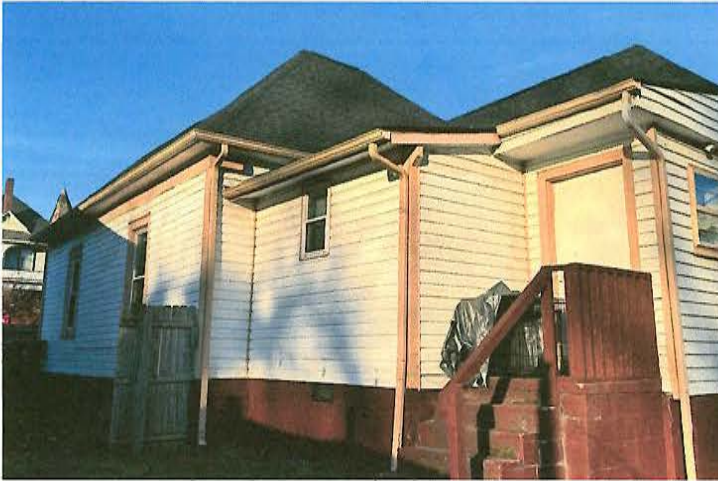
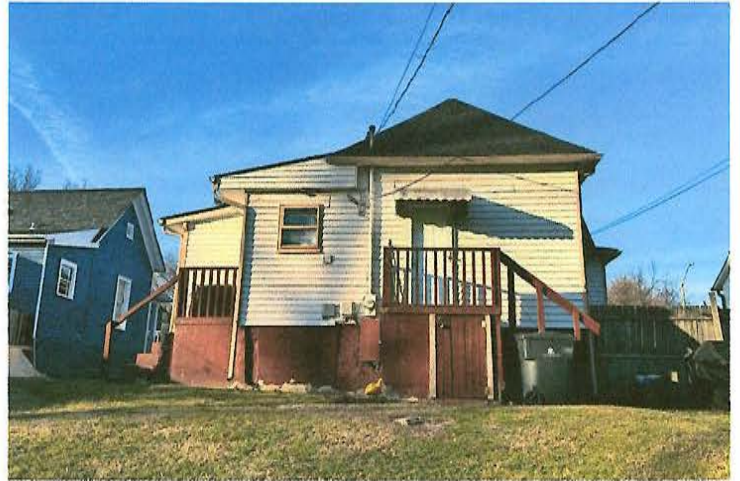
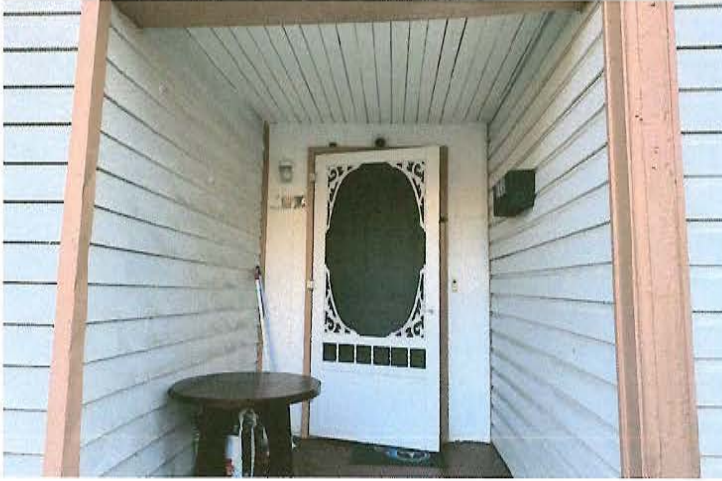
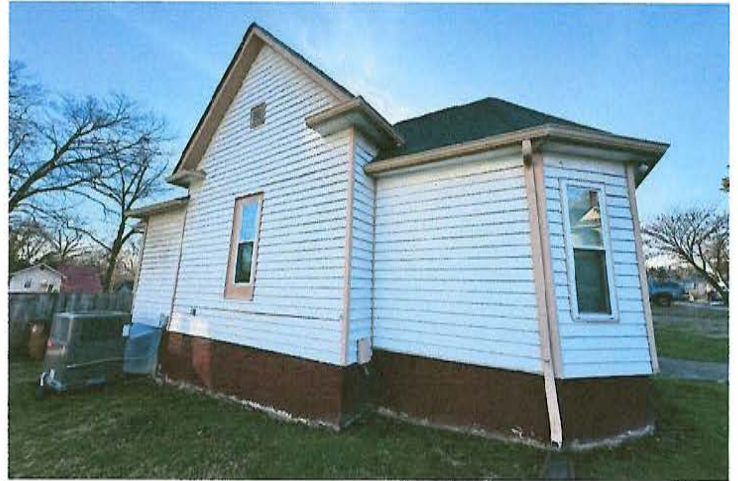
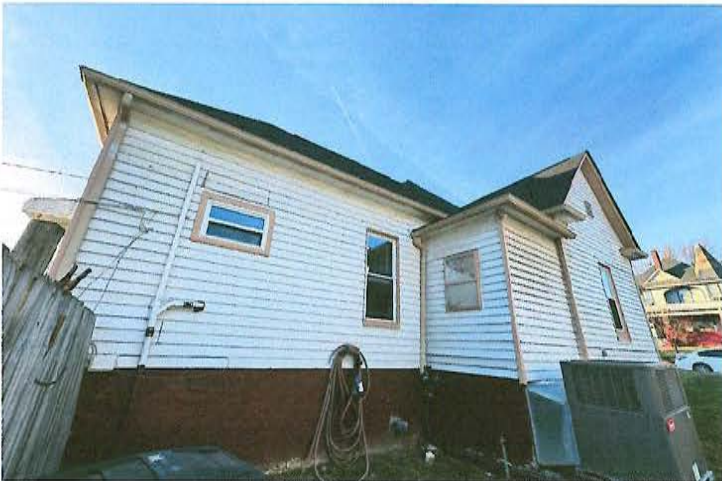
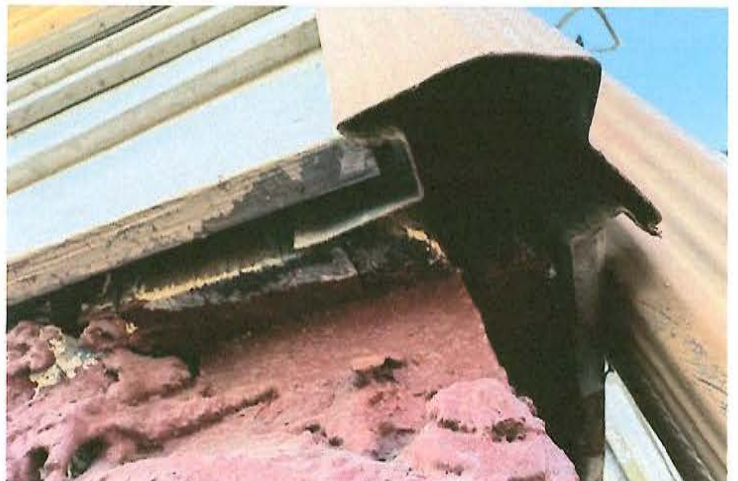
Photos

5. While there is not a significant increase in evidence of the wood lap siding's condition, presence, or absence, there is wood lap siding on at least three elevations. The existing design guidelines recommend replicating original siding, and the new design guidelines do not support vinyl if wood lap siding is present.

Based on the existing design guidelines, staff recommends approval of removal of the existing vinyl siding and denial of the proposed new vinyl siding; staff recommends installation of wood lap siding to reflect the existing in exposure pattern and installation.
