Staff Report

File Number: 5-H-26-HZ

Re: **Limited Structural Evaluation**
Site Location: 1634 Forest Ave. Knoxville, Tennessee 37916
Project No.: S26085W- Fourth Ave 31685 (UR)
Client: University Real Estate c/o Suzanne Moll

Re: **Limited Structural Re-Evaluation (of Repairs)**
Site Location: 1634 Forest Ave Knoxville, TN 37916
Project No.: S22351C(RE) – Forest Ave 22428 (Sheats)
Client: Aaron Sheats

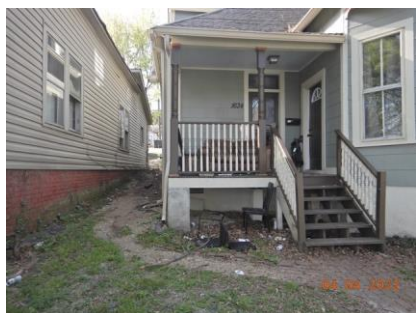
<p>04.04.2022</p>
Photo # 22	Photo # 23	Photo # 24

5. The outer ends of the front porch floor joists are not properly secured to the outer rim board and the ledger board is secured to the house with nails only and could pull loose from the house over time. (Photos #24,27,28).
