**KNOXVILLE HISTORIC ZONING COMMISSION
STAFF REPORT - CERTIFICATE OF APPROPRIATENESS APPLICATION**

PROPERTY ADDRESS: 227 Leonard PI 37917

FILE NO.: 8-F-15-HZ

LEVEL OF WORK: POSTPONED FROM 3/17/16 Level II. Rear roof addition

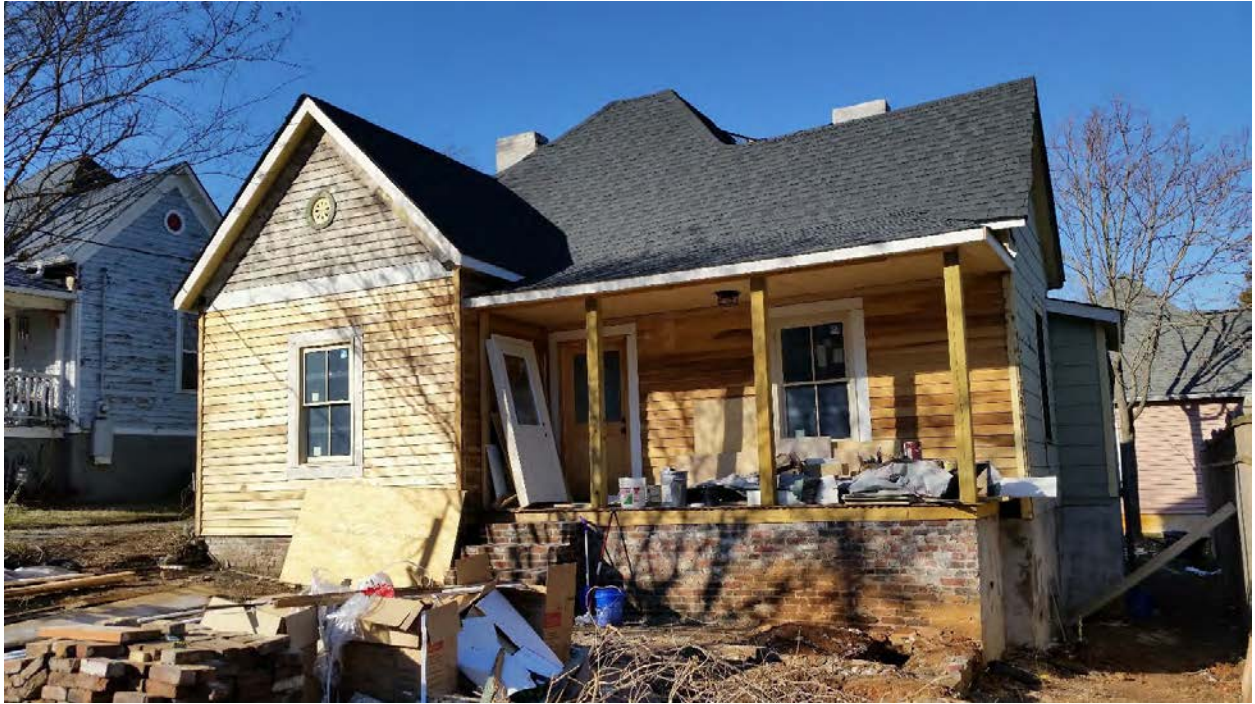
227 Leonard Place – Front façade – in progress – rear roof addition is barely visible.

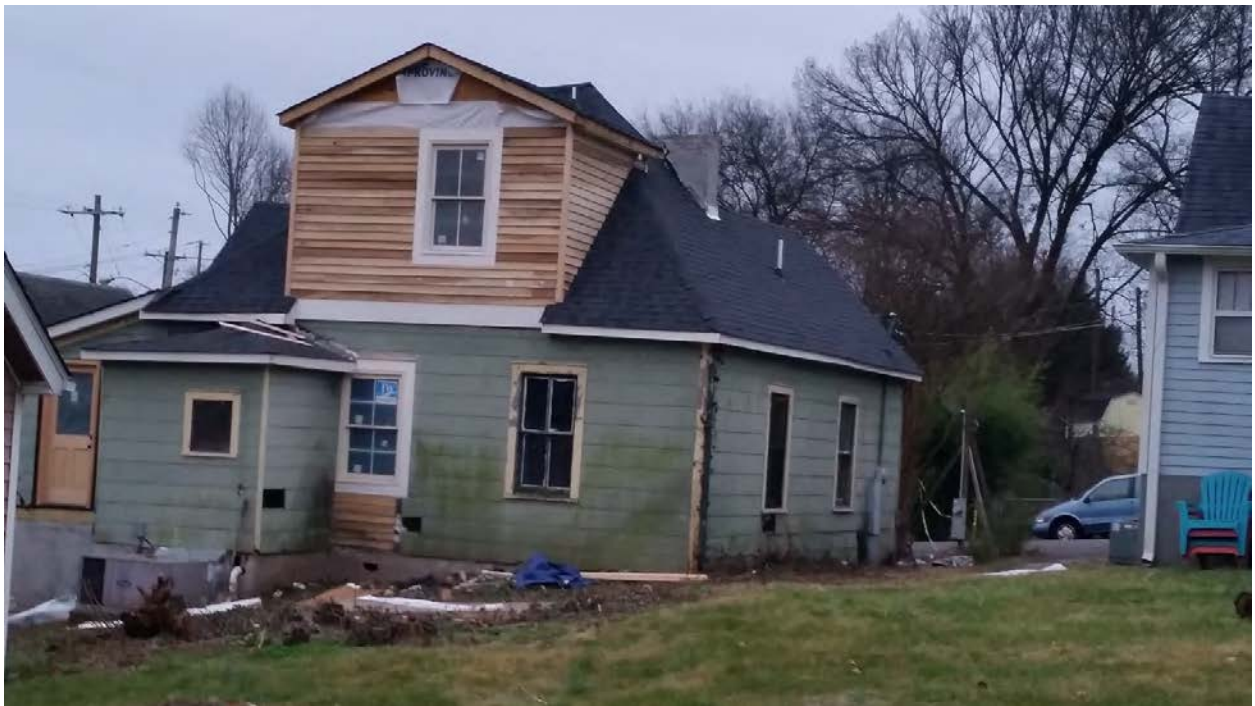
227 Leonard Place – Rear roof addition as seen from rear alley.

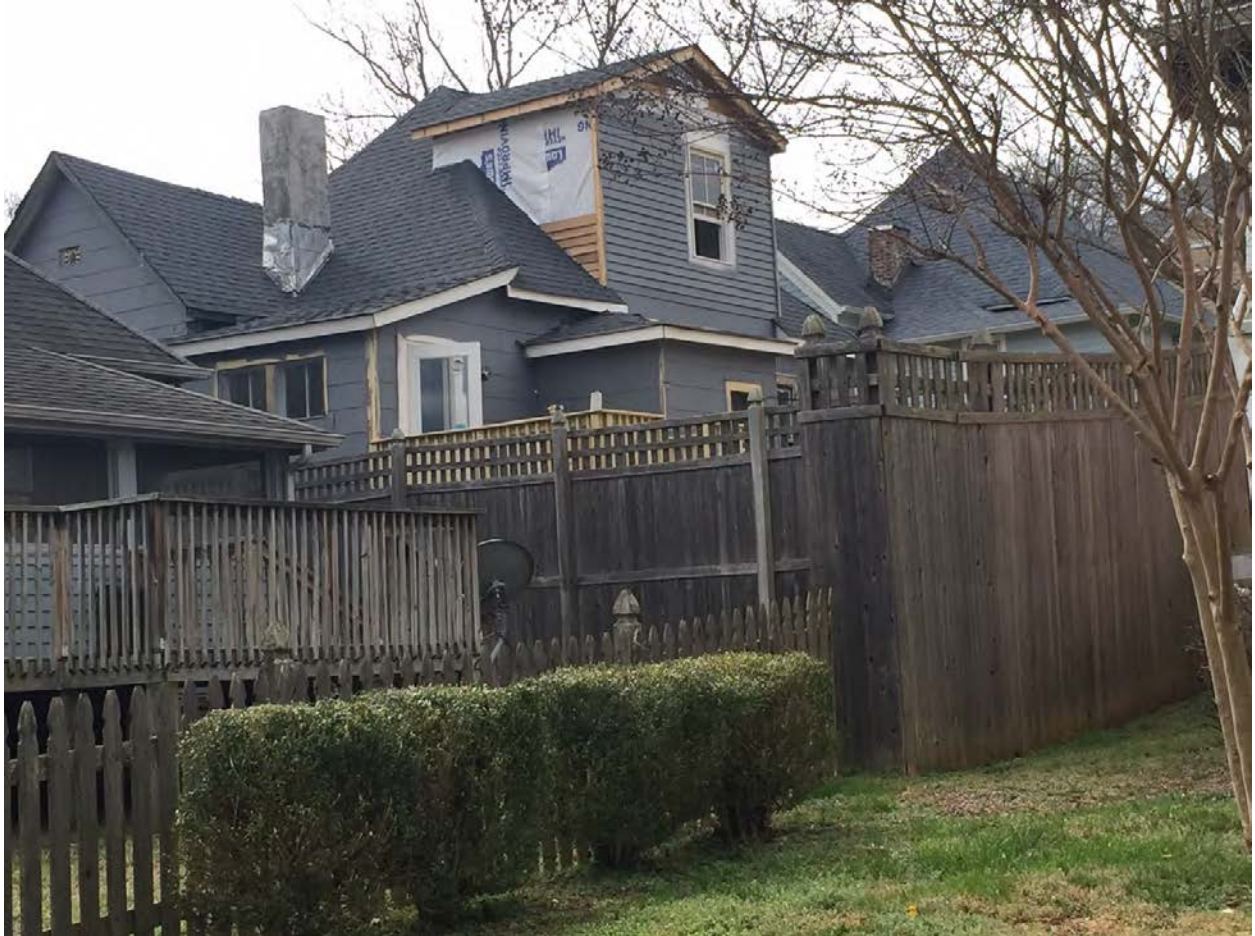
227 Leonard Place – Rear roof addition as viewed from N. Fourth Avenue (viewed from the east).

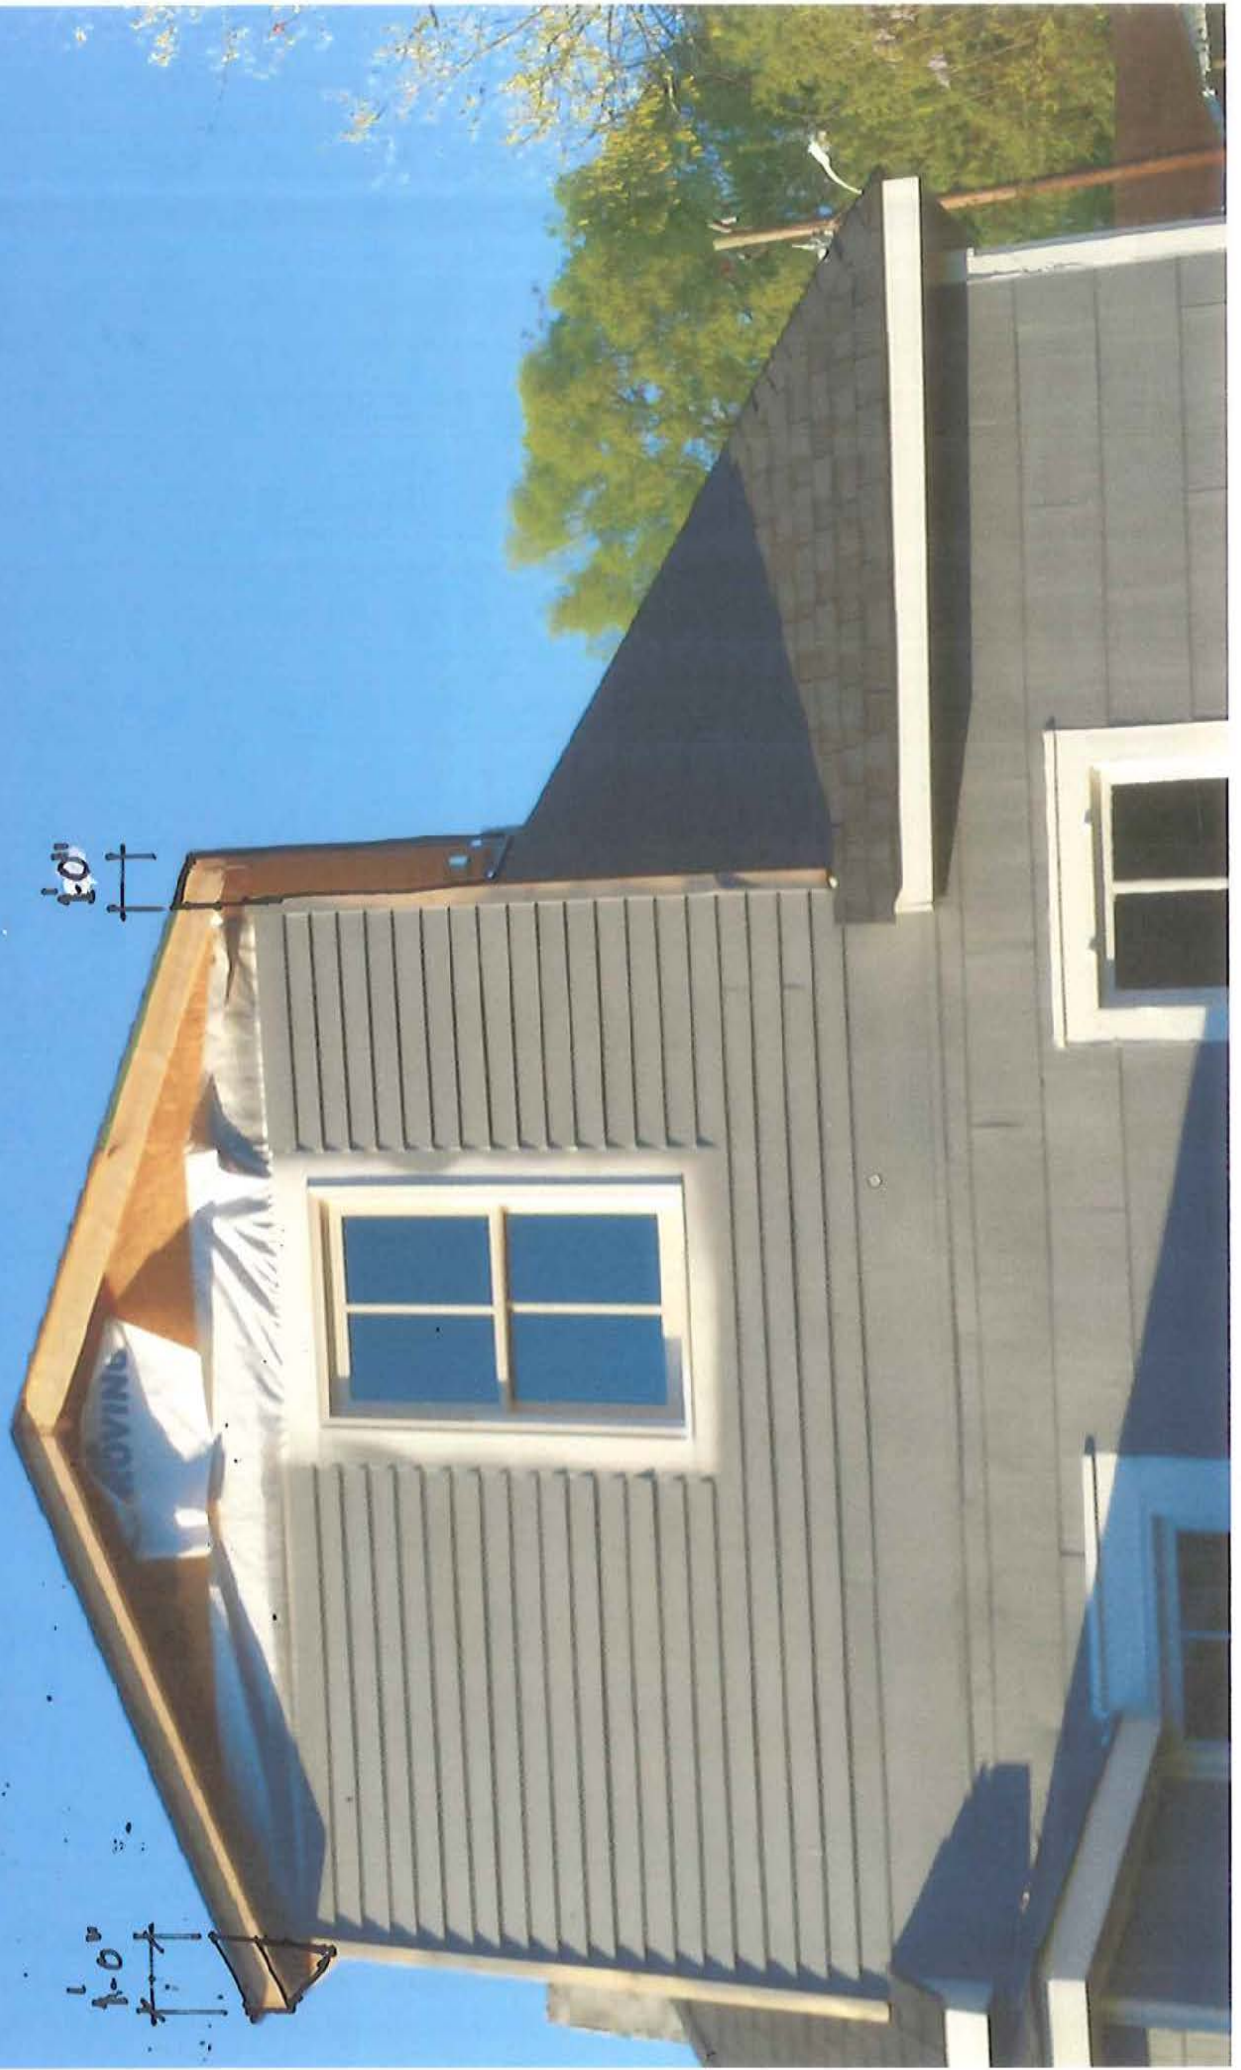
227 LEONARD PLACE
REAR ROOF ADDITION MODIFICATIONS
4.19.2016

1'-0" OF ROOF OVERHANG
TO BE REMOVED
EACH SIDE

NEW FLUSH
FACIA BOARD
ADDED

REPLACE EXISTING FACIA BOARD

1'-0"

AFTER-THE-FACT-REQUEST of 3/17/2016 POSTPONED to 4/21/2016 to explore mitigation options mainly to reduce size of gable-roofed frame addition projecting from the rear roof. The proposal is to reduce the width of the dormer by 24 inches by removing the roof overhangs on each side of the addition.

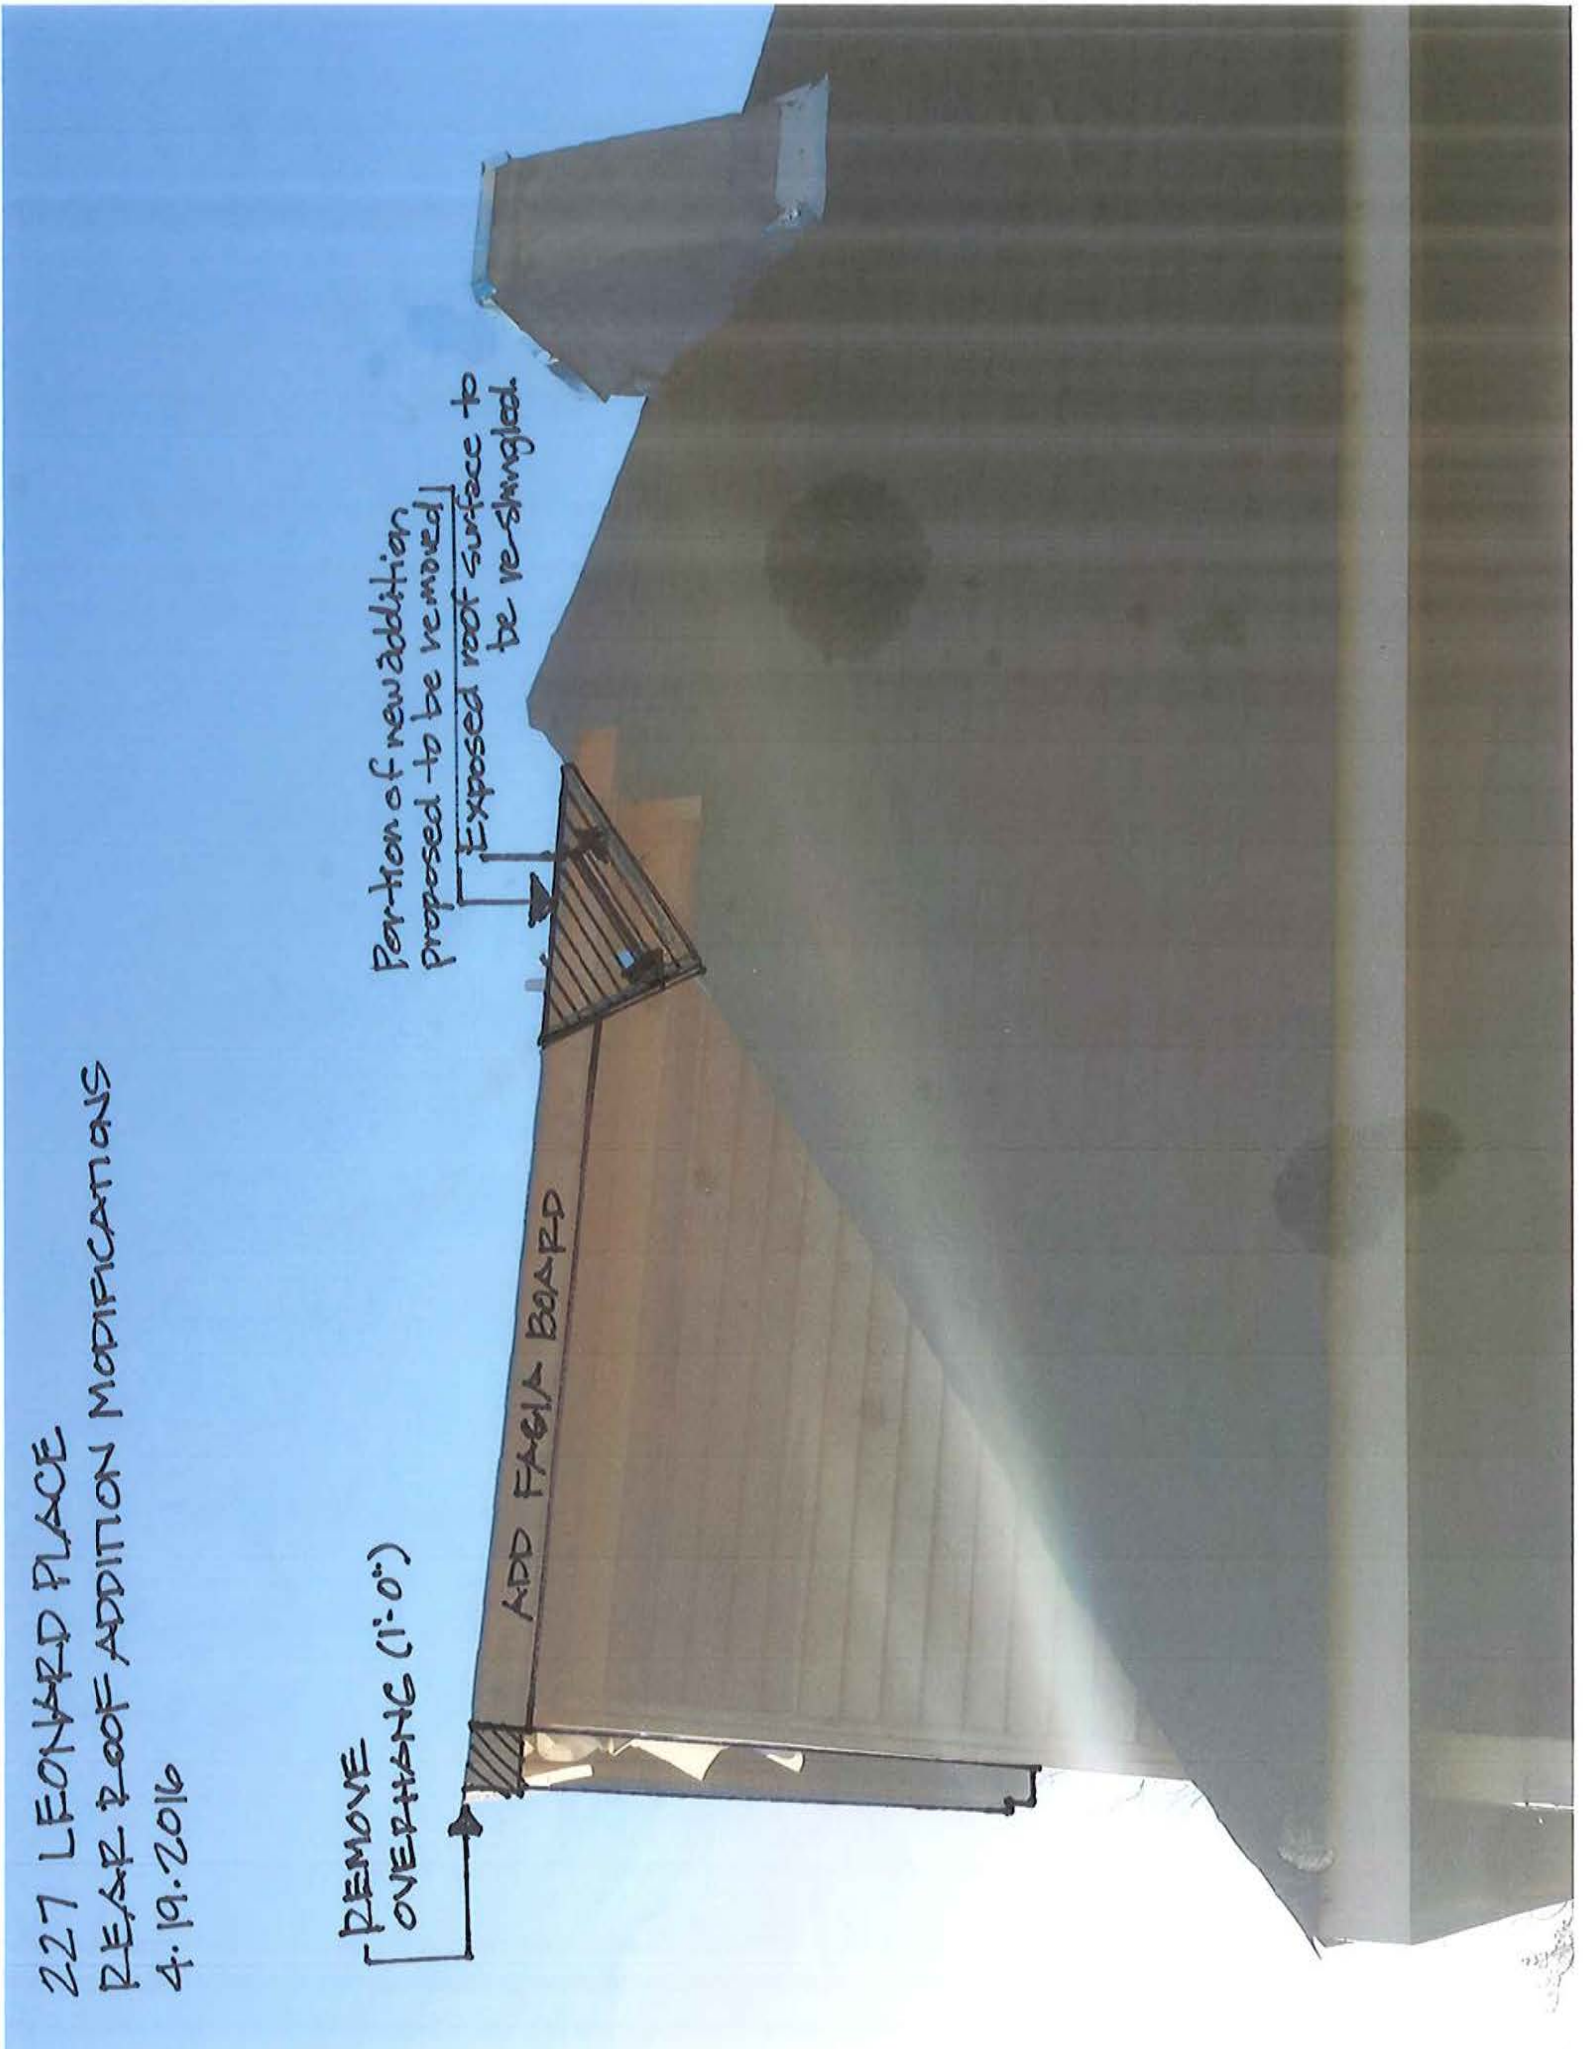
227 LEONARD PLACE
REAR ROOF ADDITION MODIFICATIONS
4.19.2016

REMOVE
OVERHANG (1'-0")

ADD FASIA BOARD

Portion of new addition
proposed to be removed
Exposed roof surface to
be resingled.

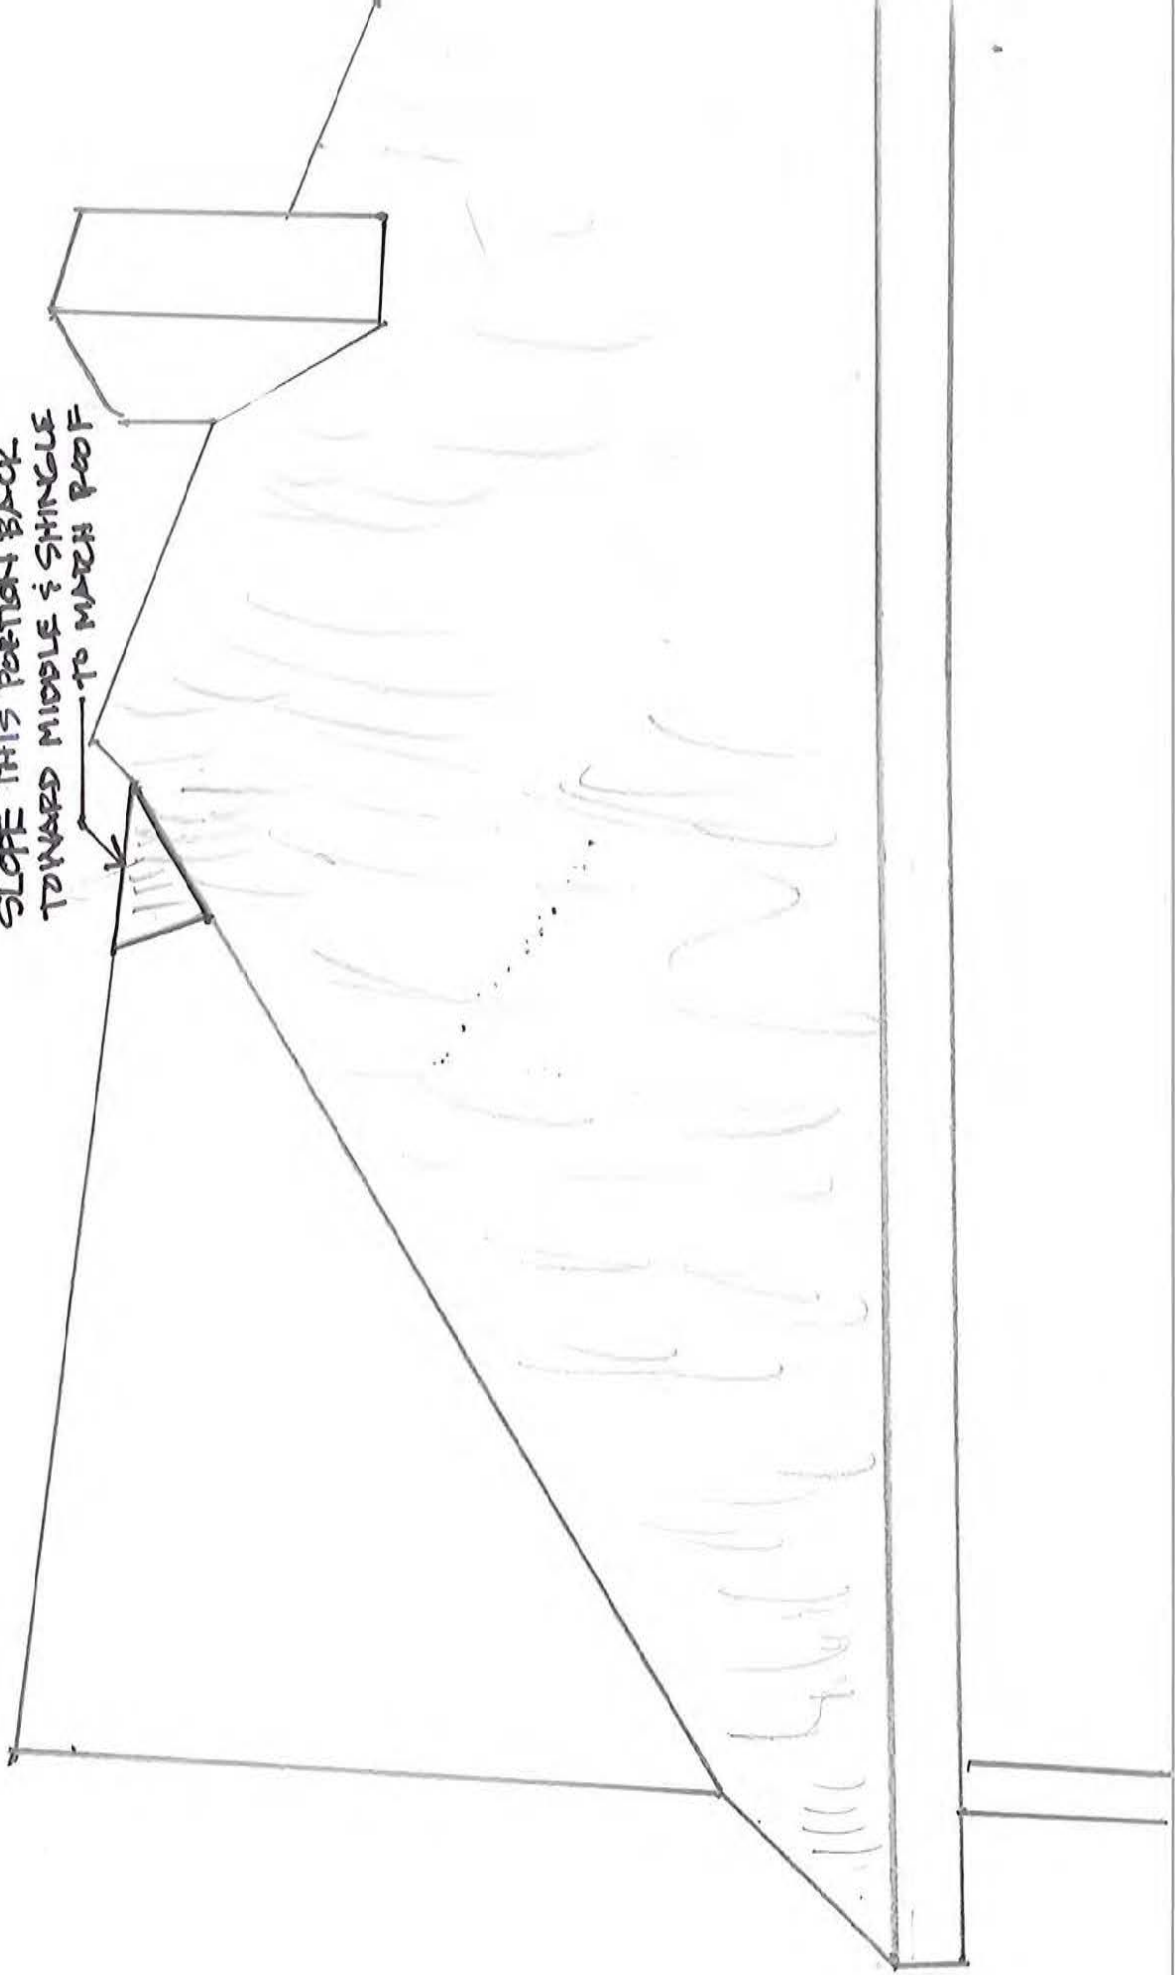
227 LEONARD PLACE
REAR ROOF ADDITION MODIFICATIONS
4/19/2016

SLOPE THIS PORTION BACK
TOWARD MIDDLE & SHINGLE
TO MATCH ROOF

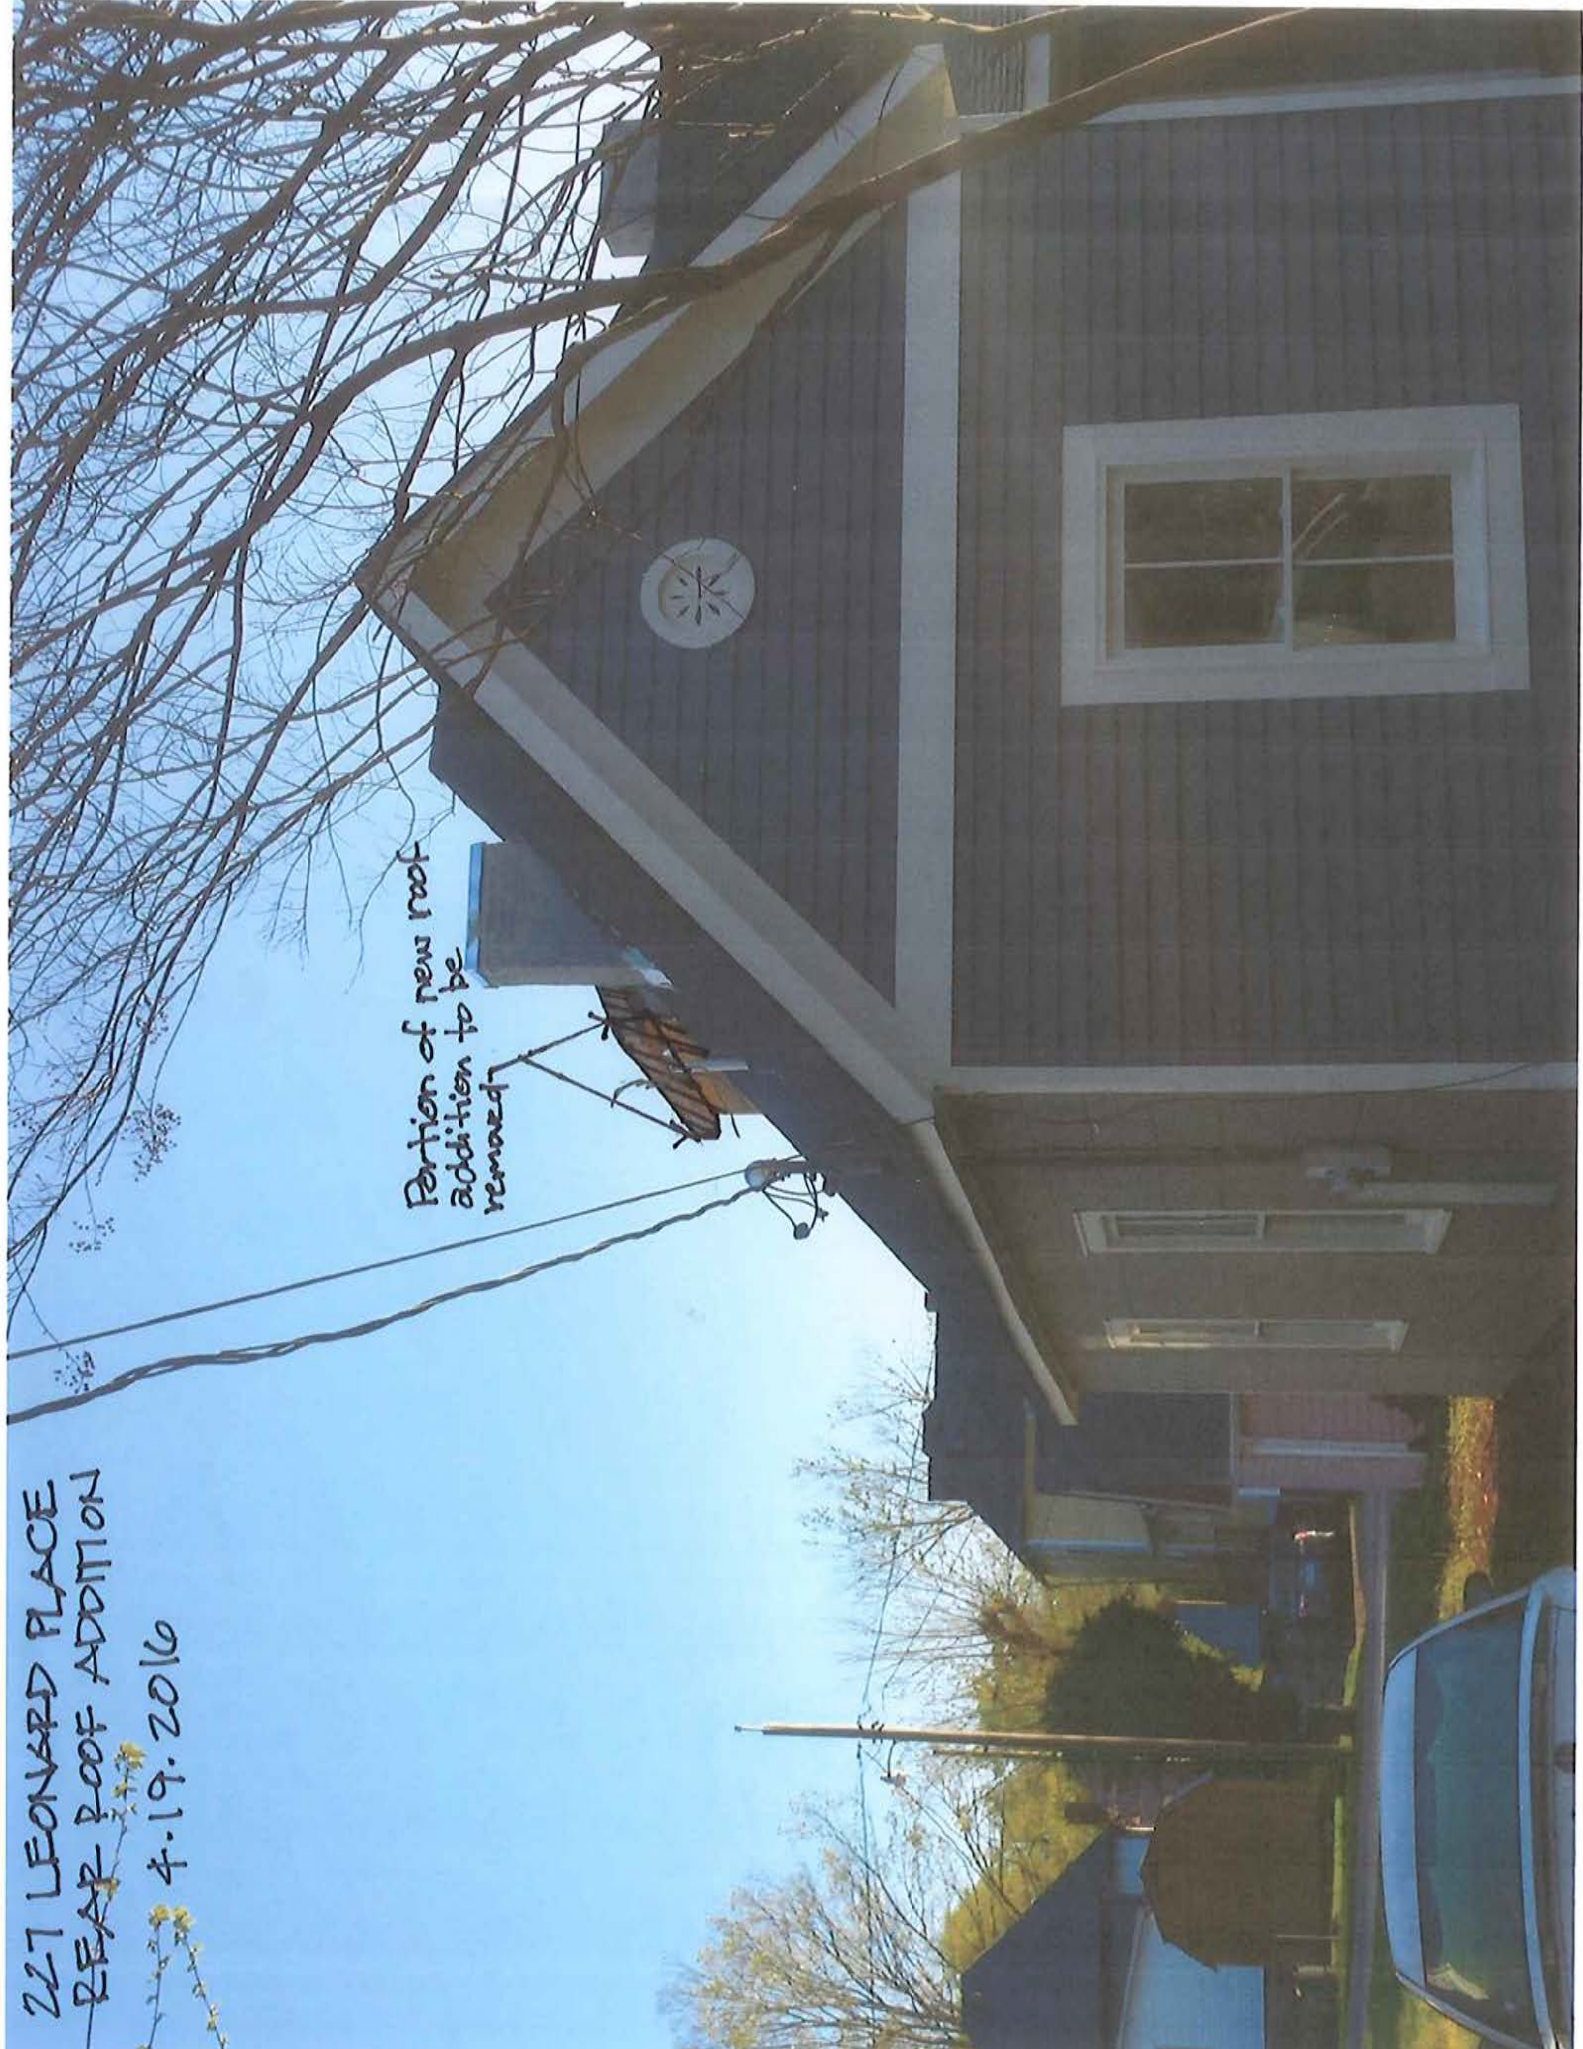
227 LEONARD PLACE
REAR ROOF ADDITION

Portion of new roof
addition to be
removed
