KNOXVILLE HISTORIC ZONING COMMISSION STAFF REPORT - CERTIFICATE OF APPROPRIATENESS APPLICATION

FILE NO.: 2-F-19-HZ

LEVEL OF WORK: Level II. Demolition and reconstruction of addition

Residential Duplex as Student Housing

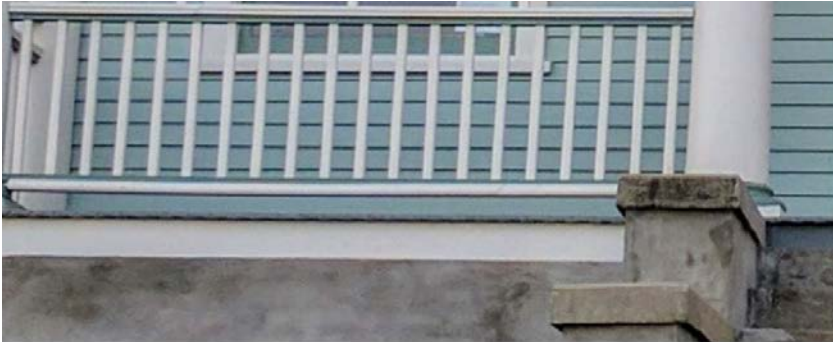
Railing: Replace handrails with 1 ¾" x 1 ¾" square pickets (similar to pic below or please specify)

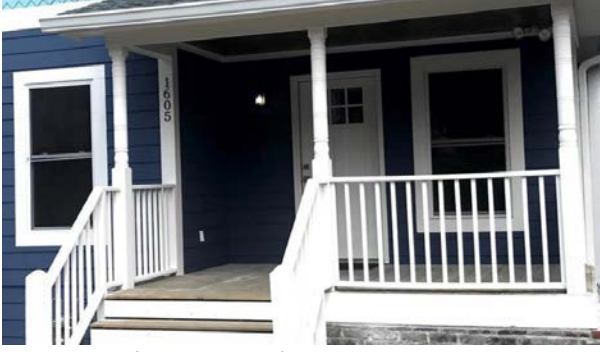
Columns: The existing Craftsman columns have been determined to have been built later after the original house and the proper style would be a Victorian porch. The existing columns are poorly built as well, they are falling apart, leaning, and are different sizes. We propose removing the 3 brick columns on front porch and replacing with 6x6 turned posts (ringed or turned as required) as shown on the picture below. There would be 5 full posts and 2 half posts. The foundation also has structural issues and will probably need to be rebuilt. The original brick would be re-used and rebuilt with cinder block wall behind it to support the porch.

Front view for columns (please suggest column styles/size)

9) The proposed demolition of the battered brick porch piers and replacement with turned posts is not appropriate since the porch roof is a heavier Craftsman style constructed at the time of the brick piers. The turned posts are too small -scaled relative to the porch roof. The later Craftsman porch has acquired significance in its own right.

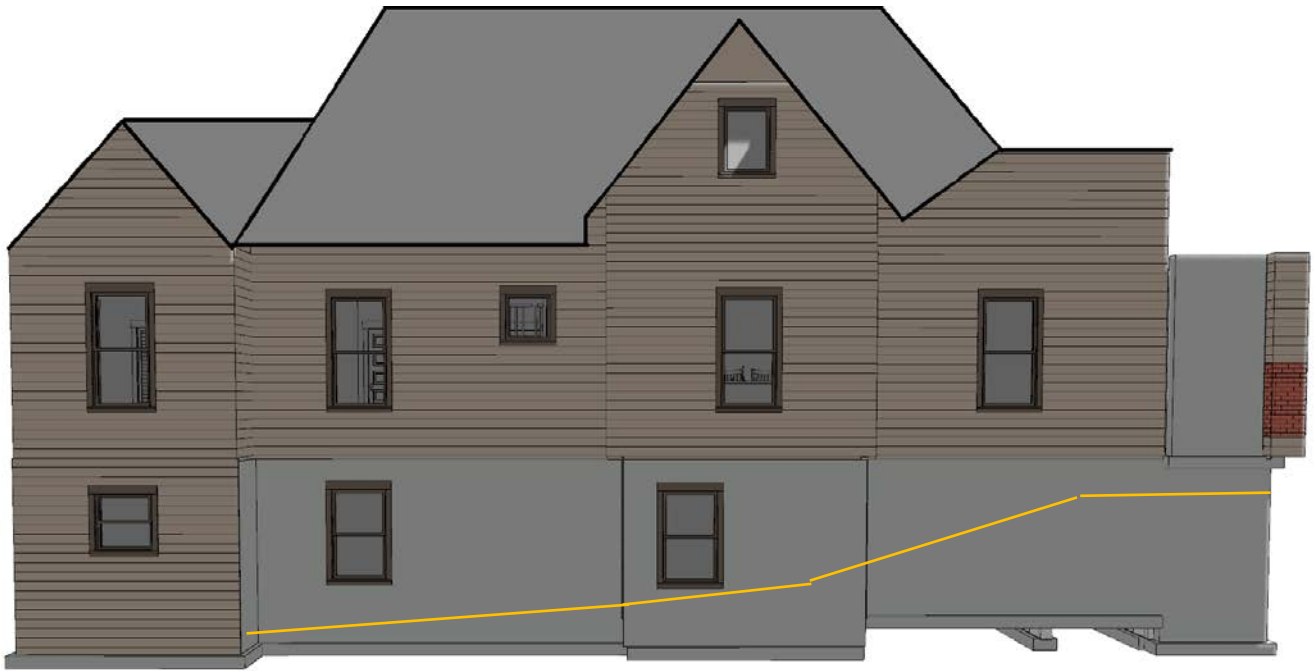
West Side:

The two windows in the gable will reduce to one centered window for the kitchen. We can install a full height window and block off the lower half to make it more consistent height wise with the rest of the house.

The yellow line is the dirt line. Exposure of the porch foundation above grade will range from 1' 6" at the front of the porch to 2' 6" at it's connection to the main house. It continues sloping downwards from 2' 6" to 6' 6" at the first window and downwards to 8' at the addition.

3. The demolished walls on the east and west sides are to be reconstructed with the condition that the window openings match the original size and locations including the replication of the original set of twin windows on the west side. The original fascia and corner trim is to be replicated.

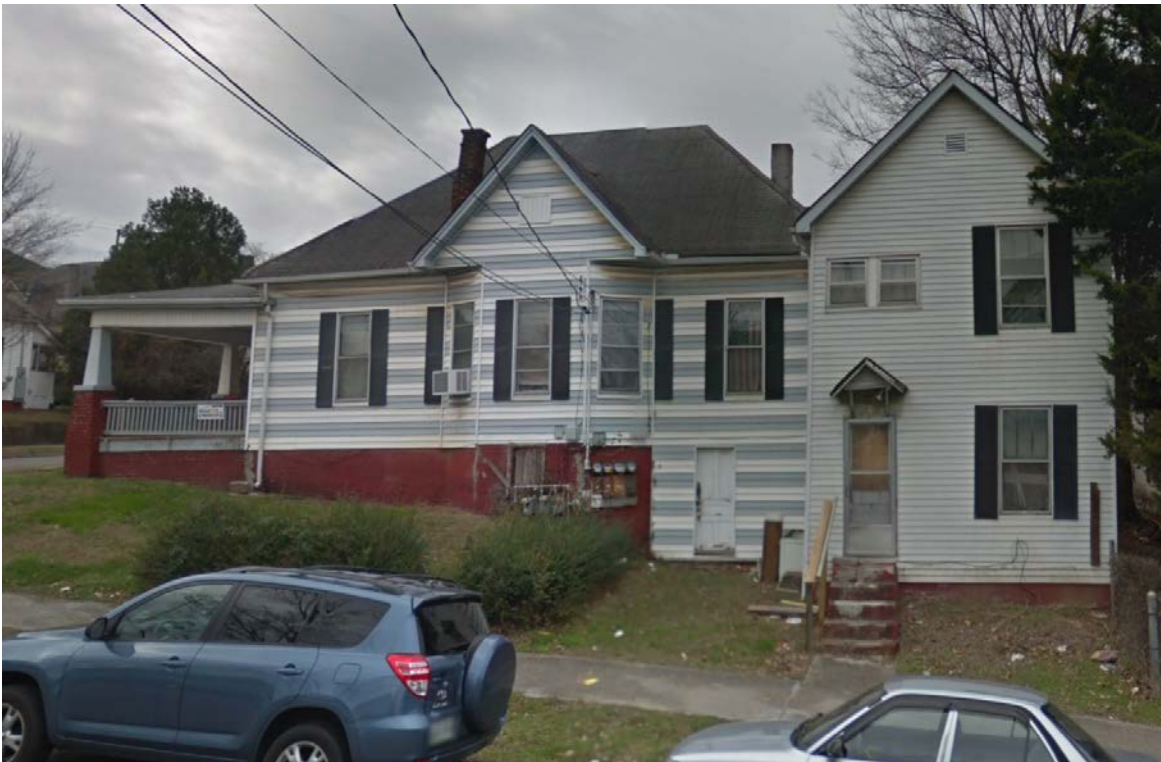
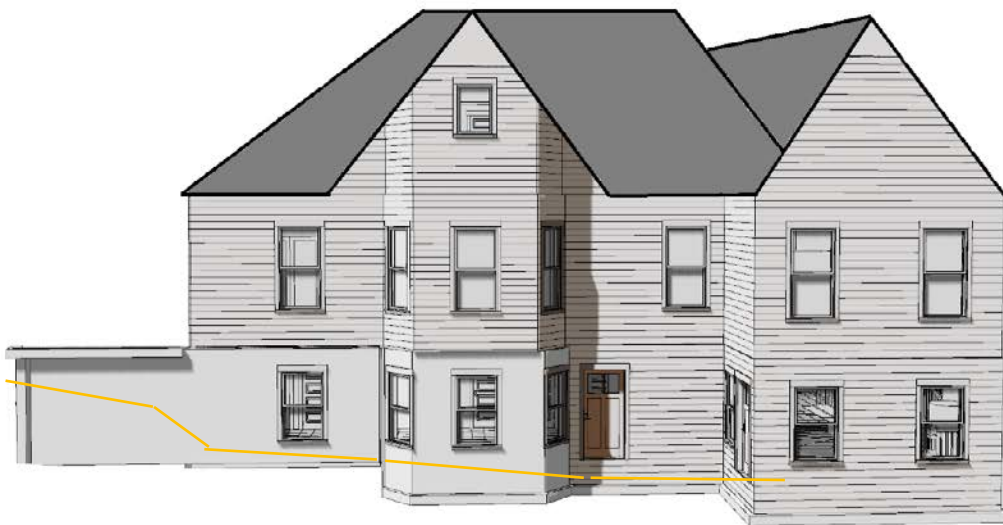
East Side:

Note: the bump out does not carry up to attic gable

The door on the East side will need to move 18" to the left to accommodate the firewall which must be built inside the house to meet building code requirements.

The yellow line is the dirt line. Exposure of the porch foundation above grade will range from 1' 6" at the front of the porch to 4' 2" at it's connection to the main house. It continues sloping downwards from 4' 2" to 6' 6" to the left side of the bay and then downwards further to 7' 2" at the addition.

6) The option of continuing the stuccoed foundation along the entire east (16th Street) elevation up to the addition is more appropriate than continuing the siding down to the basement level.

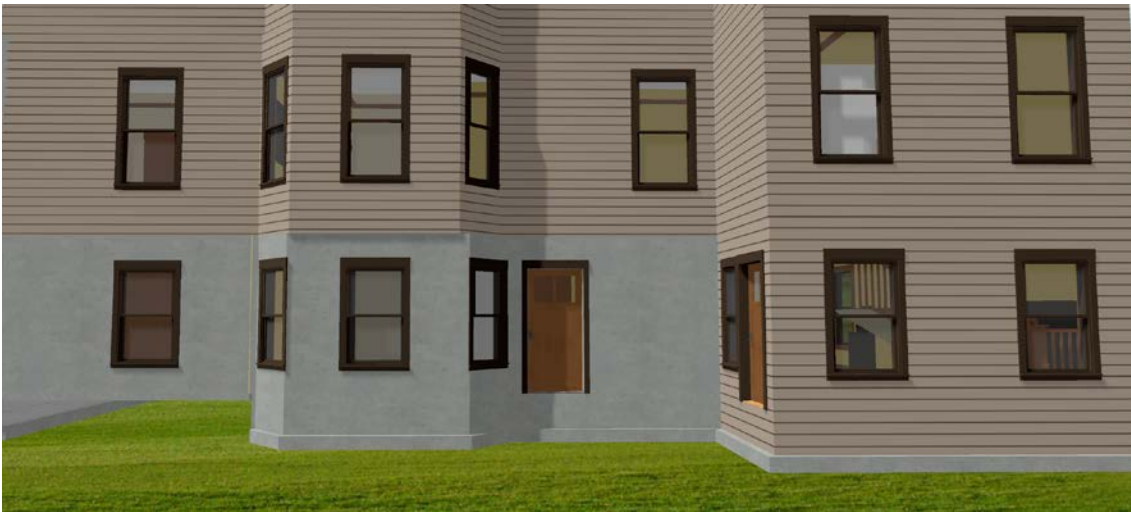
Another view of East side if stucco should be used instead of siding by the door.

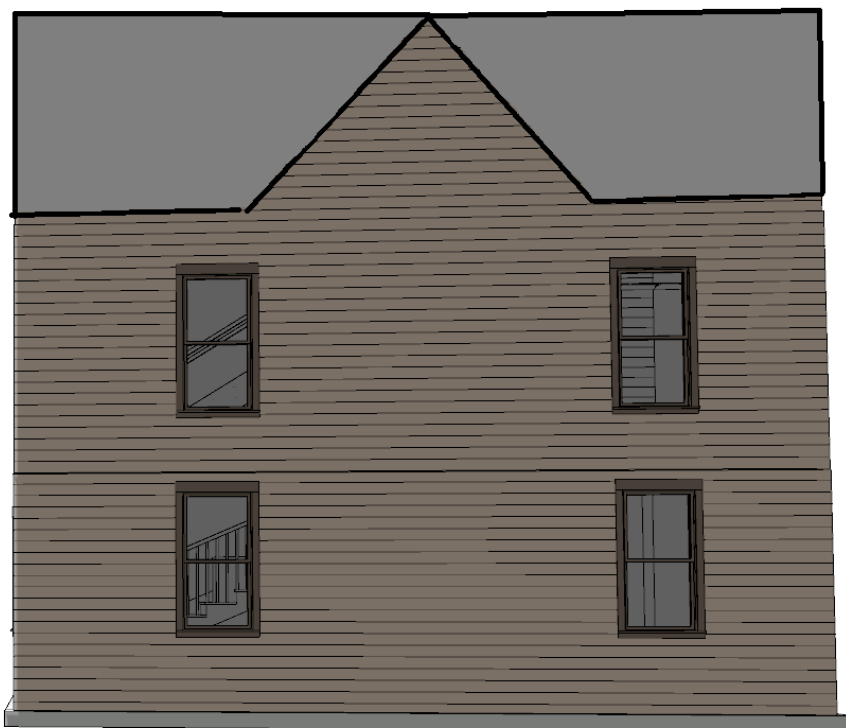
Rear:

This rear wall is required per building codes to be a firewall and no openings will be allowed due to its proximity to the property line. These 4 windows will be covered with “closed” shutters made of hardi board. See style below.

- 5) Window openings on the north (rear) side of the addition are not permitted due to the fire code; therefore, the proposed faux windows will be comprised of shutters within window frames to match others on the addition. The type of rustic board and batten shutters proposed are not the appropriate style and louvered shutters with hinge hardware are recommended instead.

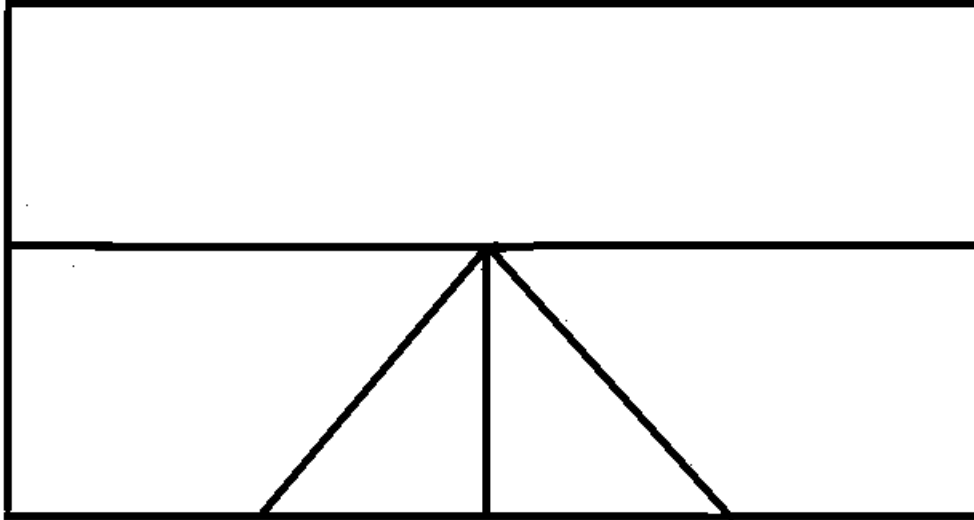
Rear Addition roof plan:

No changes are proposed to the existing roof plan shown below.

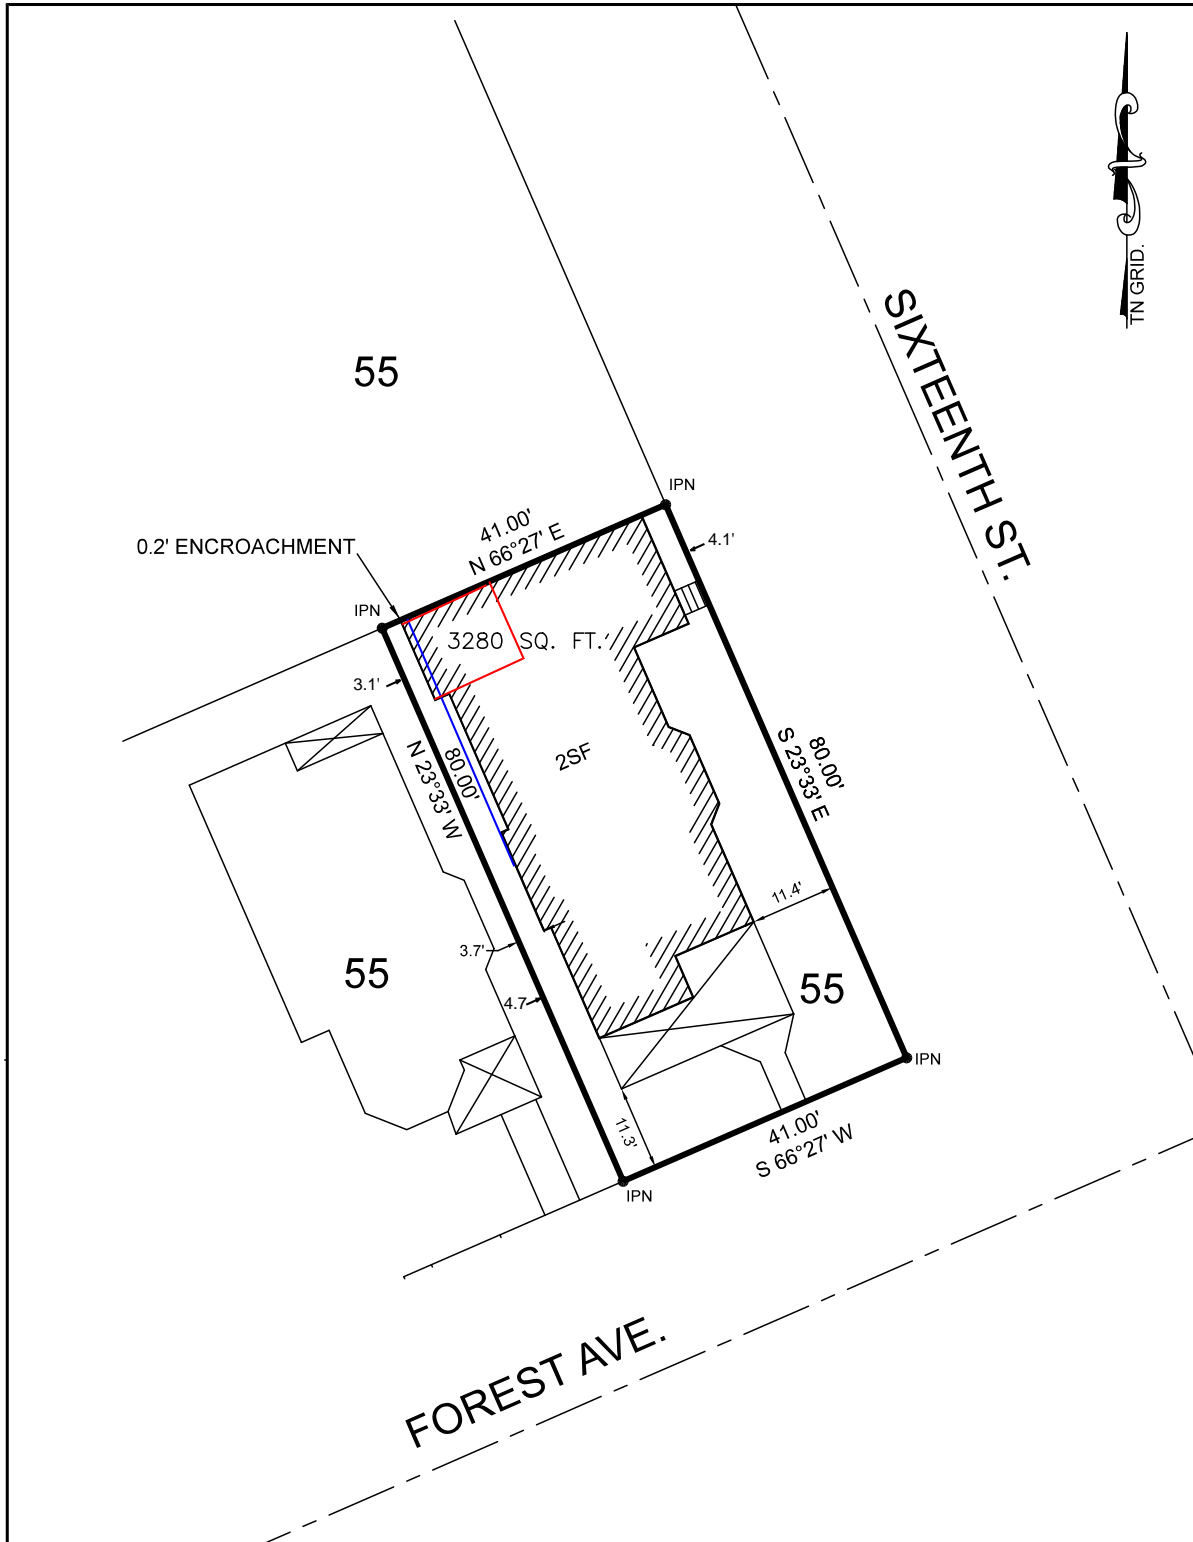
SURVEY FOR **EVIAN PARTNERS**
DIST. **4** WARD **10** CITY OF **KNOXVILLE** COUNTY **KNOX**
ADDRESS **1601 FOREST AVE.**
LOT NO. **PART OF 55** BLOCK _____ UNIT _____
S/D **RAMSEY'S ADDITION**
INSTR. **201403080054916** SCALE **1"= 20'** DATE **2-12** 2018
JOB NO. **1802002** ORDERED BY: **INDEP.**

- 1) The house is a contributing structure with the Fort Sanders NC-1 and the National Register Historic District.
- 2) The demolition of the east and west walls, foundation, and the west portion of the addition (as outlined in red on the site plan) was permitted after-the-fact by City Development Services.

Rear Addition: The Rear addition of the house as indicated on the attached survey is in poor structural shape and will need to be largely restored, it is intended to be restored exactly as it was built. A section to the back left as indicated in red on the survey has been removed as it was structurally unsound and is pending reconstruction. The building department has determined that it may be rebuilt, but the bump out must be in line with the existing house bump out, pending COA approval. This is indicated by the blue line on the survey (This is an approximately 6" reduction in the East side dimension). There is a 2" encroachment along the rear that will have to be fixed at the same time.

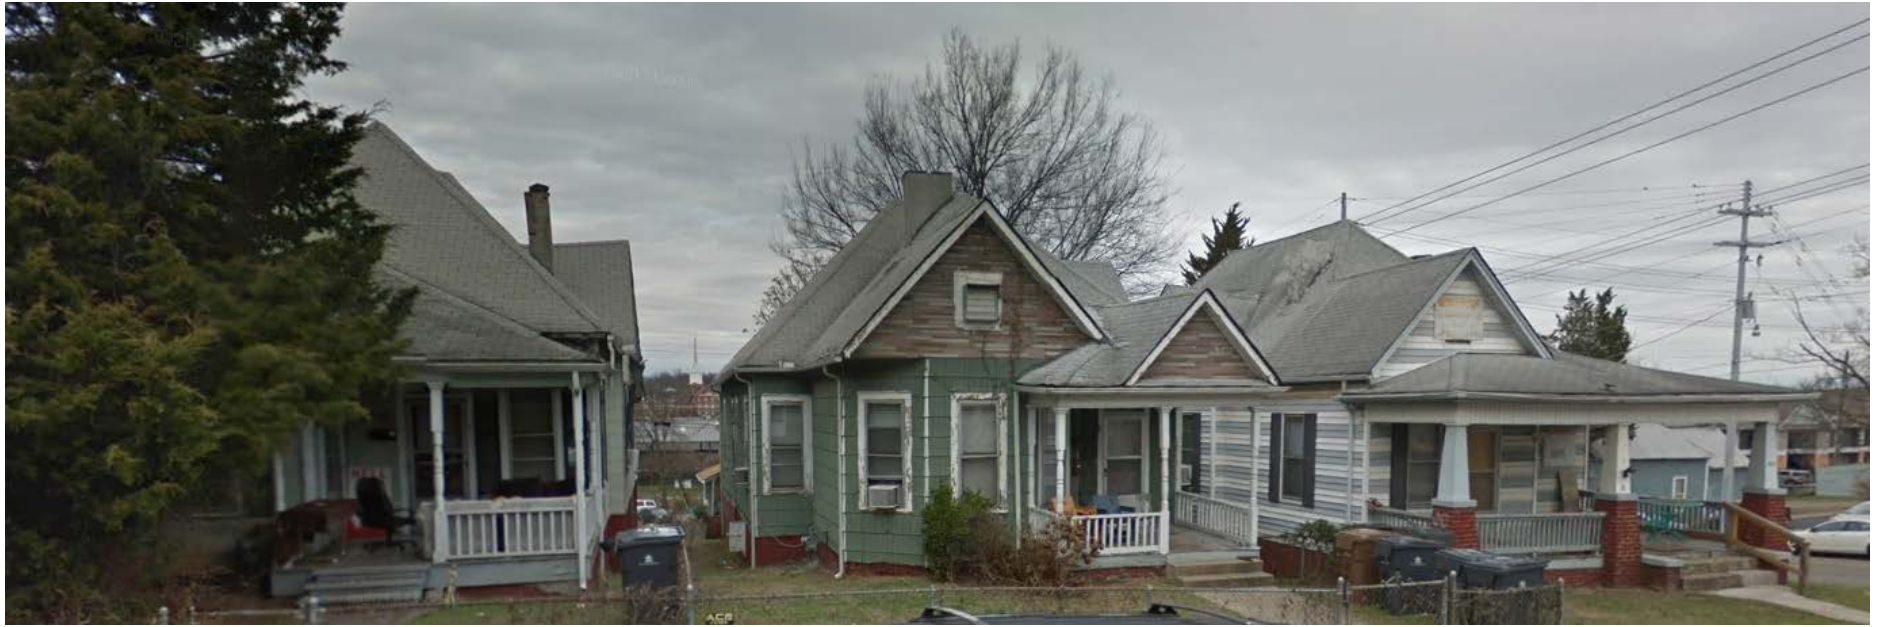
1600 Block of Forest Avenue streetscape showing turned porch posts on two houses to the west of 1601 Forest

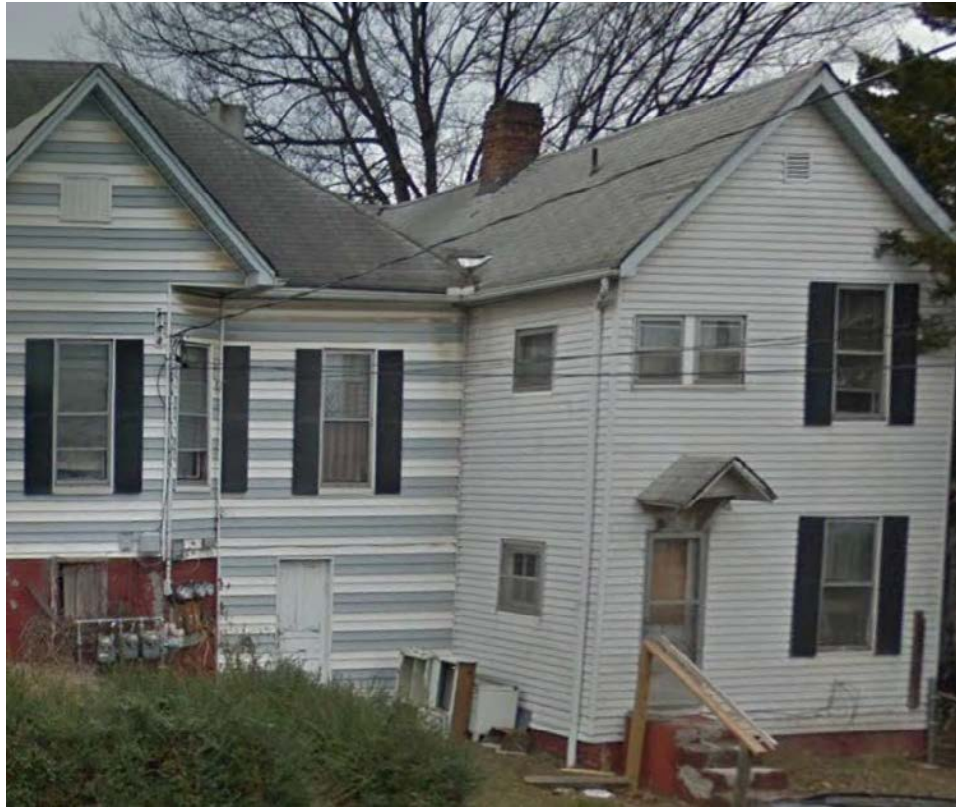
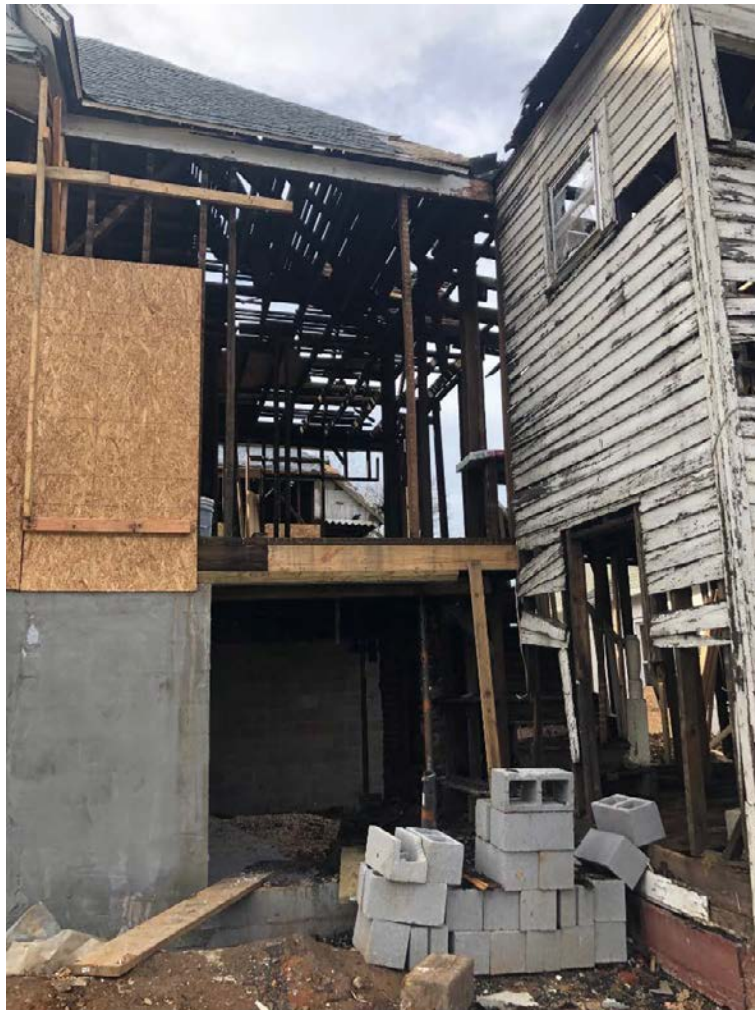
SIXTEENTH STREET SIDE BEFORE AND AFTER PARTIAL DEMOLITION
