**6-G-21-HZ**  
**APPLICATION FOR CERTIFICATE OF APPROPRIATENESS**

**204 E. Scott Ave. 37917**  
**Old North Knoxville H**

Full exterior rehabilitation project, along with a garage/deck addition in the rear.

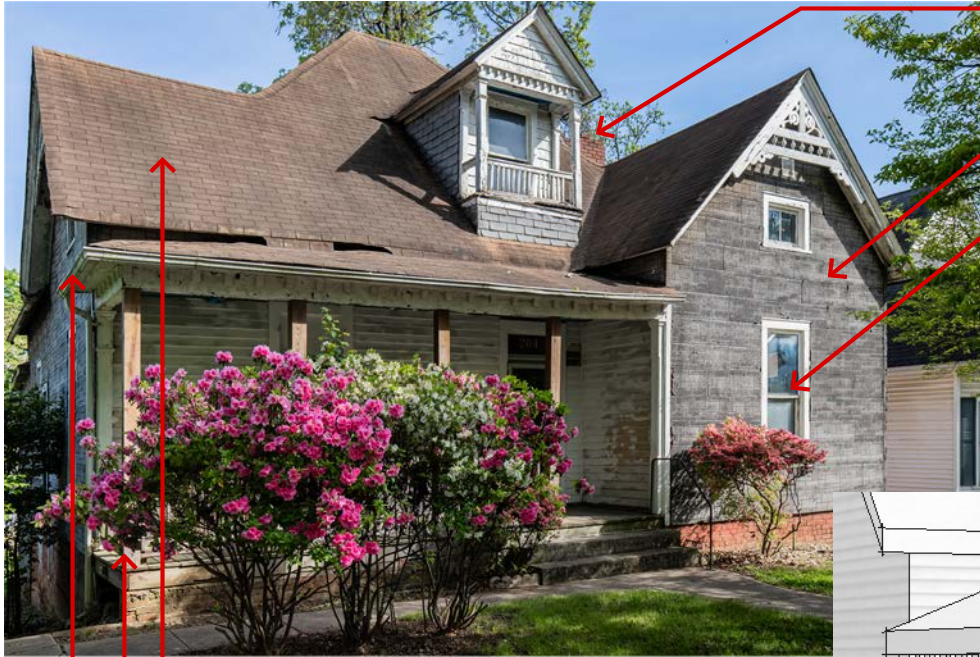
Repair masonry chimney between living and dining room

Remove asphalt siding from exterior, repair original wood siding underneath

New wrought iron handrail at steps

Concrete steps to remain

Façade (northwest elevation): removal of temporary porch supports and installation of new painted wood columns to match originals in size, detail, and placement. Repair to original porch beam and dentil molding. Replacement of skirtboard with new painted wood skirtboard to match original in size and profile. New wrought iron handrail on right side of steps. Concrete steps to remain.

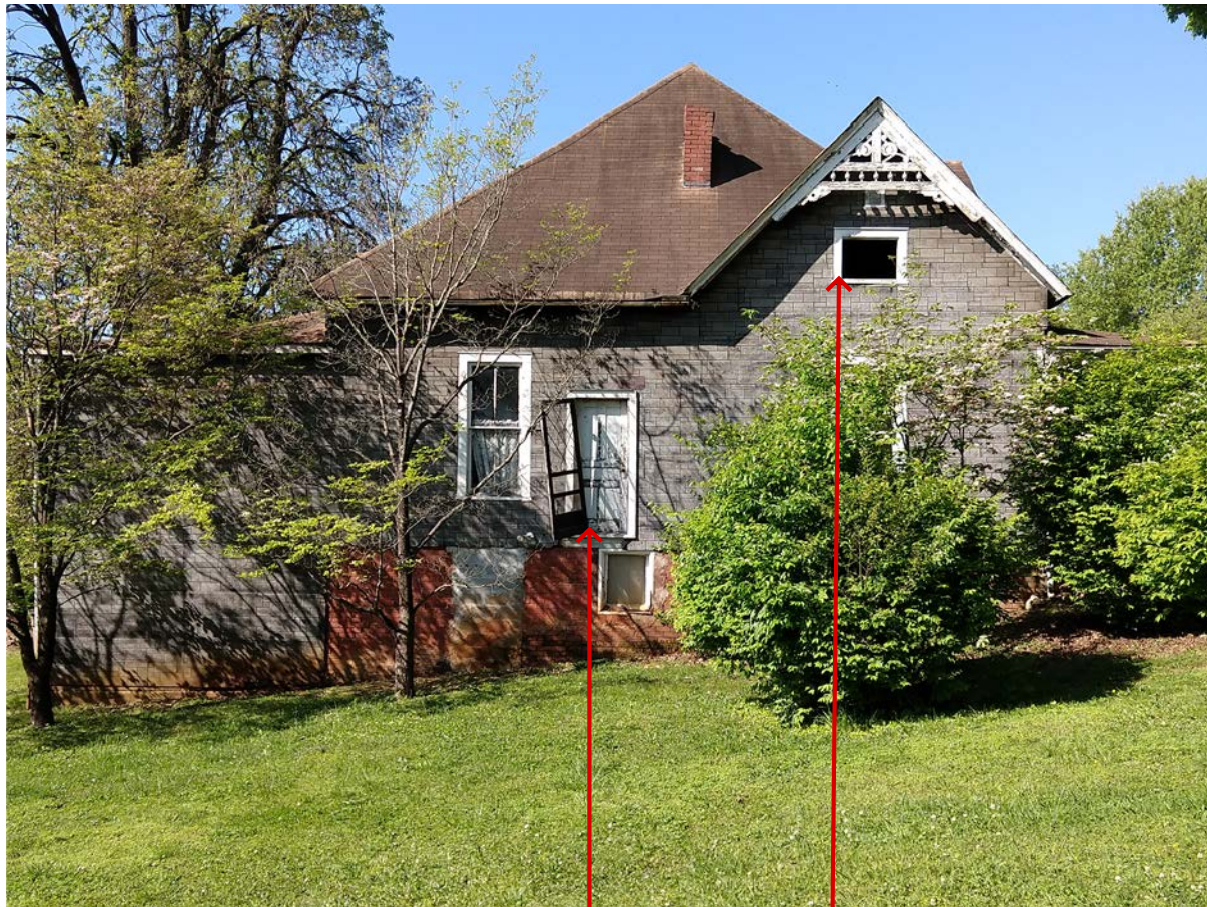
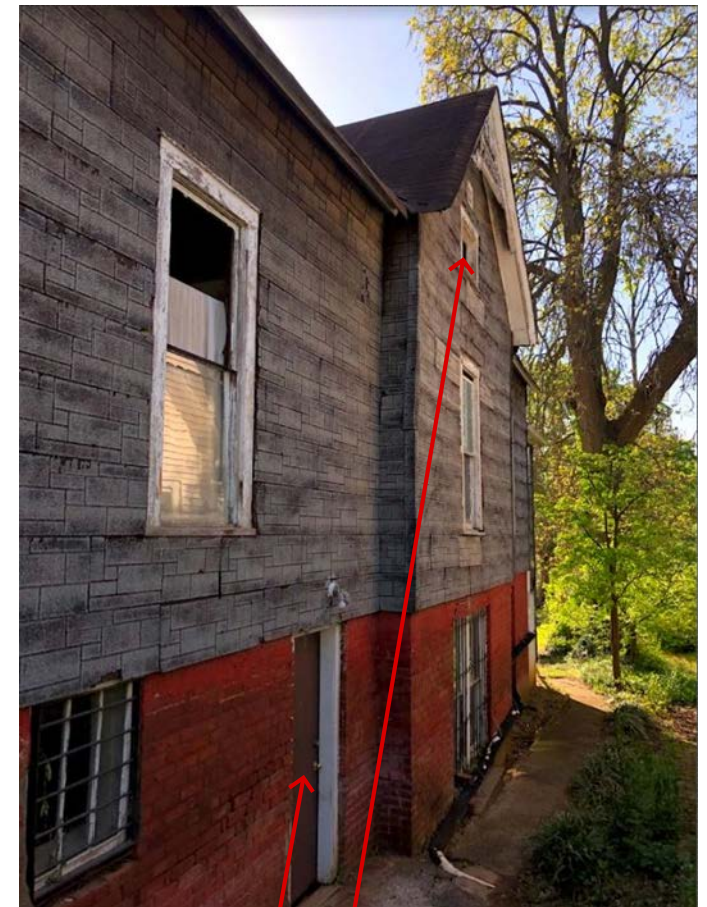
Remove "floating door." Cover opening with siding to match original.

Remove this basement door, replace with brick to match foundation brick.

Remove this kitchen chimney. This is the only angle of the house from which it can be seen.

This old addition on the rear is water-damaged beyond repair. It will be removed, saving any windows or other in-tact historic elements that can be reused. A new addition will be built in the old footprint; see next page.

Left side (northeast elevation): removal of "floating" secondary door (no deck or porch access); opening to be enclosed with siding to match original. Removal of basement door; opening to be enclosed with brick to match foundation brick. Gable windows on left (northeast) and right (southwest) side elevations to be increased in head height by 6" to create egress windows; new casement windows to be built to match original style of windows. New wood trim on gable windows to match existing.

- Removal of interior brick masonry chimney on rear roof slope.
- Rear addition (two-story, shed-roof section) is deteriorated and proposed to be removed. New addition to be constructed in the same footprint, with a standing-seam metal shed roof in the same placement as existing. New rear addition will feature wood lap siding, above a brick-clad foundation, separated by a water table trim band. The rear addition will feature two four-light, fixed wood windows (salvaged from original addition if possible) on the left half, followed by one multi-light French door (accessing the new deck) followed by a bay of multi-light wood casement windows.

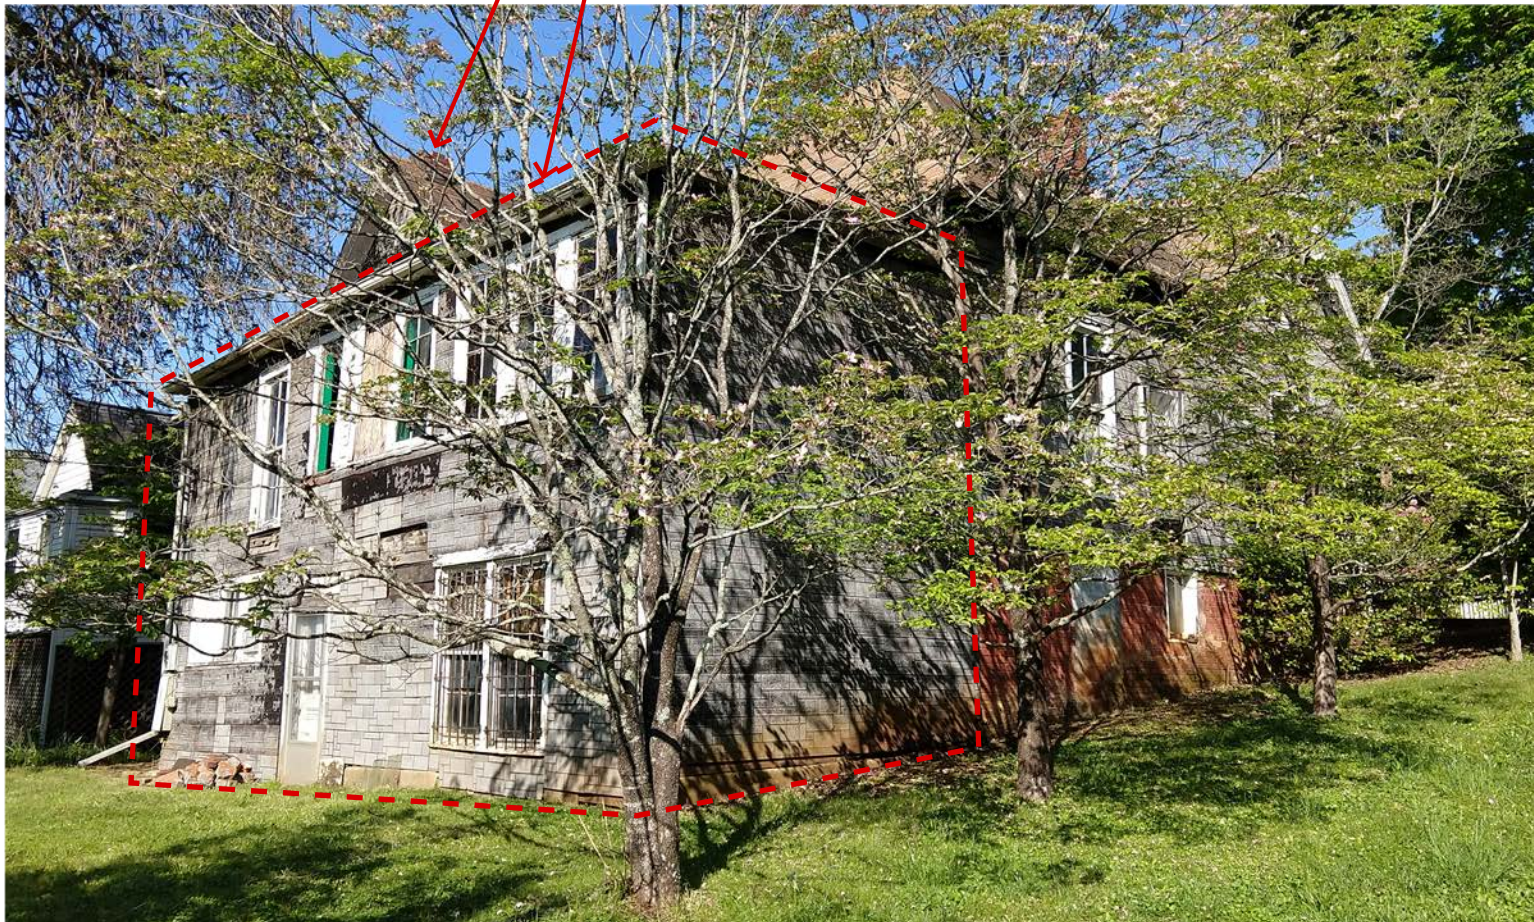
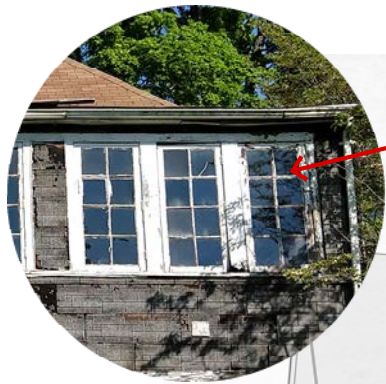
New wood double casement window. Trim, frame, and muntin profiles to match original windows on house. Photo shows original windows to be used as basis of design.

New partially-covered deck above garage. Columns and railing posts (6x6 size) to have chamfer detail similar to front porch columns.

- Garage/deck addition: a new wood deck above a two-car garage will project from the right half of the rear elevation. The garage (at basement level) will feature two carriage-style garage doors to match submitted specifications facing the rear property line, a brick foundation, and two new wood double-hung windows (52" by 38") on the right side elevation. New basement windows will match design of original basement-level windows. The deck will be partially covered (right half) with a flat roof, supported by 6 by 6 columns with chamfer detail similar to front porch. Deck railing and posts to reflect renderings in application.

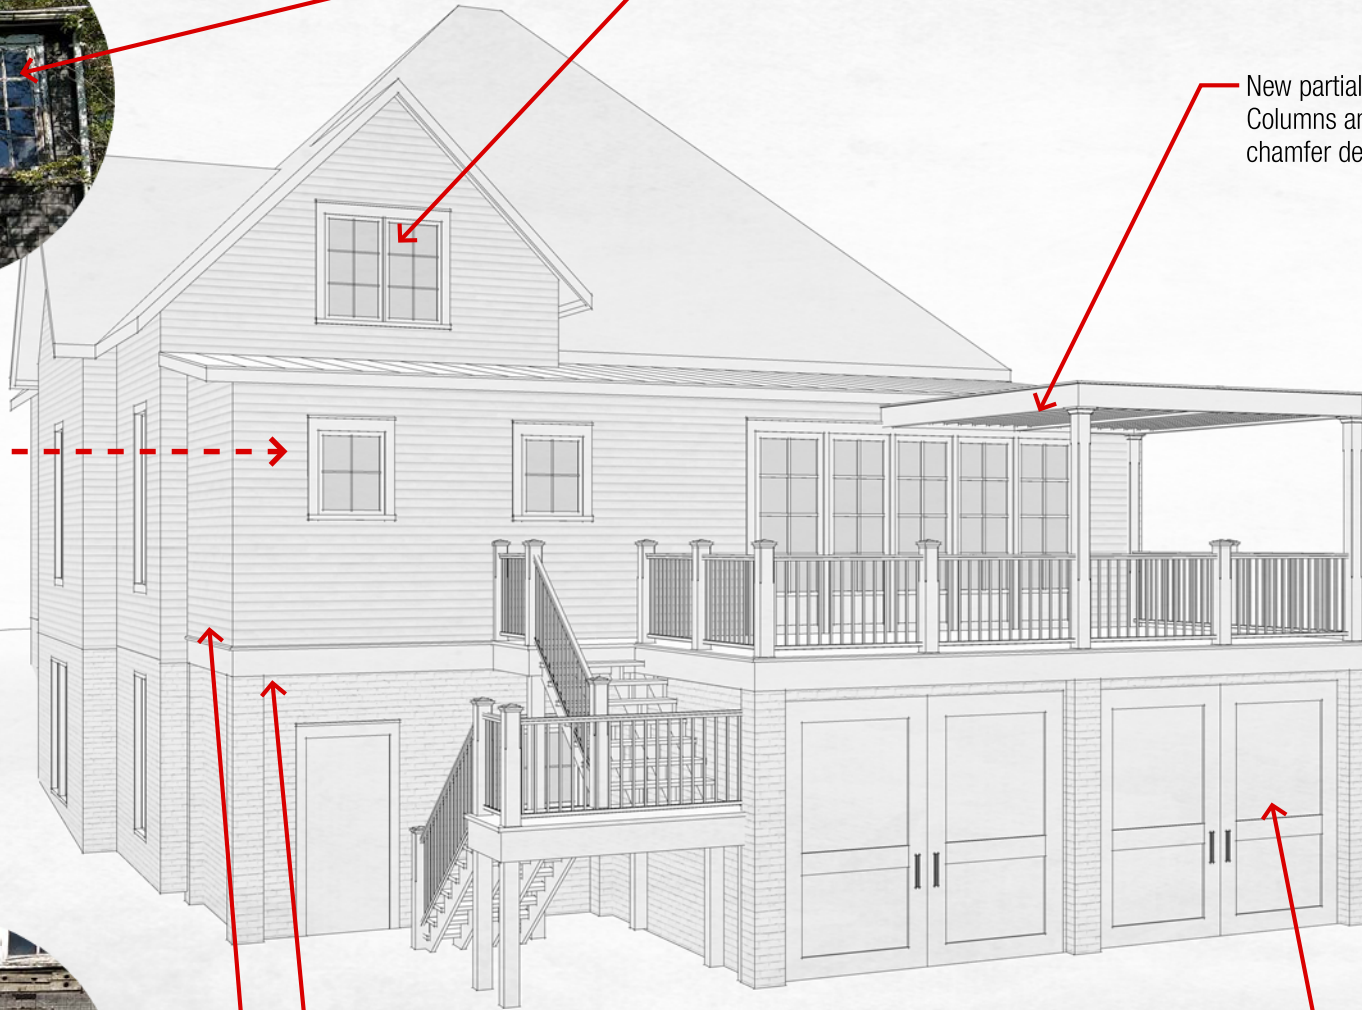
Carriage-style garage doors. See attached specification.

Water table trim band divides lap siding and brick foundation; continues around deck.

New, reconstructed addition. Main level to have lap siding to match original, lower level to have brick cladding to match house foundation.

Salvage these windows for reuse if possible

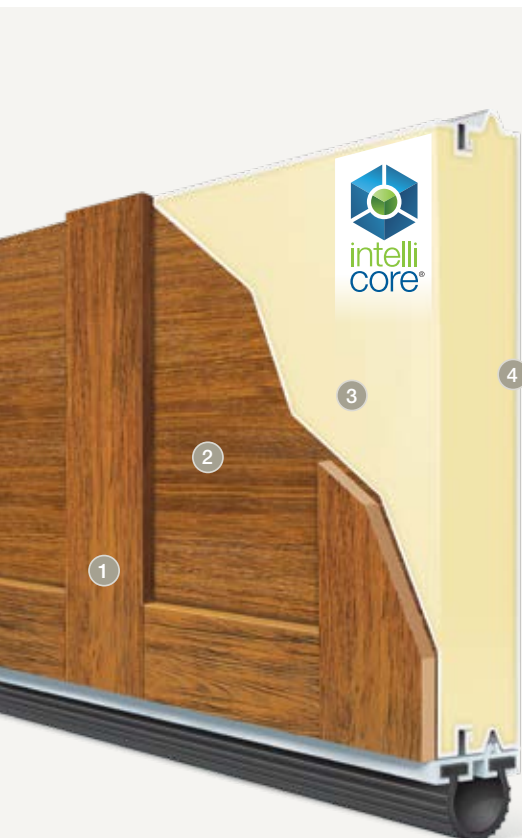
Design 35

## 4 LAYER CONSTRUCTION

- 1 COMPOSITE OVERLAY
- 2 STEEL WITH ULTRA-GRAIN® PAINT FINISH (SHOWN) OR SOLID COLOR STEEL
- 3 2" INTELLICORE® POLYURETHANE INSULATION
- 4 STEEL

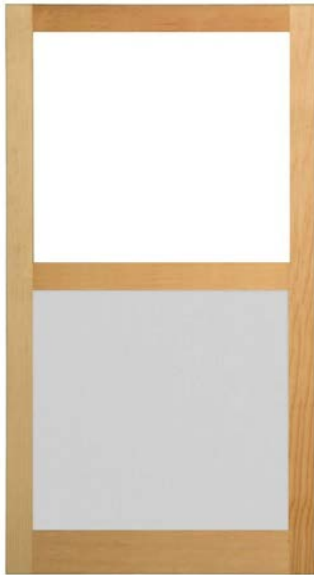
## SELF-STORING STORM/SCREEN WINDOW

### GENERAL

Made from clear pine — no finger joints

3. The proposed storm windows meet the design guidelines, which recommend wood or color clad metal, and should be installed so that the meeting rail duplicates the original window and they do not damage or obscure the original window or frames.
