3-B-21-HZ
APPLICATION FOR CERTIFICATE OF APPROPRIATENESS

2328 Jefferson Ave. 37917
Edgewood-Park City H

Petitioner: Matthew and Amanda Beard

Location: 2328 Jefferson Ave. **Parcel ID** 82 J T 010
District: Edgewood-Park City H
Zoning: RN-2 (Single-Family Residential Neighborhood)
Description: Queen Anne cottage, c.1910

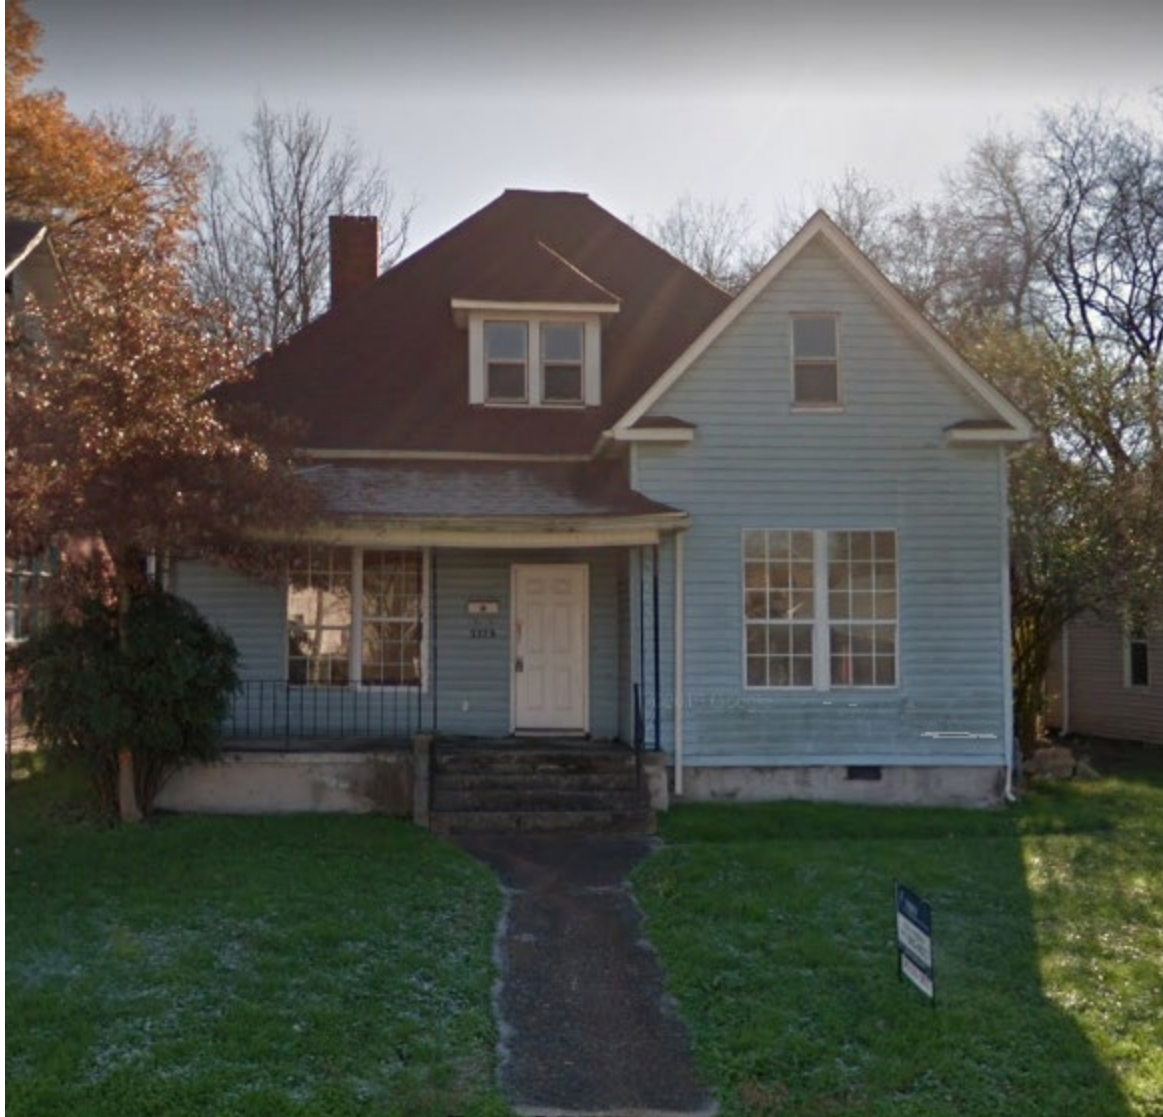
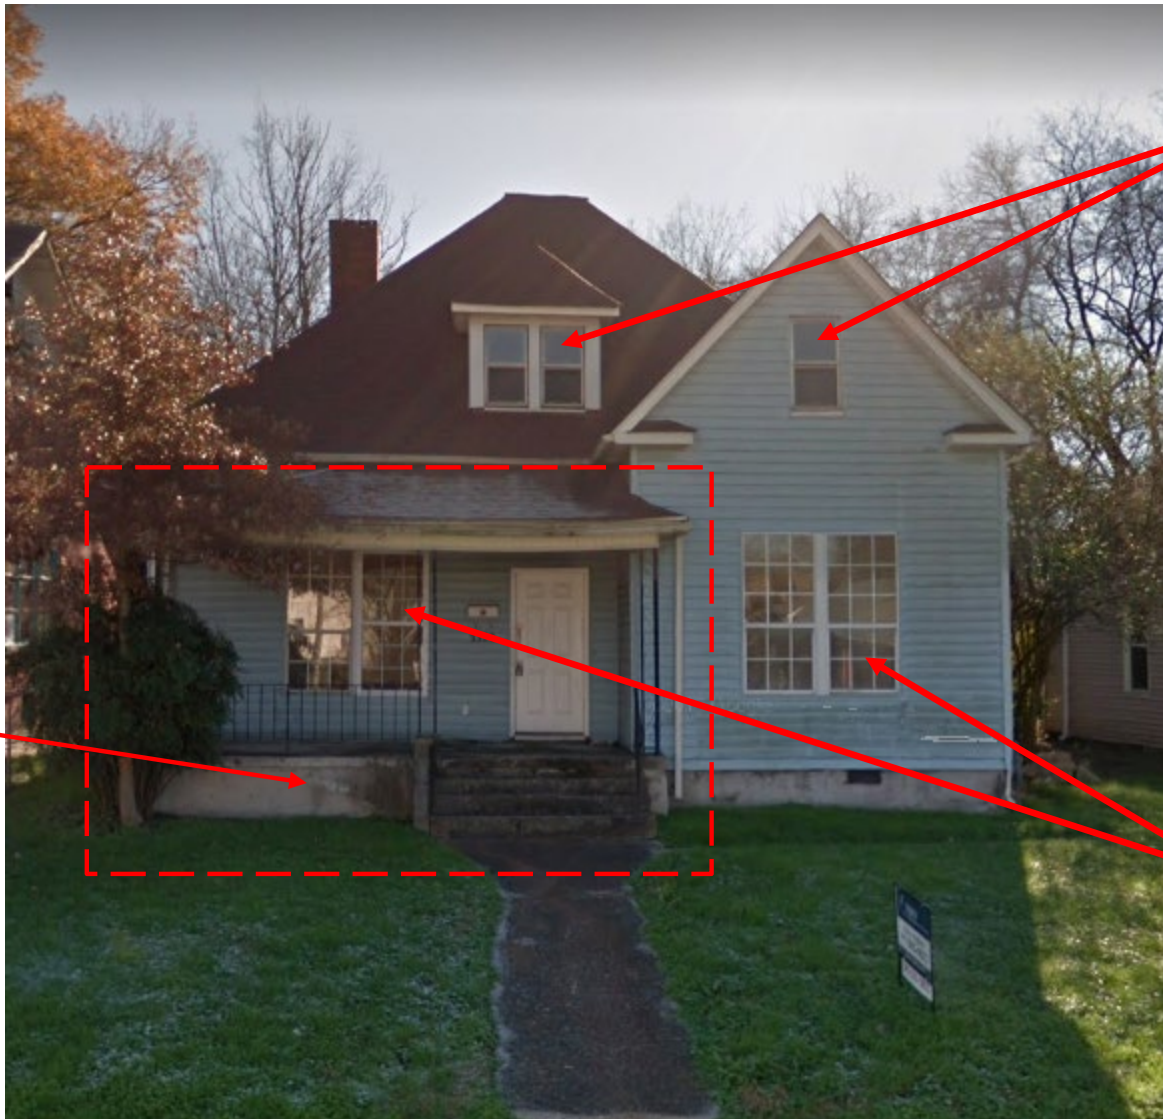
Original Windows

Concrete Porch w/steel columns correct size but not original. Creating structural issues with house front wall.

Non-historic Replacement Windows

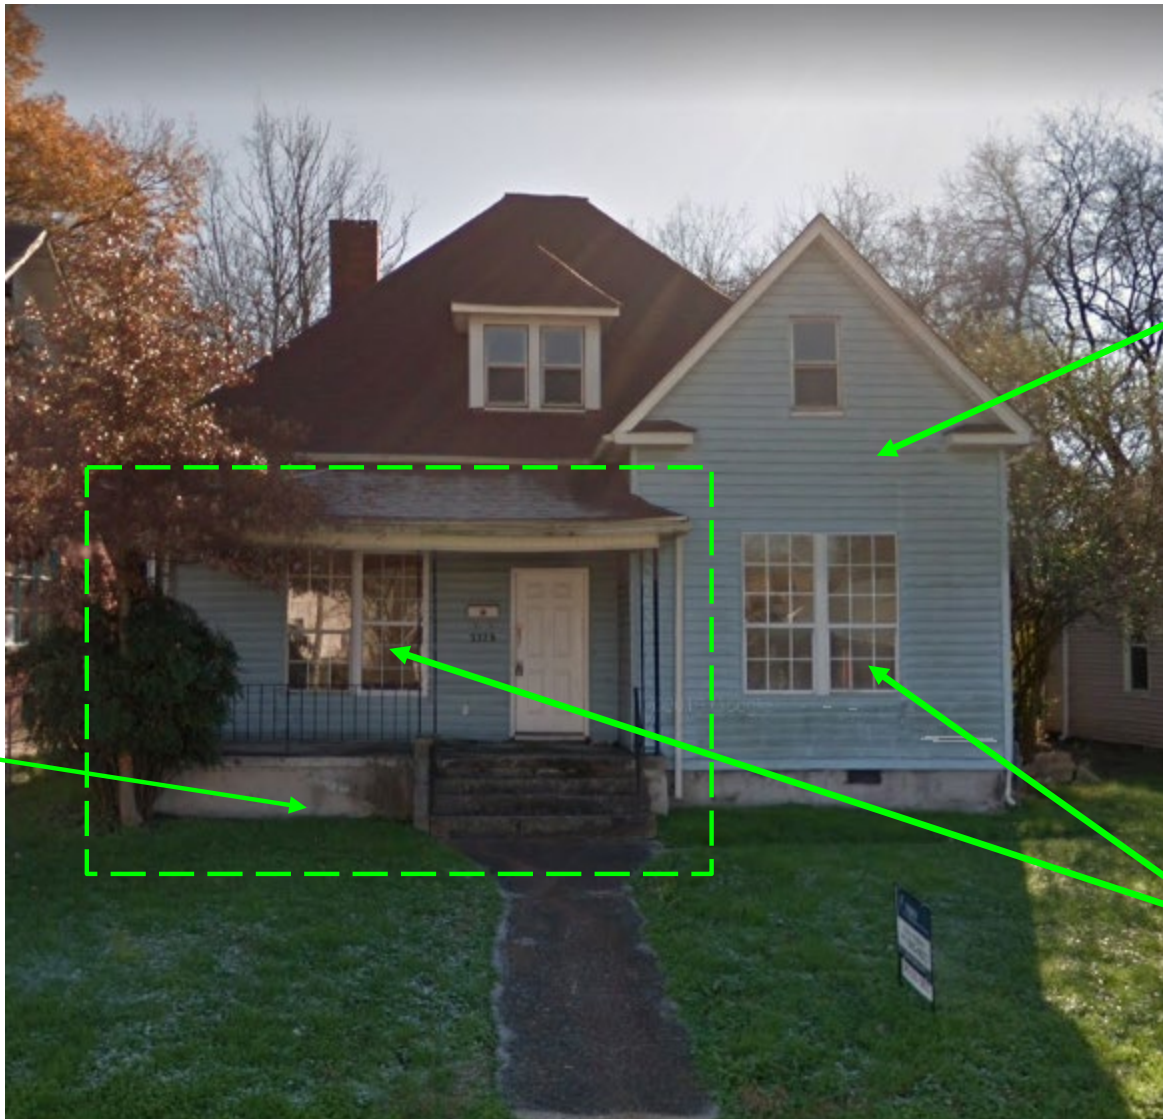
Front wall of house to be lifted and foundation repaired. Concrete porch floor to be replaced with wood as original, w/wood columns + railings

Vinyl siding to be removed, original wood siding / details to be restored/repainted.

Vinyl/aluminum windows to be replaced with wood framed windows

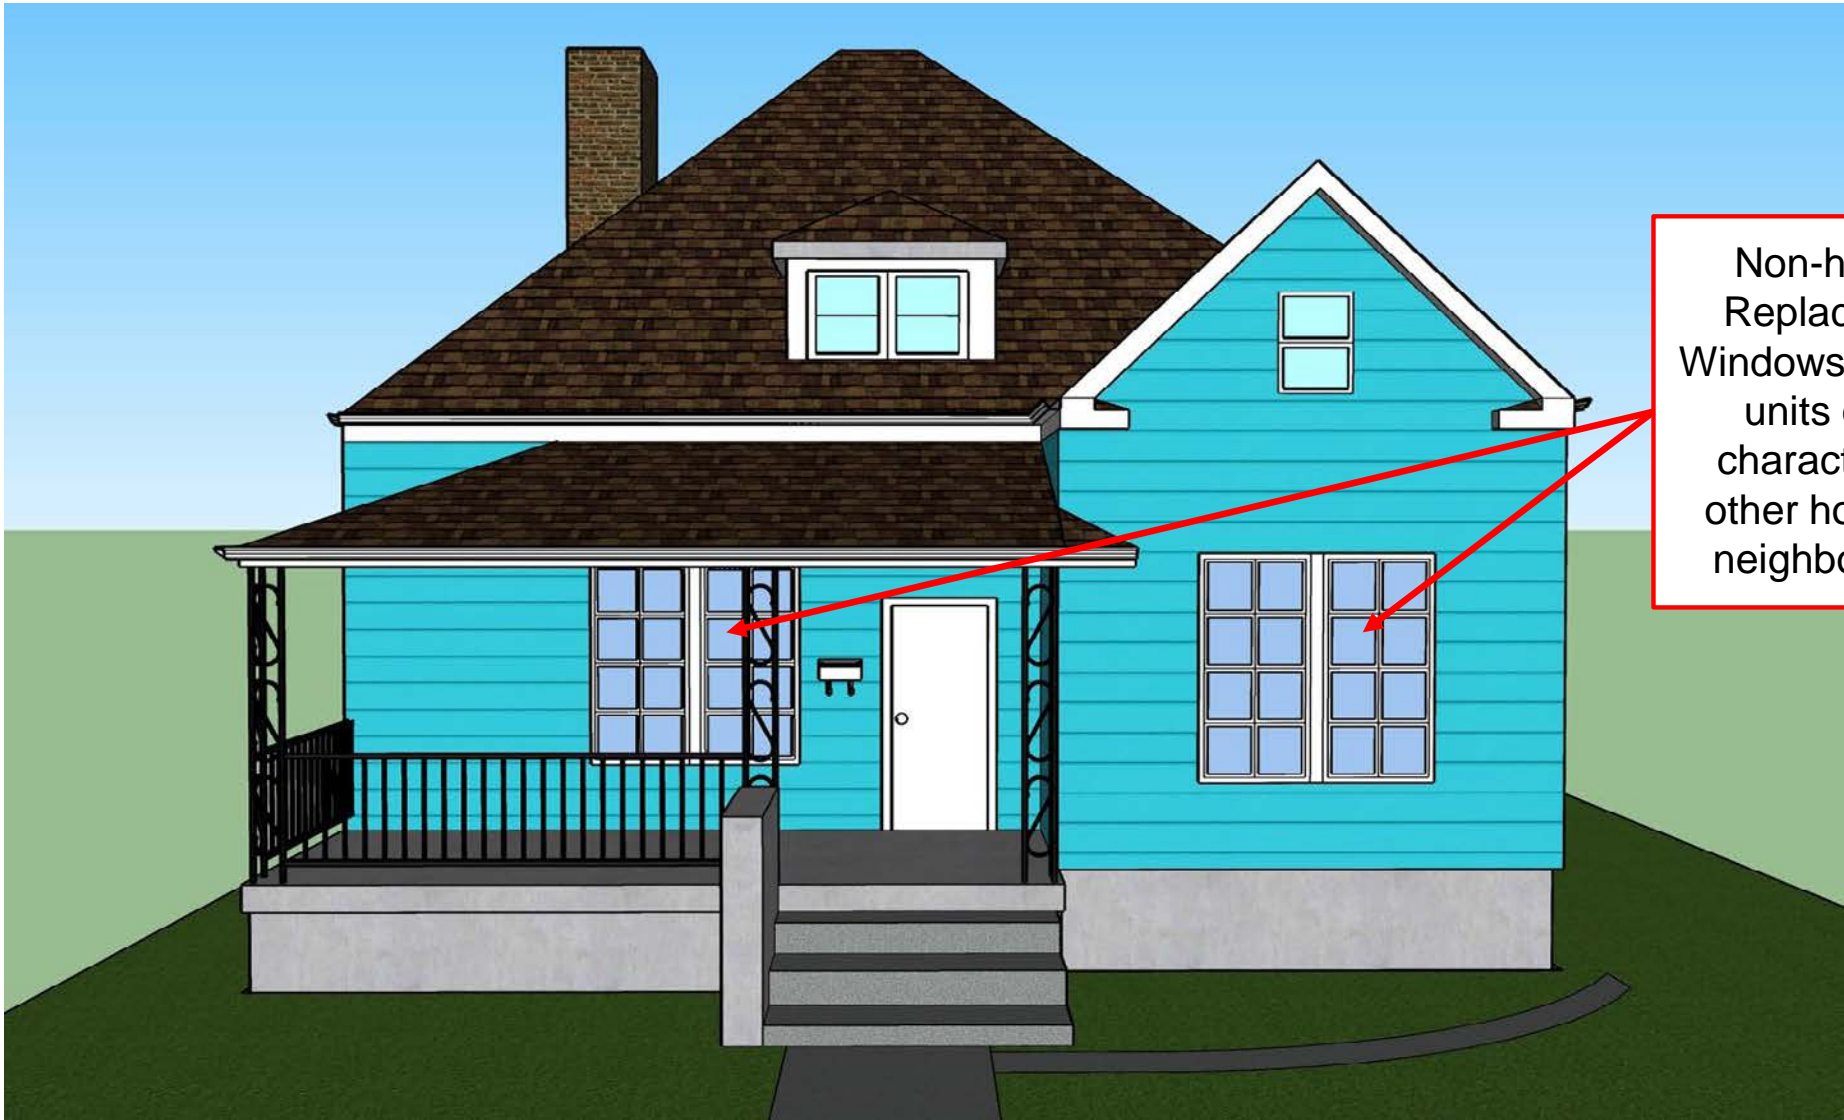
Non-historic Replacement Windows. Double units out of character with other houses in neighborhood.

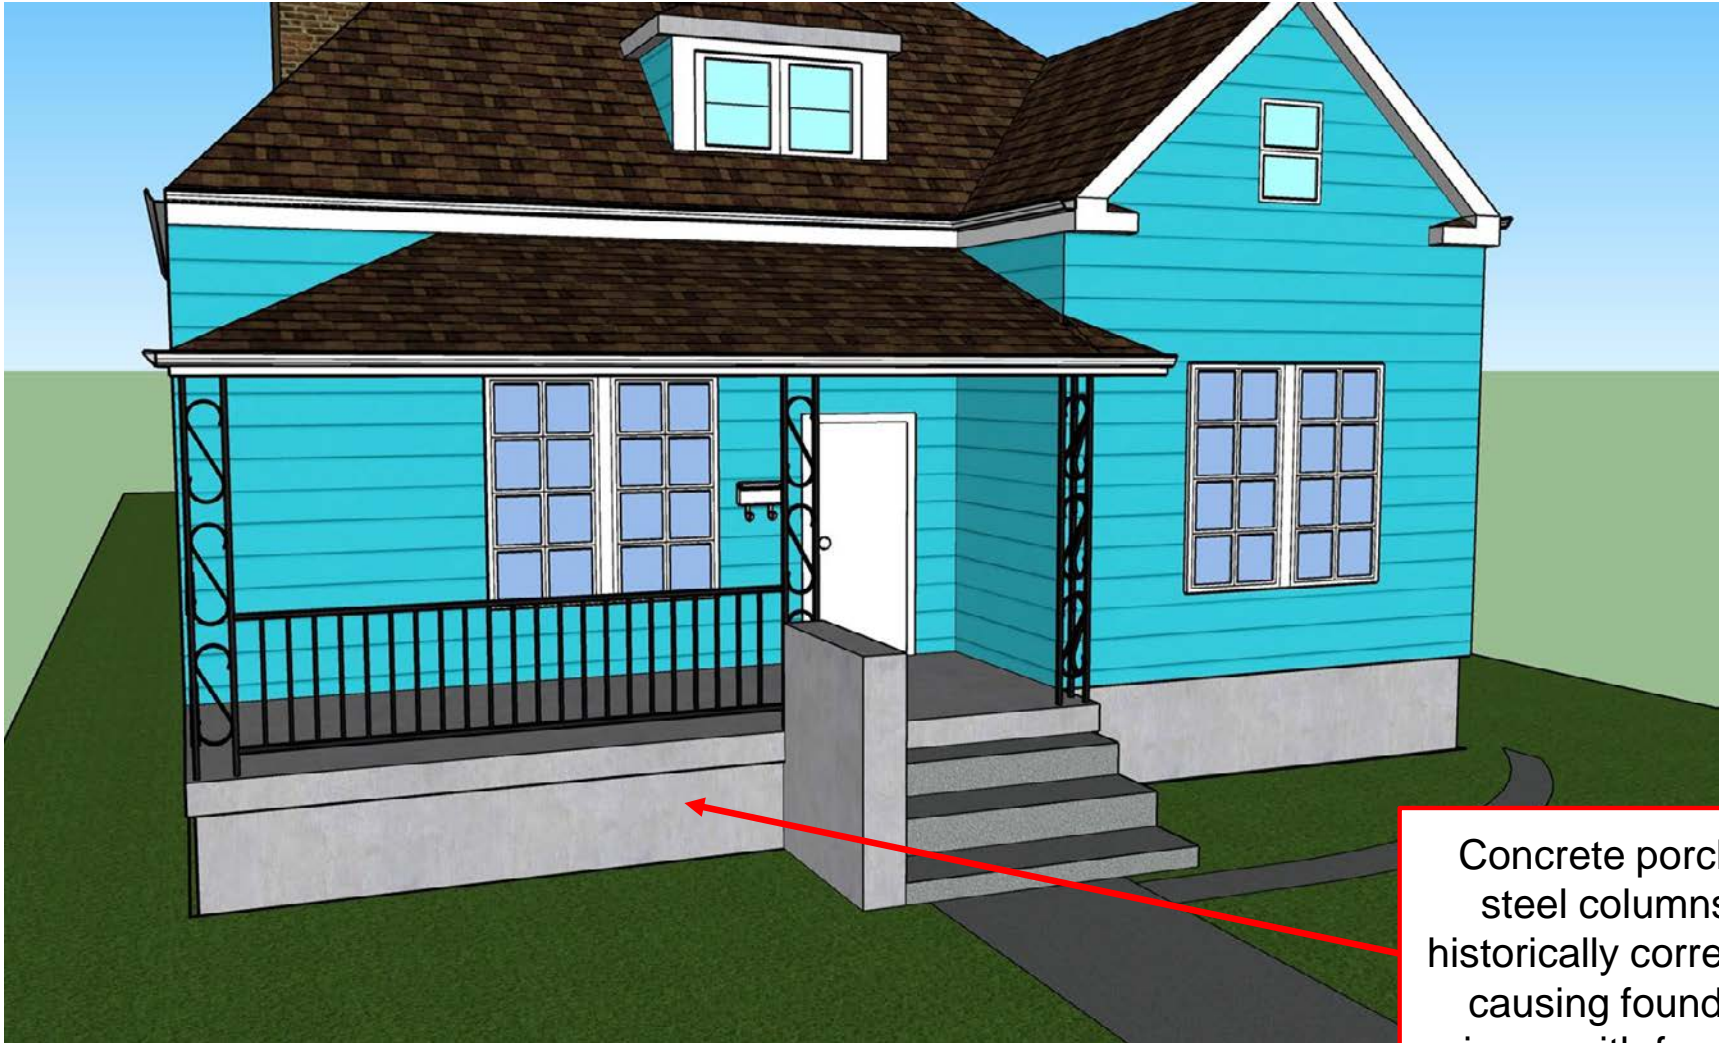
Concrete porch with steel columns not historically correct, also causing foundation issue with front wall

4. The porch reconstruction will not expand the existing footprint or modify the roofline. Removing the concrete porch floor (a porch floor material discouraged by the design guidelines) and replacing with wood tongue-and-groove flooring on a stuccoed foundation is appropriate.

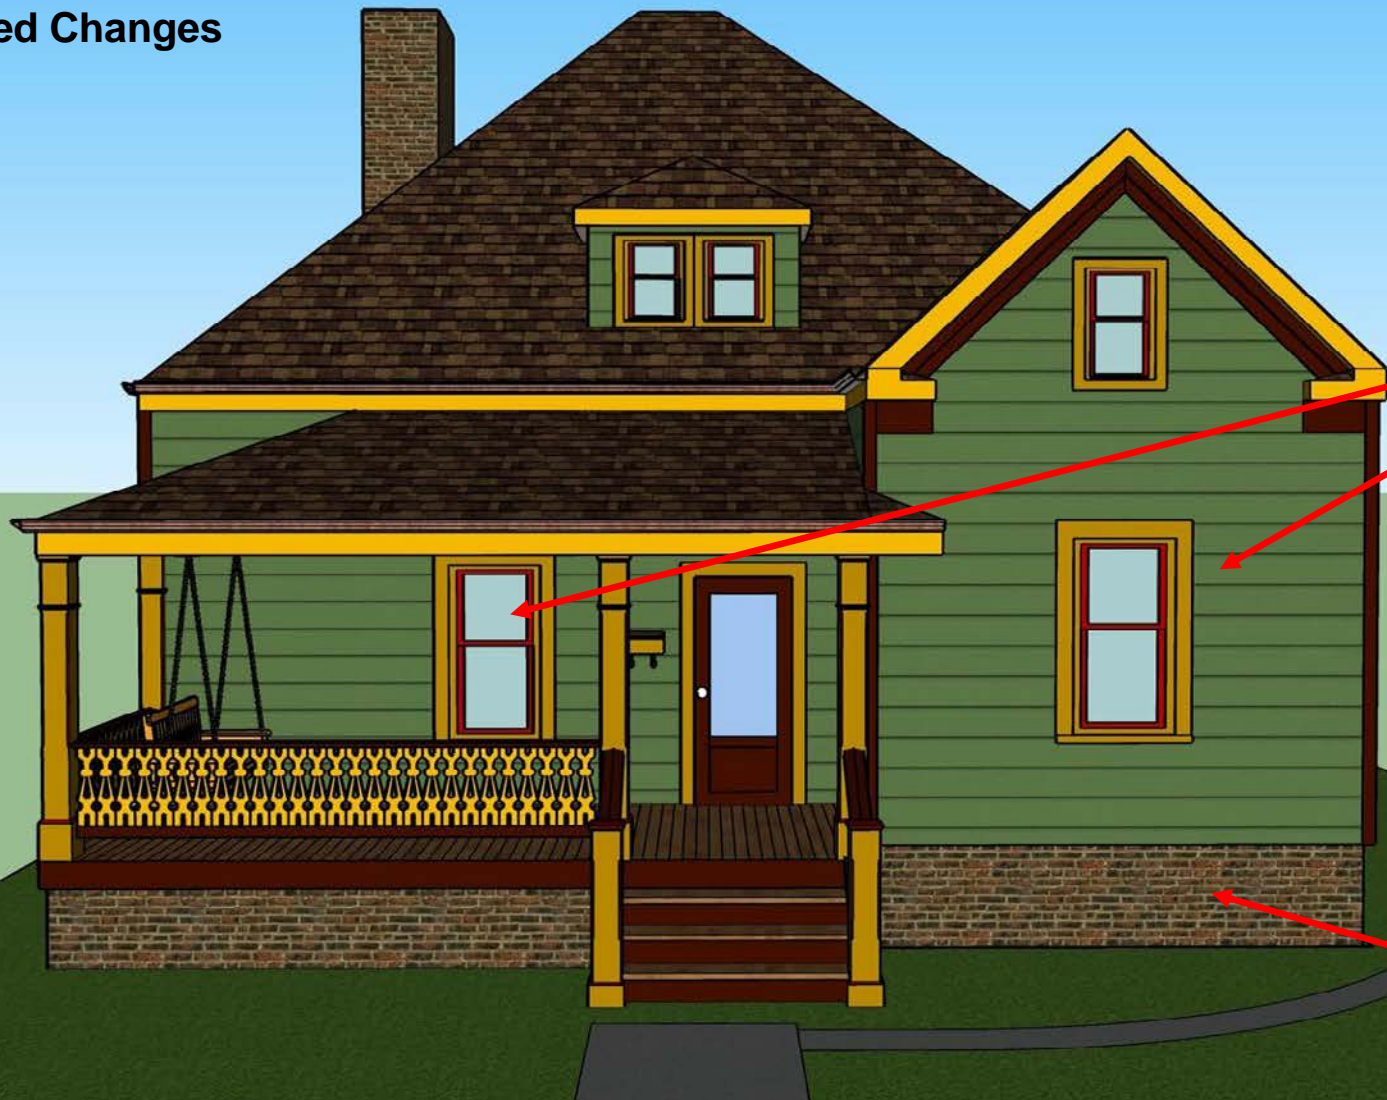
Proposed Changes

Replace existing windows with restored historic units, 1/1 singles of appropriate size

Original brick foundation plastered over, uncover/repoint

3. The replacement of one-over-one, double-hung wood windows with wood trim meets the design guidelines. The proposed replacement window on the front porch matches a similar window on an adjacent property and a Sears Roebuck catalogue from 1910. If the applicant is unable to find a window in the submitted design, a 1/1 double-hung wood window would also be appropriate.

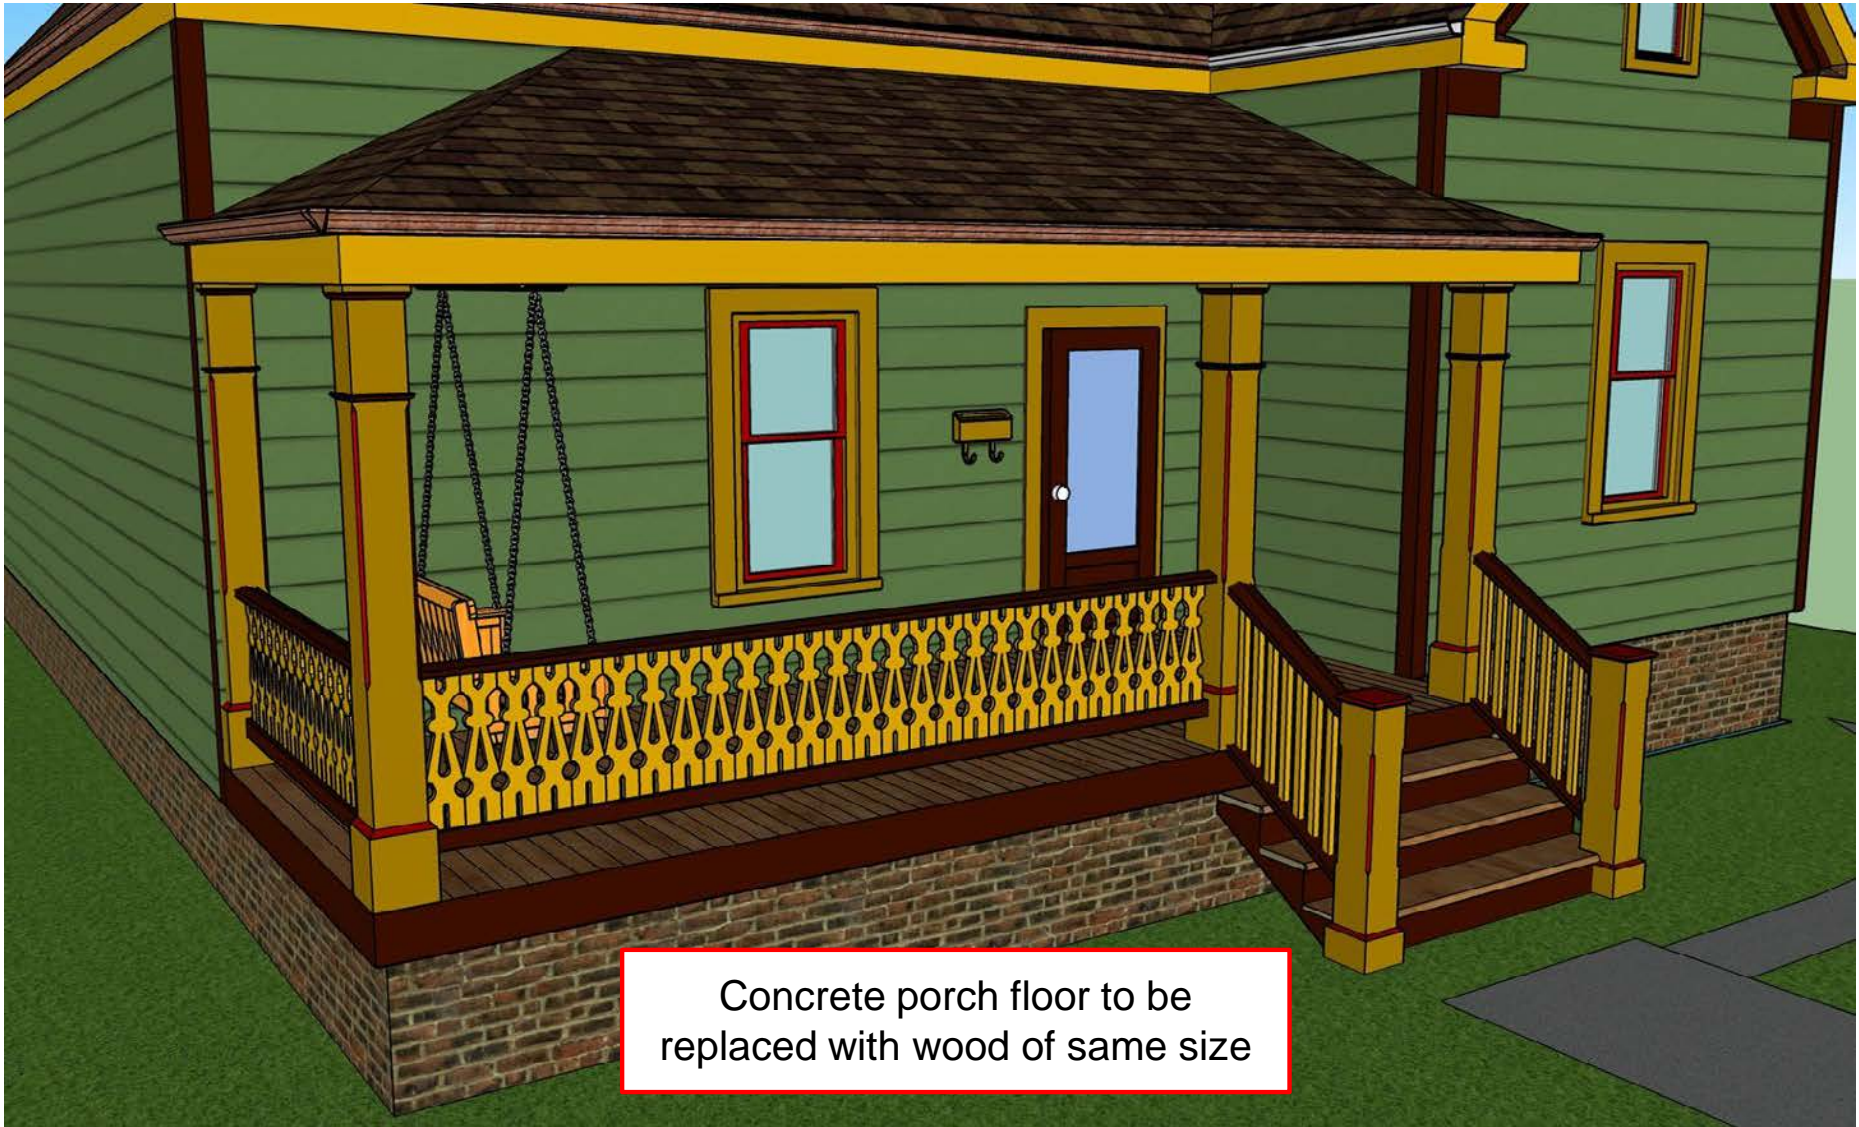
Concrete porch floor to be replaced with wood of same size

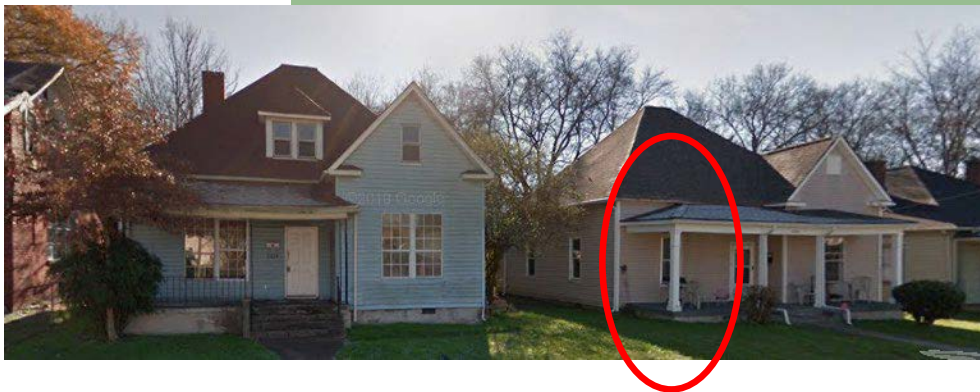
Proposed Porch Facade Details

New columns to be fabricated using measurements taken from a surviving column from neighbor's house of same design and era, located 50 feet away.

5. The porch work also includes the removal of non-historic wrought iron columns and railing and installation of wood materials. The dimensions and design of the proposed square wood columns with simple trim at the top and bottom will reflect those on an adjacent, comparable house.

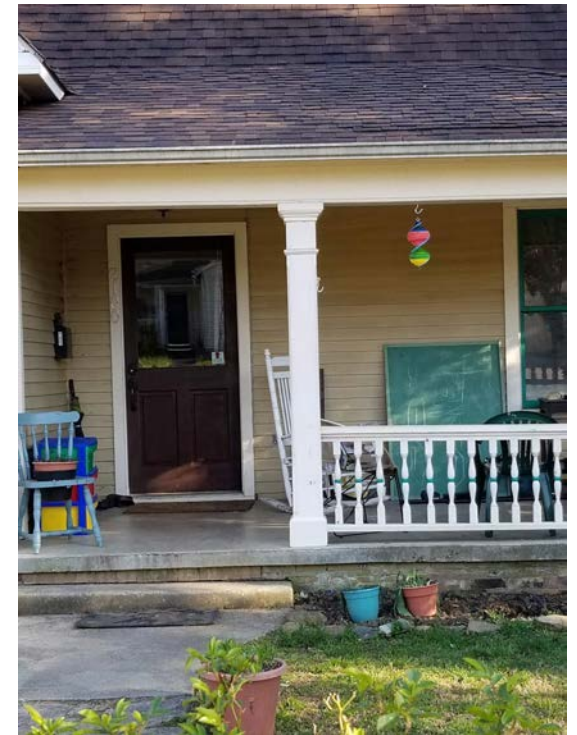
Example of front window shape and trim on neighborhood house. Porch post/column design as on two neighborhood houses on Jefferson Avenue.

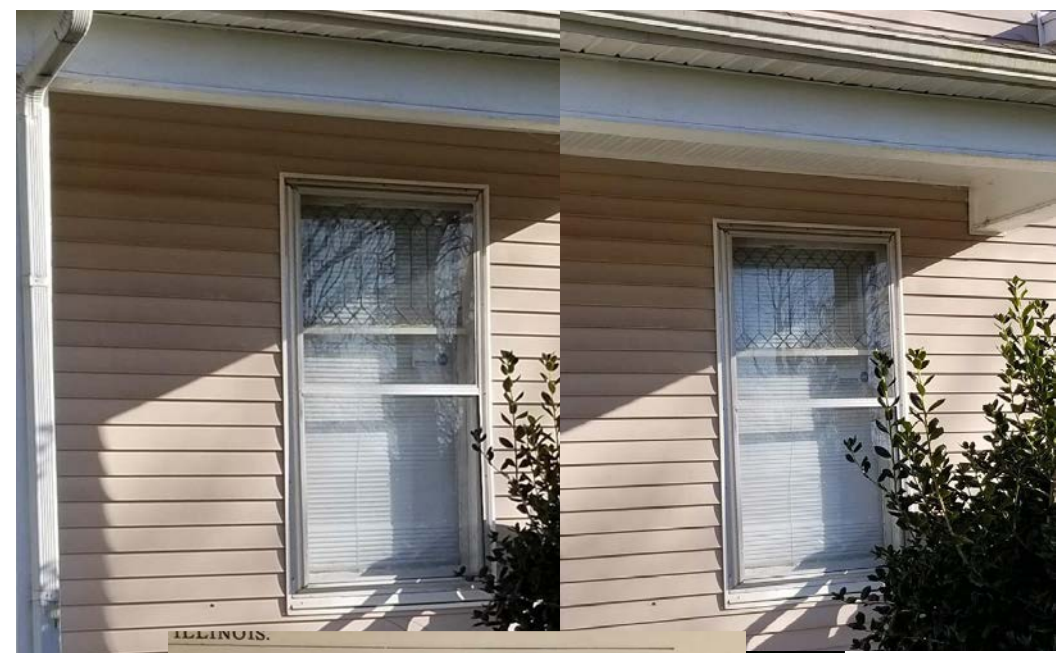
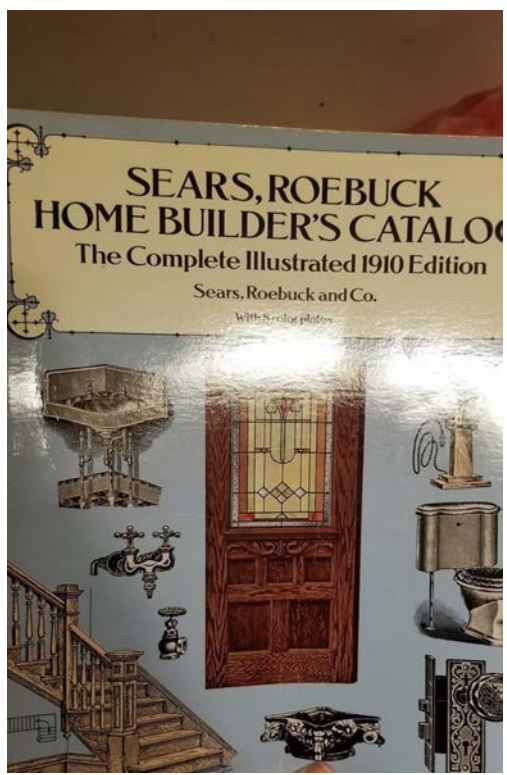
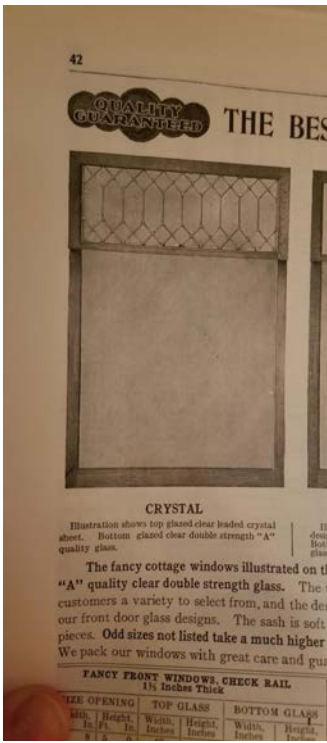
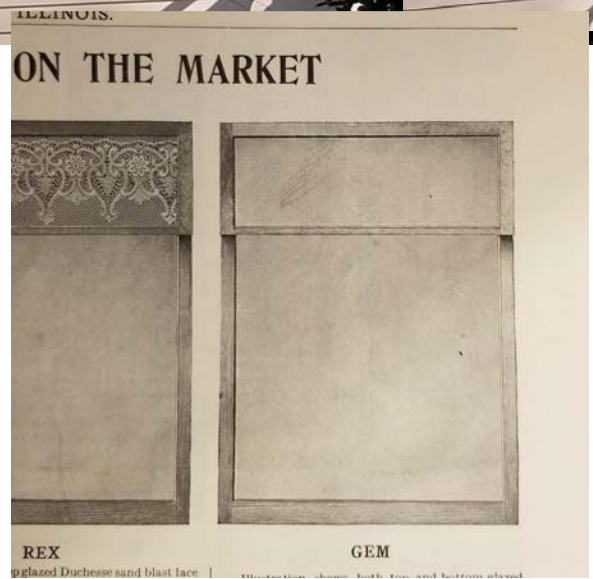
Front window replacement for under porch, similar to design on neighboring house and as advertised in a contemporary primary source. Source architectural salvage yard for replacement.

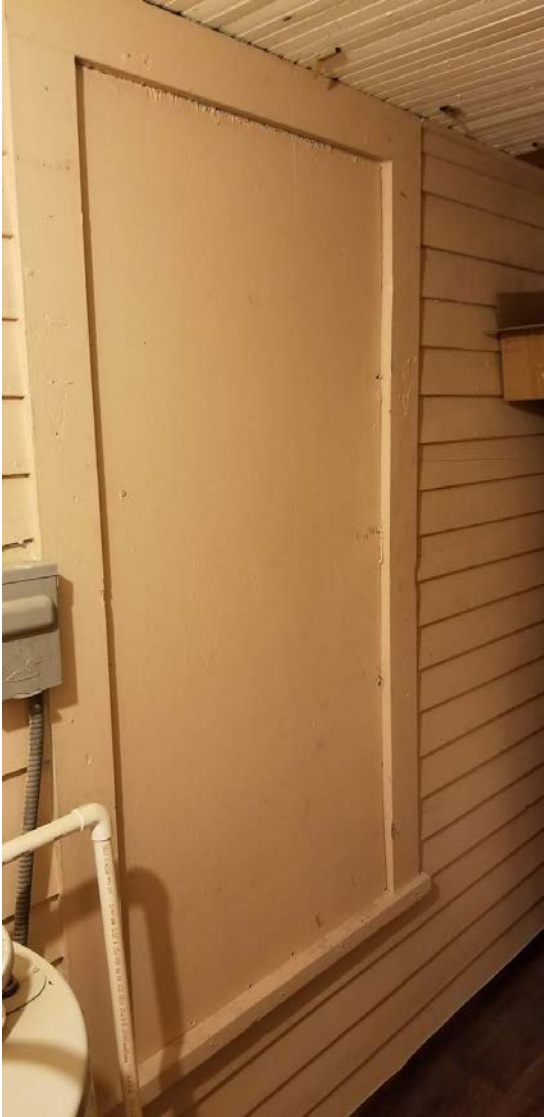
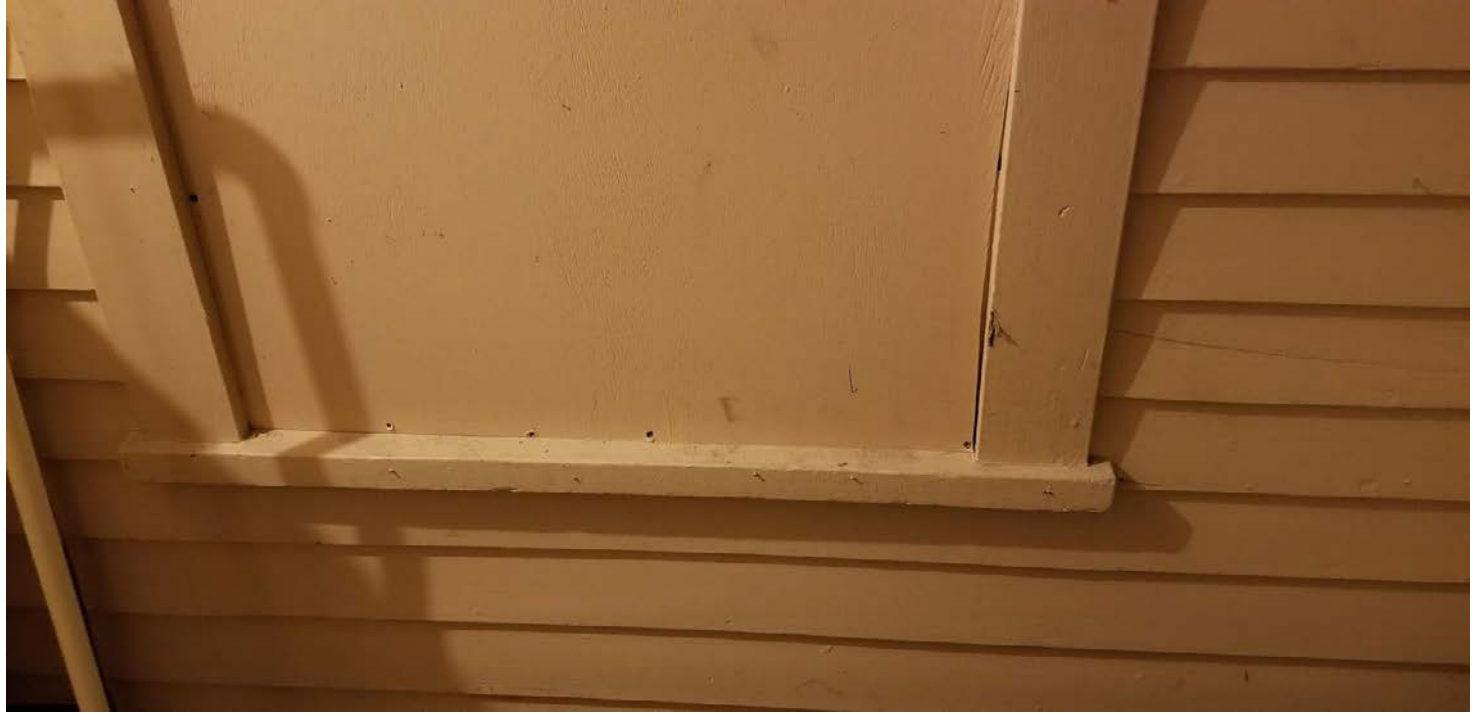
In situ window frame size and trim to be replicated on all exterior windows except for the front facade

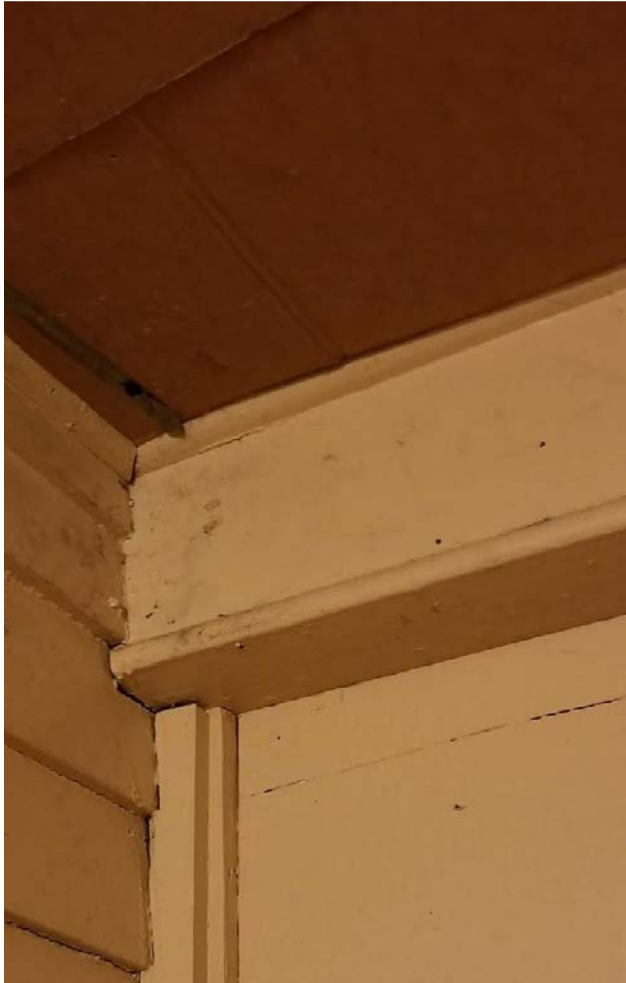
In situ exterior trim work on enclosed rear porch. This can be referenced as possible for the front porch. Details of the front porch are either removed or currently covered by vinyl siding and trim.

Enclosed rear porch includes wood lap siding and wood trim to be used as guide for window trim, siding exposure, and exterior trim details.

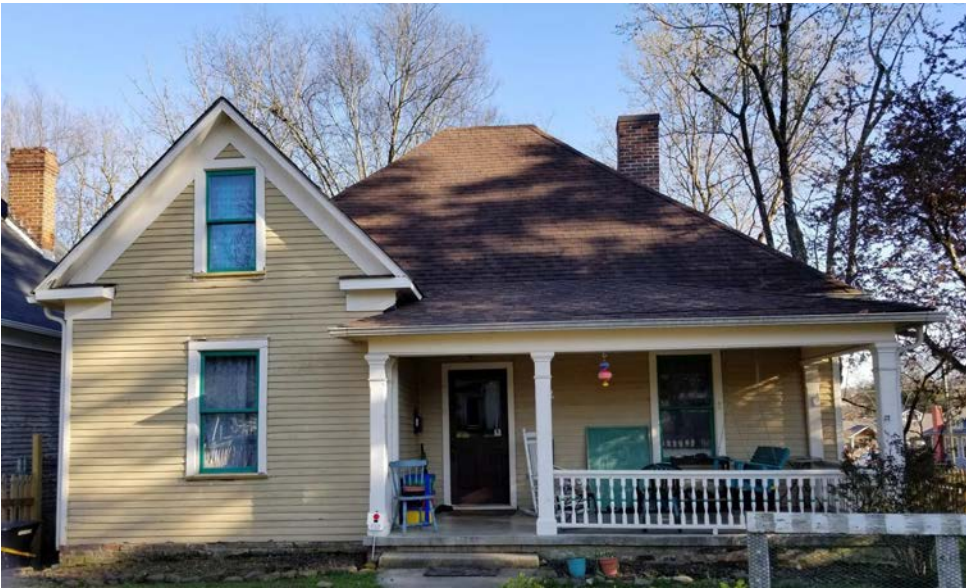
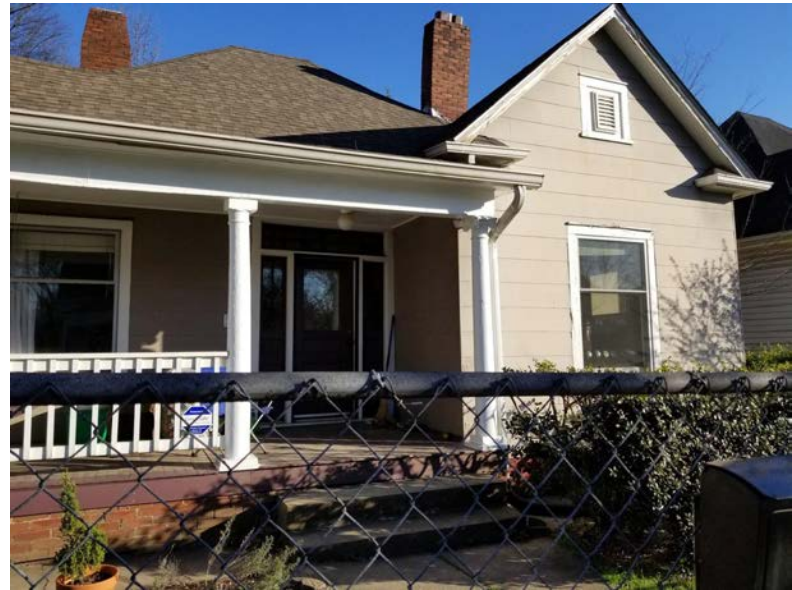
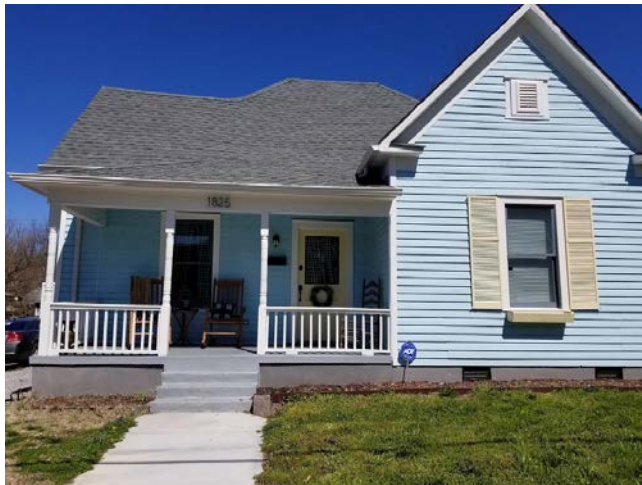
Similar sized and shaped structures in the same neighborhood.

Porch floor and columns/railings to be fabricated using surviving details on peer houses as guides.
