10-E-21-HZ
APPLICATION FOR CERTIFICATE OF APPROPRIATENESS

120 Leonard Place 37917
Old North Knoxville H

Original Print Date: 10/8/2021
 Knoxville/Knox County Planning -- Historic Zoning Commission

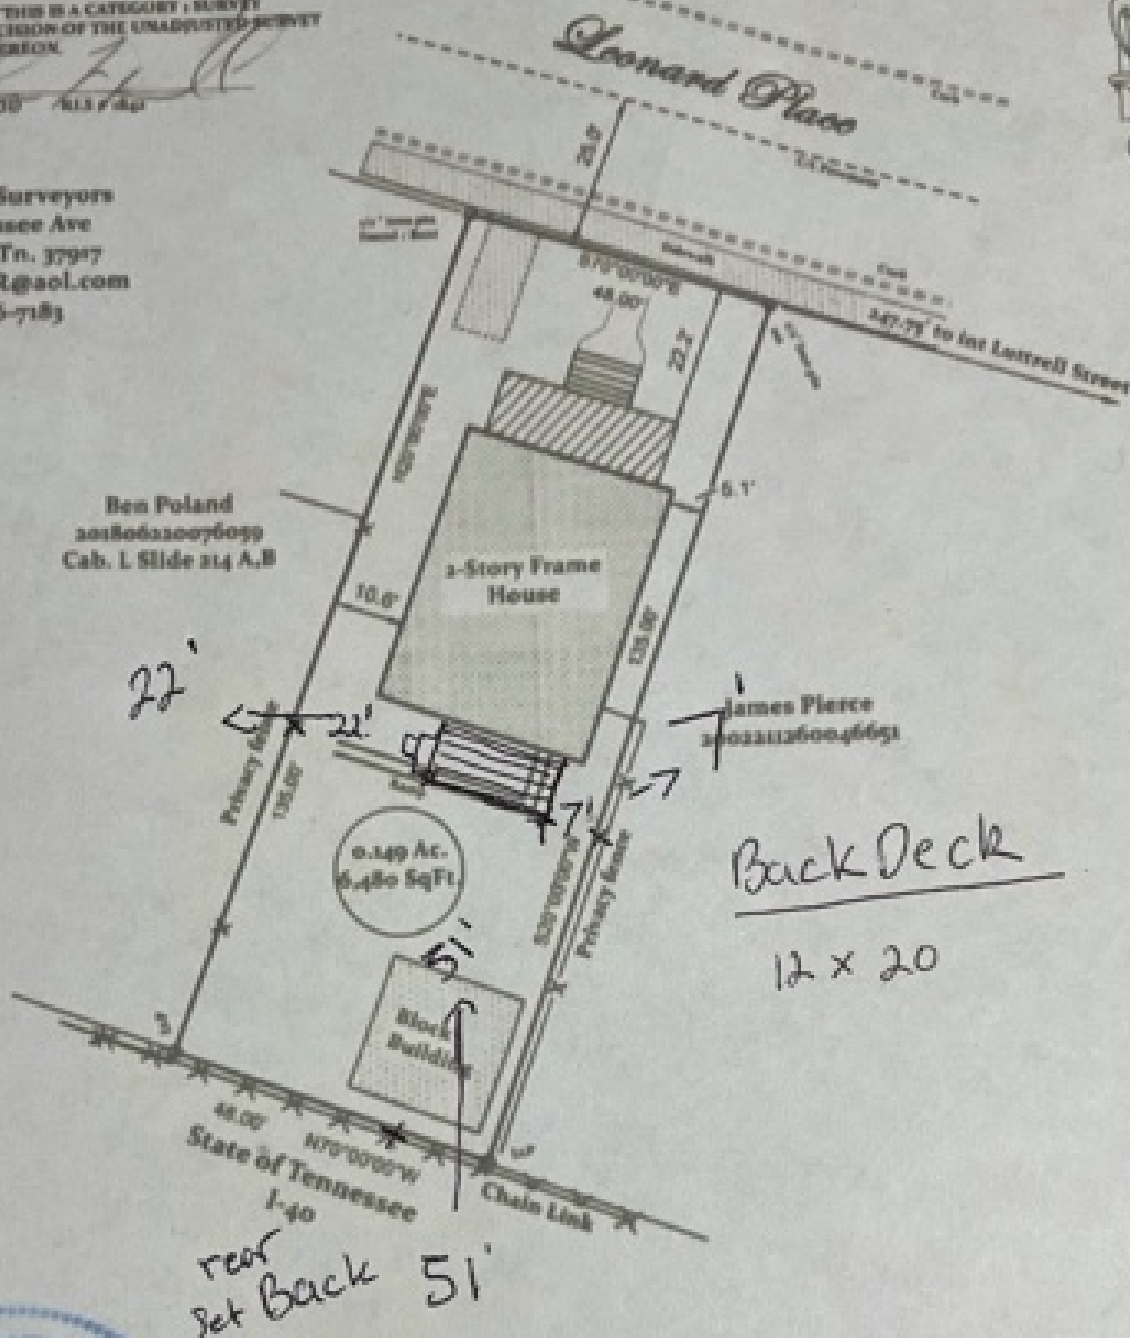
rear
 Set Back 51'

Survey of:
 Part lot # 11 Mayfield S/D
 Cab. A Slide 170-A-B
 Dist 3 Knox Co. Tn.
 11th Ward City of Knoxville
 CLT Map 81-L-H Parcel 4
 Deed Book 1922 Page 120
 Date Jan. 7, 2021
 Scale 1" = 30'
 City Block # 11262

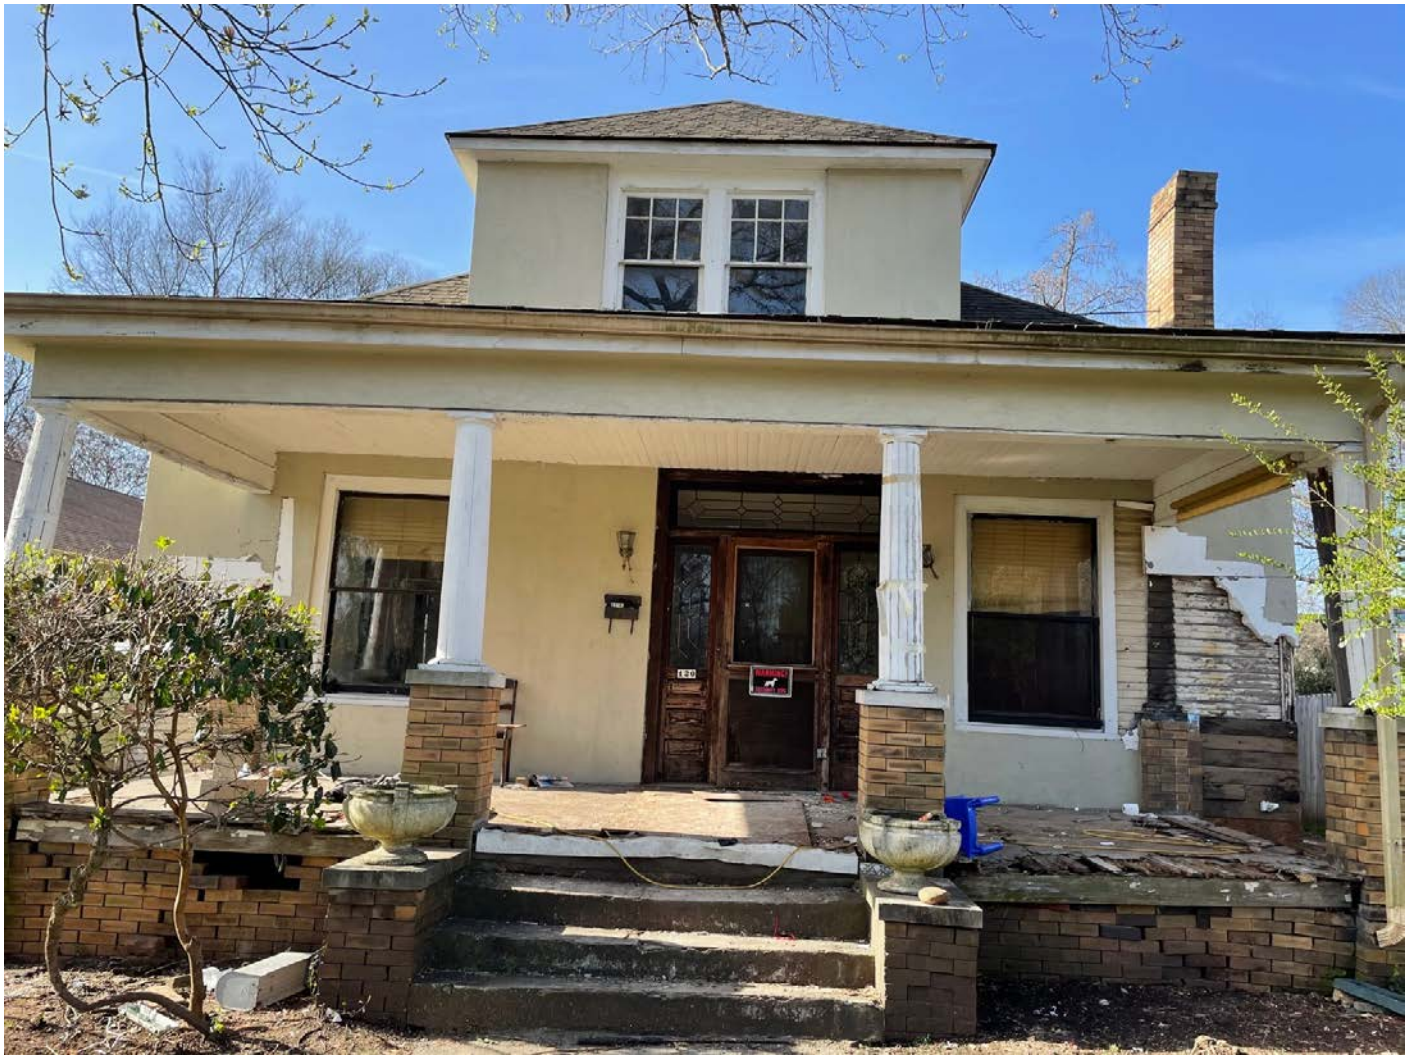
10"DIA. X 8'H ENDURA-STONE COLUMN,
ROUND SHAFT (FRP) W/TRUE ENTASIS
TAPER, TUSCAN BASE & TUSCAN
CAPITAL (PLAN TYPE A)

Columns: the four round wood columns on the façade were initially proposed for repair or replacement in-kind with solid round wood columns. The wood columns were determined to be rotted and incapable of supporting the porch roof; the applicant is requesting replacement with "Endura-stone" round fiberglass columns.
