Meeting: 1/20/2022**Applicant:** Sean Bolen**Owner:** Sean Bolen

Location: 115 E. Scott Ave.**Parcel ID** 81 K F 040**District:** Old North Knoxville H**Zoning:** RN-2 (Single-Family Residential Neighborhood)**Description:** Queen Anne, c.1890, 2006

1-E-22-HZ
APPLICATION FOR CERTIFICATE OF APPROPRIATENESS

115 E. Scott Ave. 37917
Old North Knoxville H

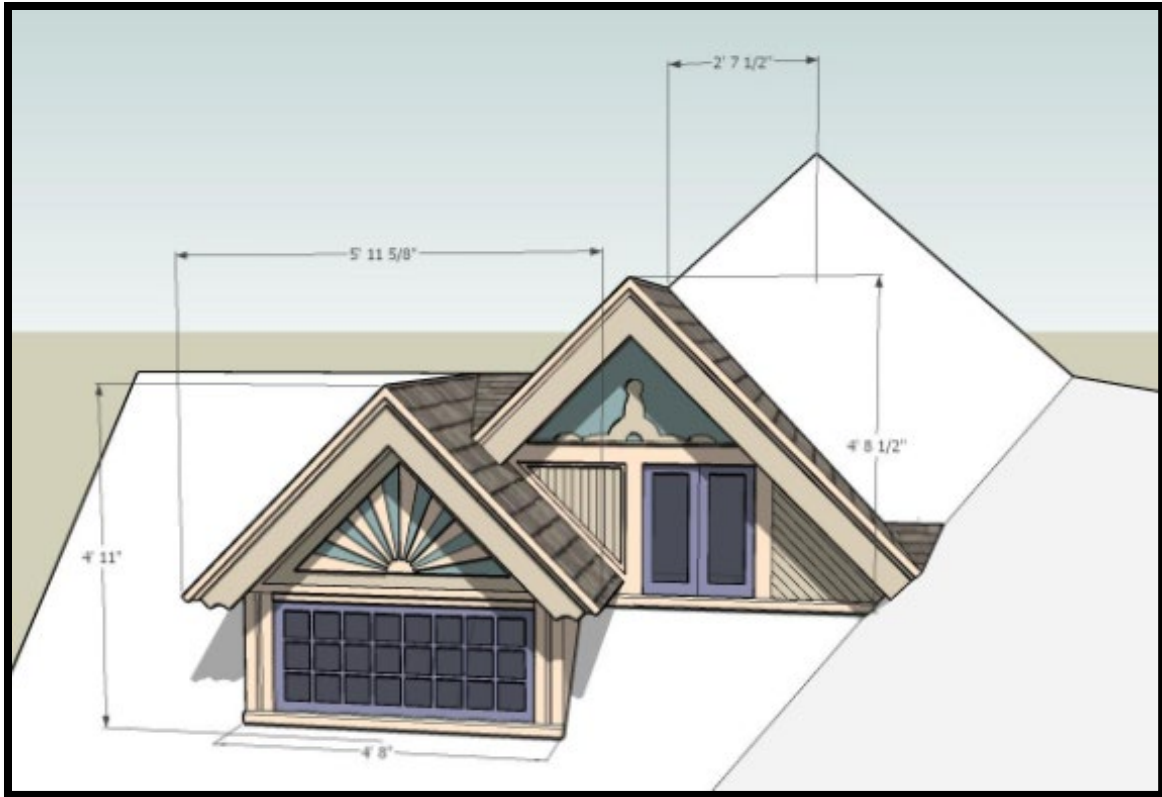
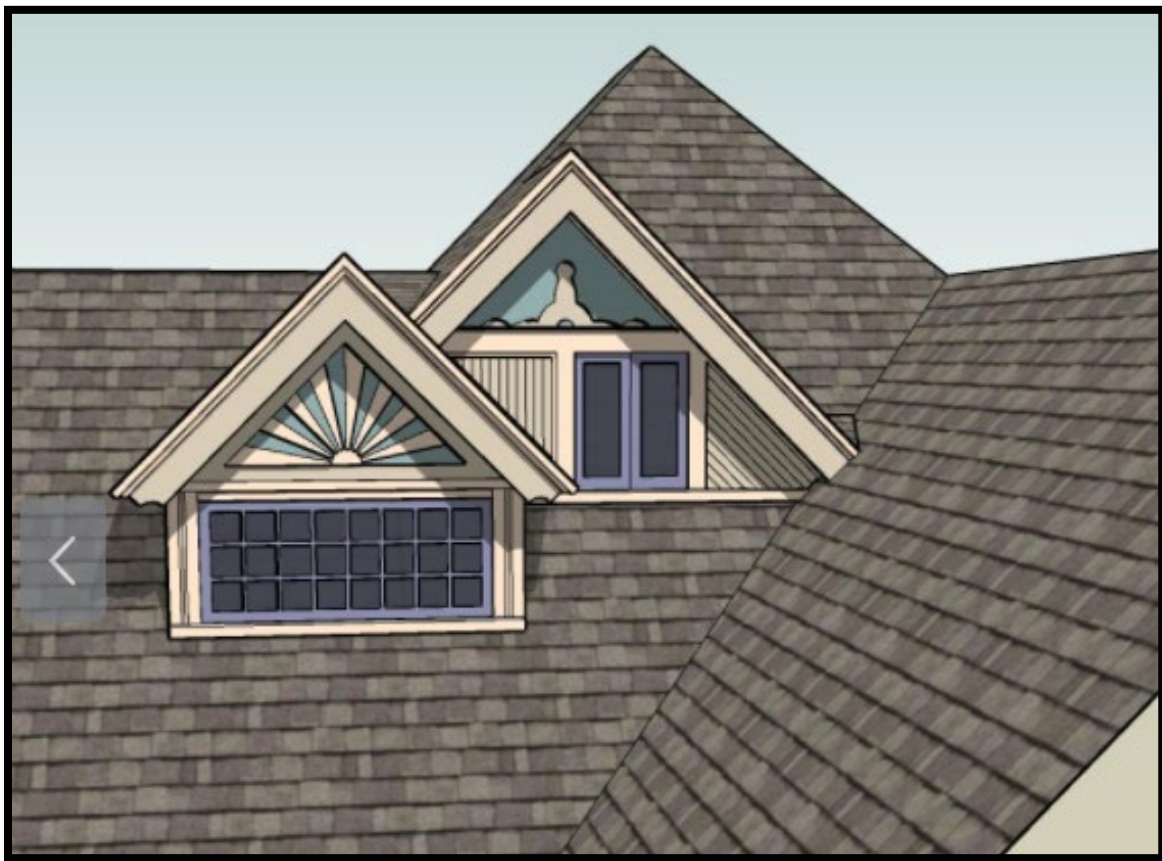
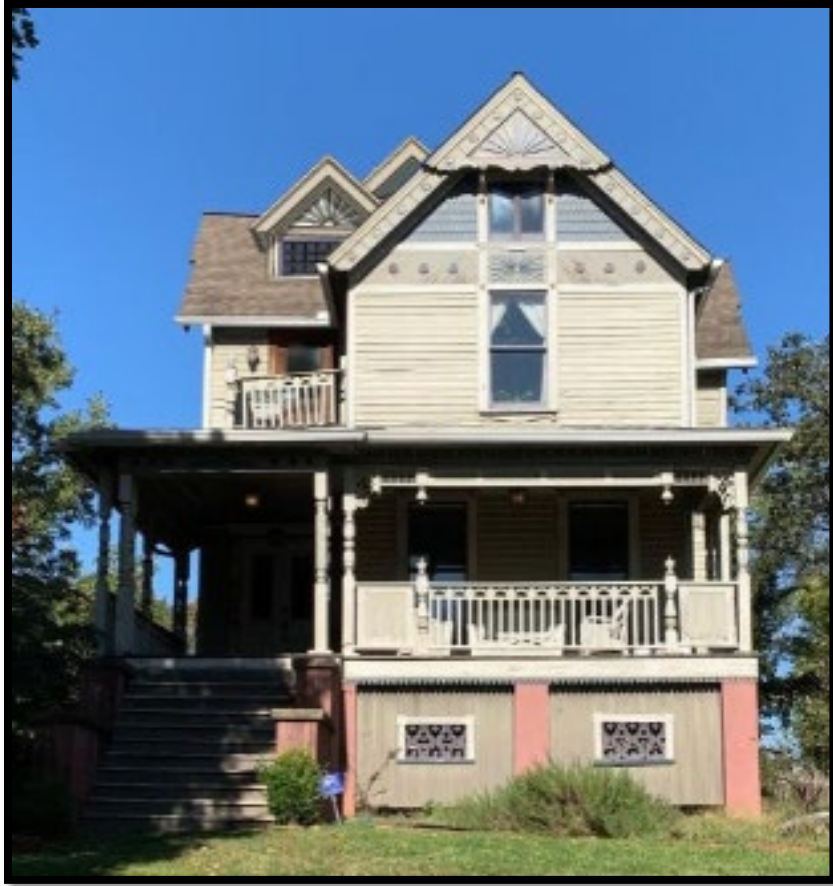
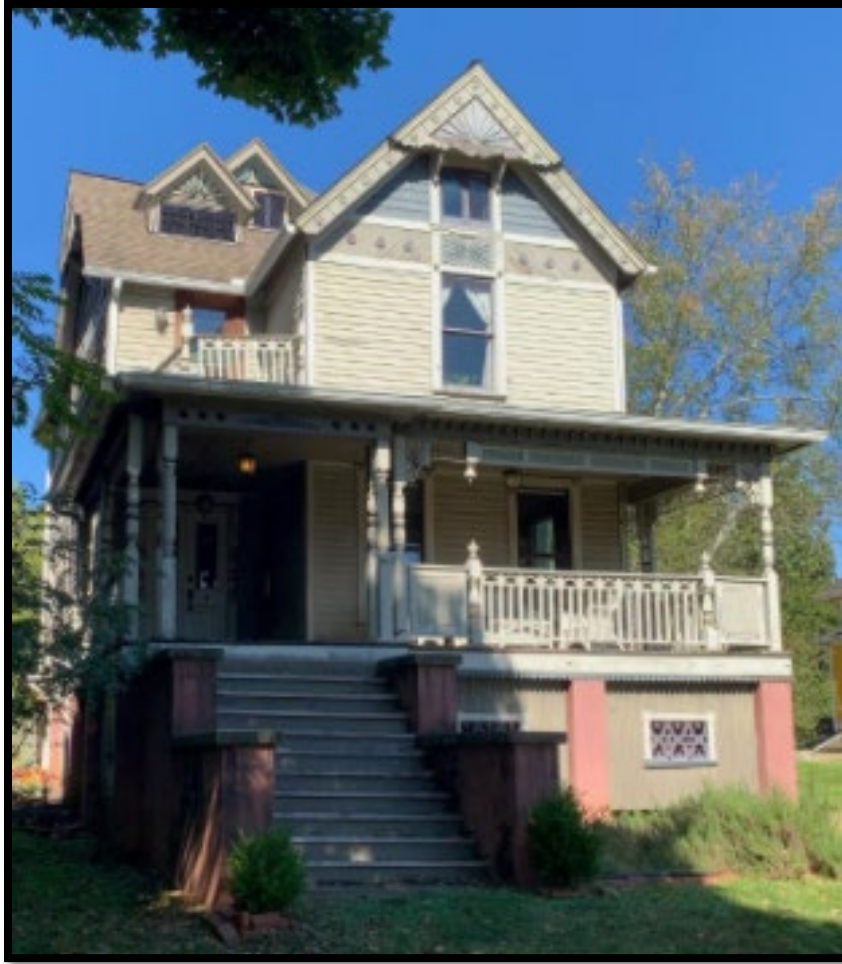
1. Dormer Reconfiguration
 - a. Current, approved but not correctly installed, dormer will be reconfigured into two dormers. A detailed larger parent dormer will be prominent and mimic the original detail on the house, and a smaller child dormer at its side. This configuration corrects the interior space issues and is a clear argument of why an architect is required for certain design elements.

Reconstruction of front dormer: existing front dormer was approved as an addition to the house when the house moved locations in 2006, but constructed in an incorrect location. Existing dormer will be removed and reconfigured into two dormers to address code issues. New dormers will feature a larger gable-roof dormer extending from the left side of the primary roof hip, and a smaller front-gable roof dormer projecting out from its left side. The rightmost dormer measures approximately 4'-8.5" in height total, and the left dormer is 4'-11" tall by 5'-11 5/8" wide overall. Detailing draws from George F. Barber designs, with a multi-light window on the left dormer.

2. The previous review to add a dormer on the front roof slope (9-Q-06-HZ) noted that "the roof was not originally designed with a dormer, but dormers were often present on Barber-designed houses. Locating a front dormer on the front elevation of this house will provide adequate access to the living space being constructed in the attic. It is also appropriate for the neighborhood and for the block where it is situated, where dormers are found on neighboring houses."

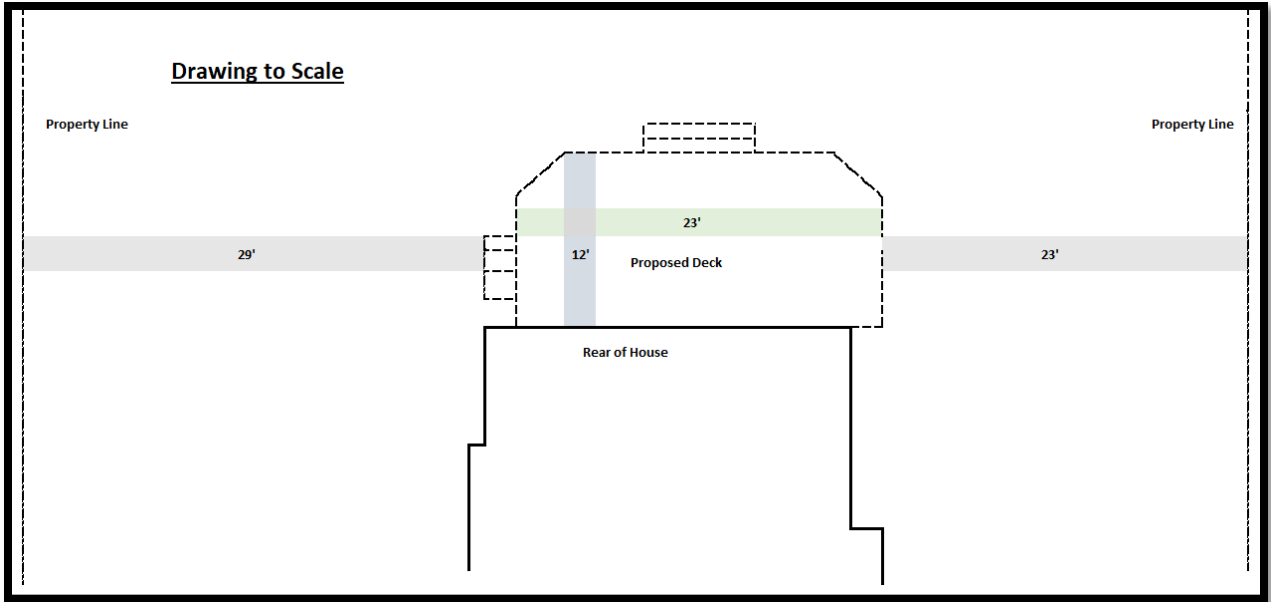
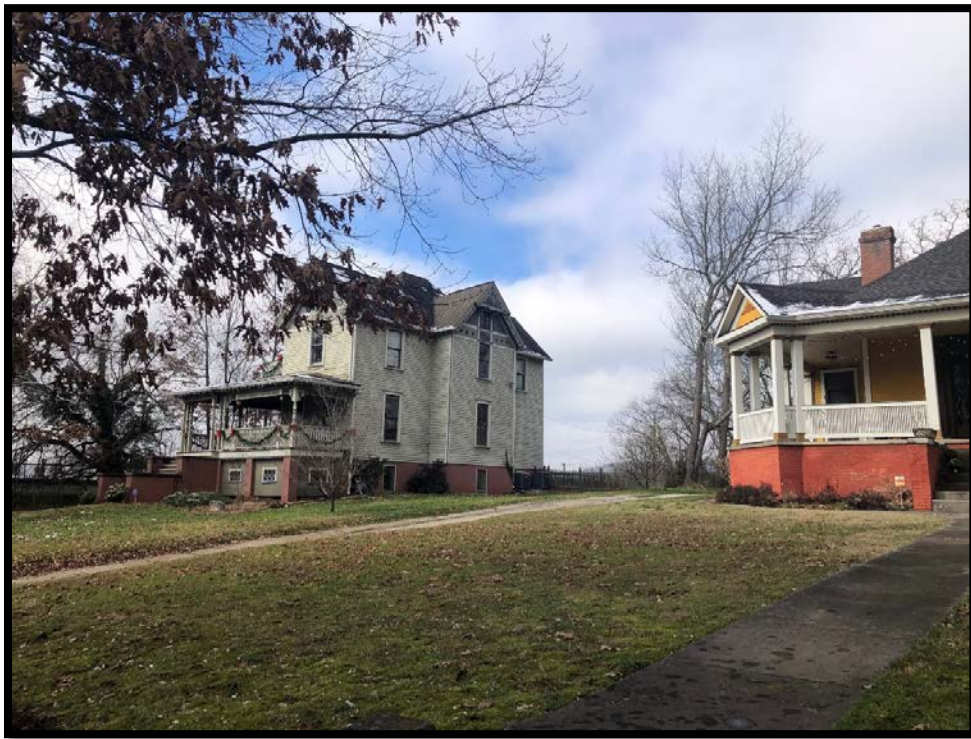
2. Rear Deck Addition

- a. The rear deck addition (23'x12') is no wider than the main body of the house and cannot be seen while directly looking at the house. This house sits on a wide lot, 75' verses 50', so the deck will be somewhat visible from the right of way from the east.
- b. The contruction will be wood with horizontal cable balisters.

New rear deck: new pressure-treated wood deck to extend from rear elevation, measuring 23' wide by 12' deep, with steps extending from the rear and left side of the deck. Deck will feature a horizontal metal cable railing.

4. The proposed rear deck is appropriately placed, minimal in size, and will be minimally visible from the street, if visible at all.
 5. Removal and replacement in-kind of the upper porch elements meets the design guidelines. The replacement of wood tongue-and-groove flooring with some brands of composite tongue-and-groove flooring material has been previously approved in Old North Knoxville, especially on second-story porches which are exposed to the elements. The applicant should provide the final specifications for the composite flooring material to staff for approval.

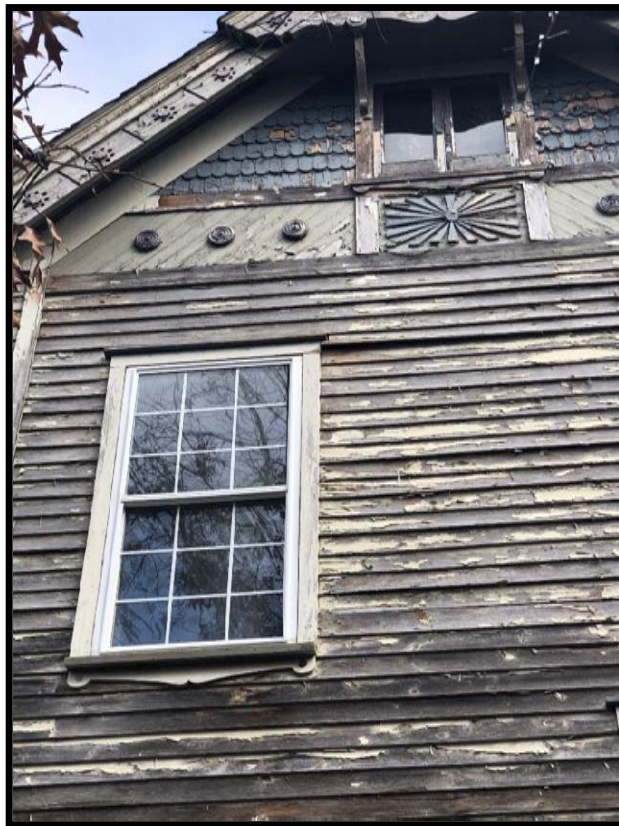
Vinyl window to be replaced with one-over-one window of wood the same dimension as the opening, which match the same full-sized windows on the upper floor (roughly 36x69).

Window replacement: removal of one-over-one, non-historic vinyl window on the west elevation and installation of a one-over-one, double-hung wood sash window with dimensions to match the original opening.

3. Vinyl Window Replacement with a 1-over-1 Window
 - a. A west facing vinyl staircase window will be replaced with a wood one-over-one window of the same dimensions (also the same dimensions of the current windows on the house).

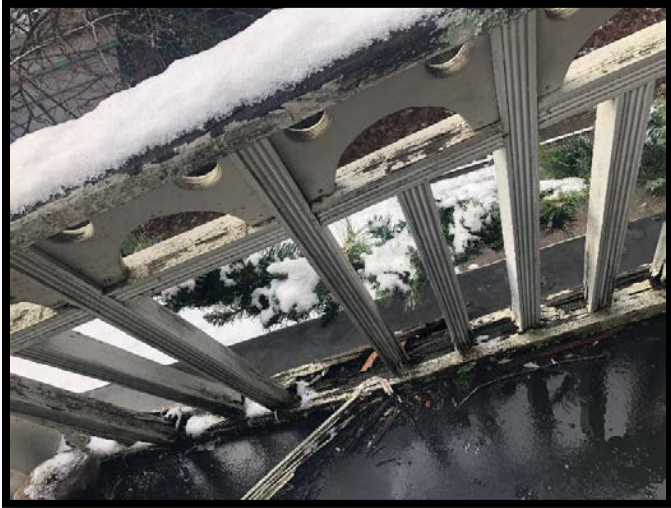
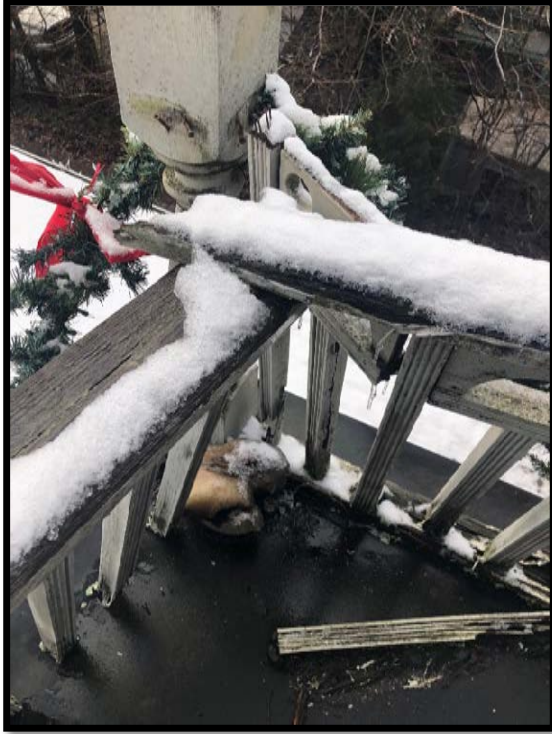
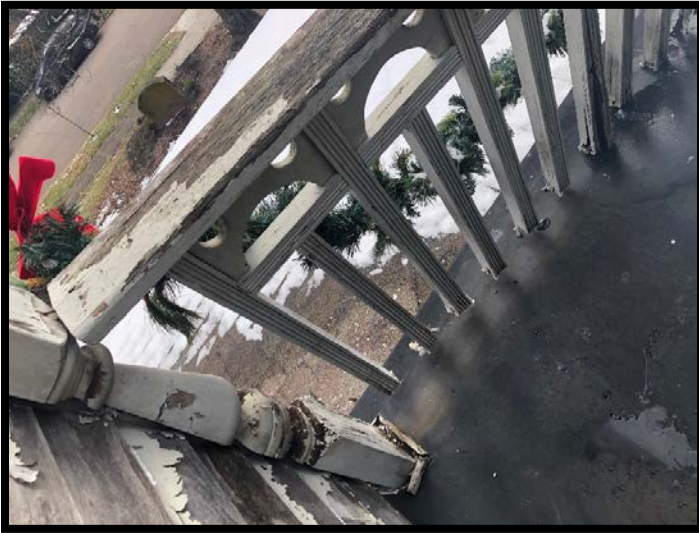
4. Upper Porch Rebuild with Like Materials (though the floor will be composite tongue in groove)
- a. The upper porch has rotted due to the exposure to the elements and the poor stock of the current supply of lumber. The porch will be replaced with old growth red oak in kind (interestingly from a tree that had to be taken down on the lot) and a composite tongue in groove flooring will be installed, though it can't be seen from the street.

Upper porch work: removal and replacement in-kind of upper porch elements. All wood elements to be reconstructed and replaced in-kind, with materials and dimensions to match the existing. Porch flooring will be replaced with a composite tongue-and-groove flooring.

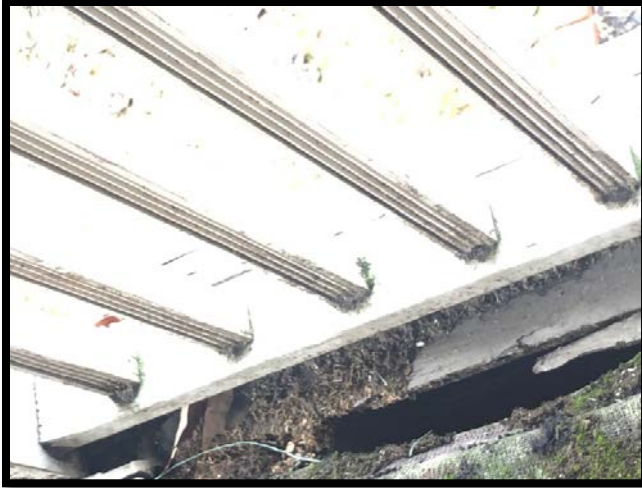
5. Lower Porch Flooring Repair and Replace in Kind

- a. The lower front porch has rotted due to the exposure to the elements and the poor stock of lumber supply. The porch will be replaced with old growth red oak tongue in groove flooring (also from the tree from the lot). Bases to the columns will also be replaced by composite, breathable, bases.

Lower porch work: removal and replacement in-kind to wood tongue-and-groove porch flooring. Bases to porch columns will be replaced by composite bases.
