Meeting: 6/16/2022
Applicant: Brian Pittman Johnson Architecture, Inc
Owner: Knollwood Historic Preservation, LLC

Location: 150 Major Reynolds Place **Parcel ID** 121 A A 02807
District: Knollwood Individual H Landmark
Zoning: C-G (General Commercial)
Description: Neoclassical, c.1851 with modifications dating to 1890s and 1930s
See attached designation report and design guidelines for architectural description of house.

Comprehensive exterior rehabilitation, new secondary structure, and modifications to site design.

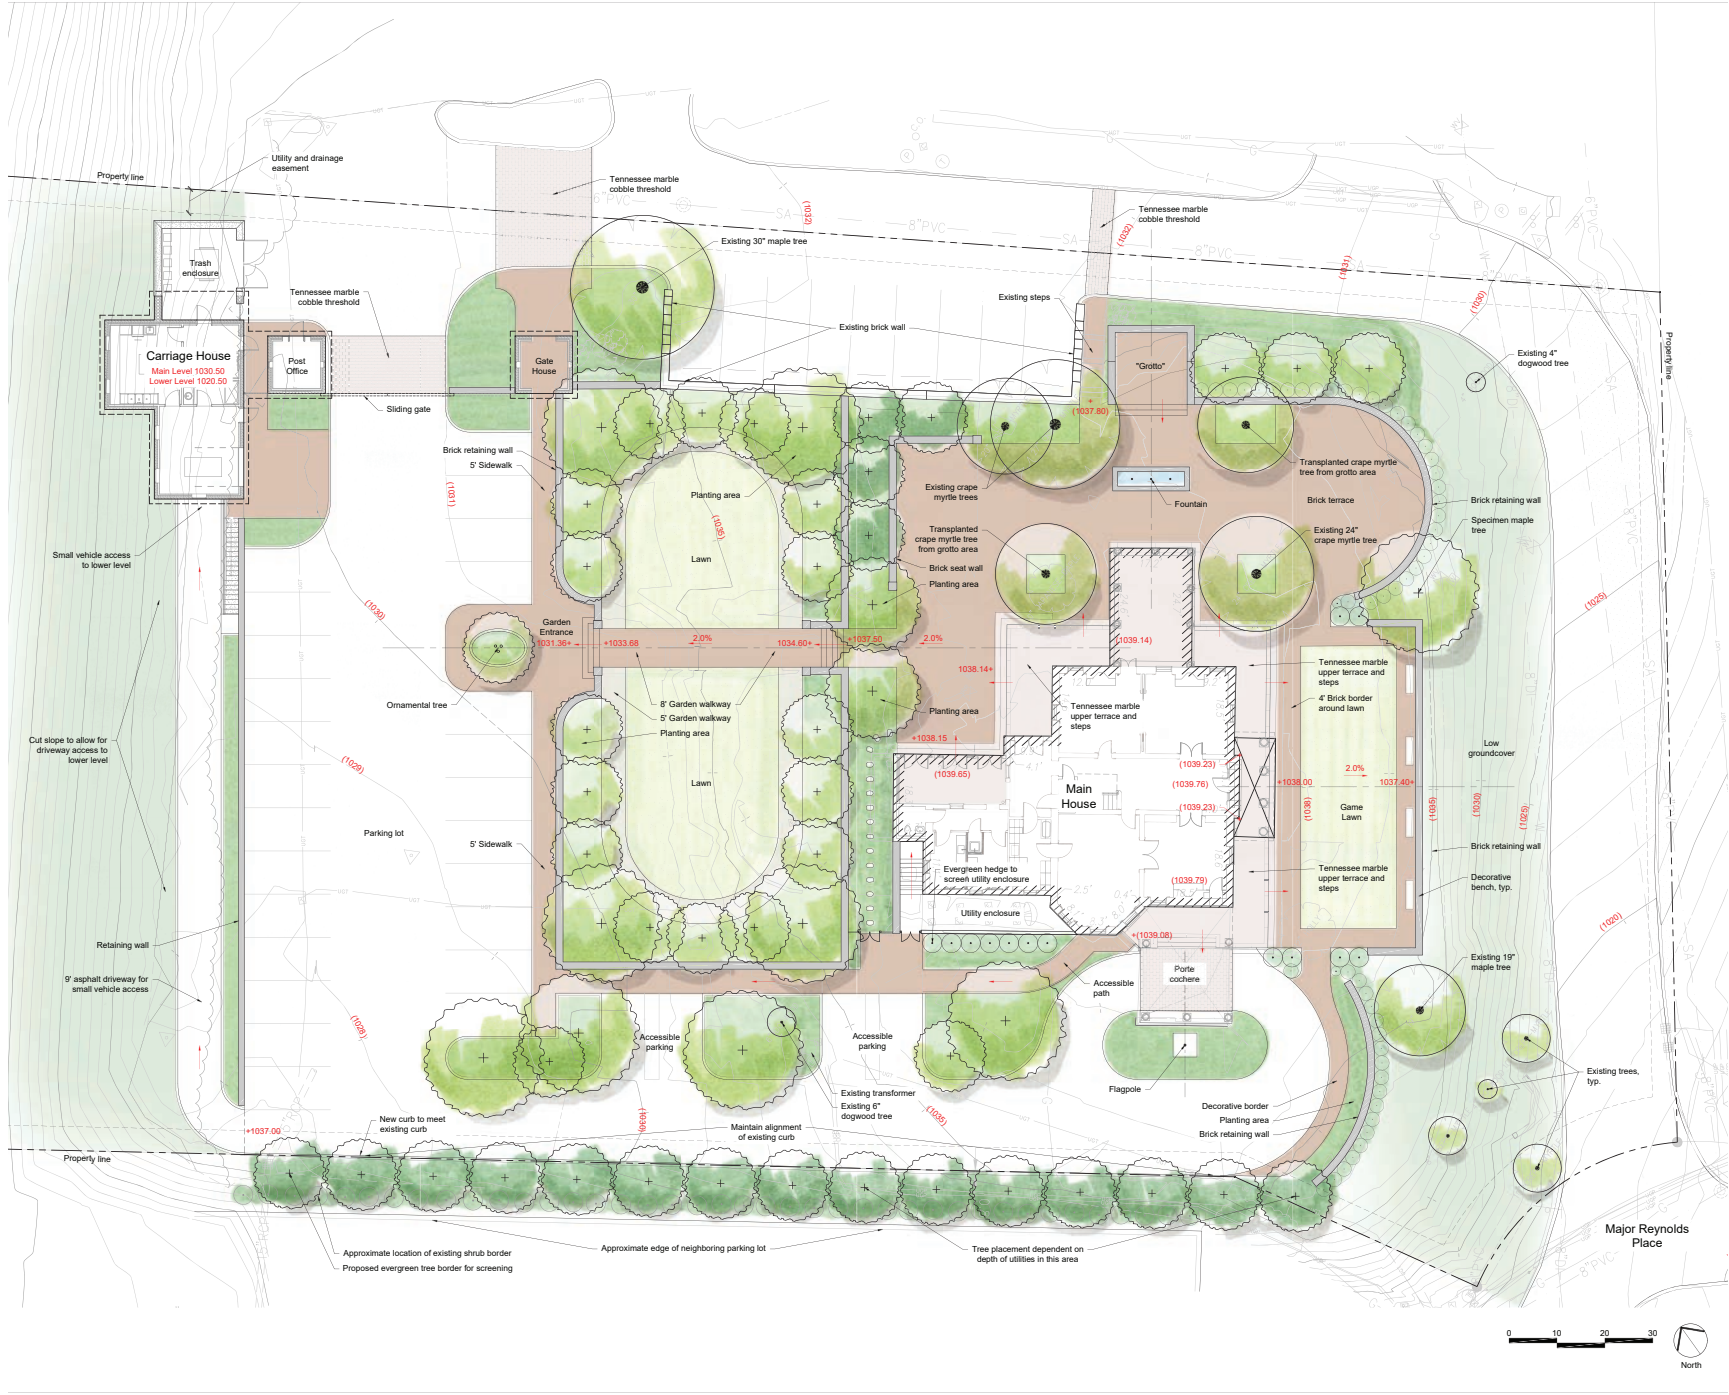
PROPOSED LANDSCAPE/SITE DESIGN

Tennessee marble 'cobblestone' pavers shall be installed as accent pavers to new asphalt driveways.
Refer to page 1 of this packet.

Redesign later-added unsafe cellar door entrance to rotate towards west access road. The entrance shall be parallel to the brick wall on the north elevation and leading to a standard, safer basement door access.
Refer to page 1, 7 of this packet.

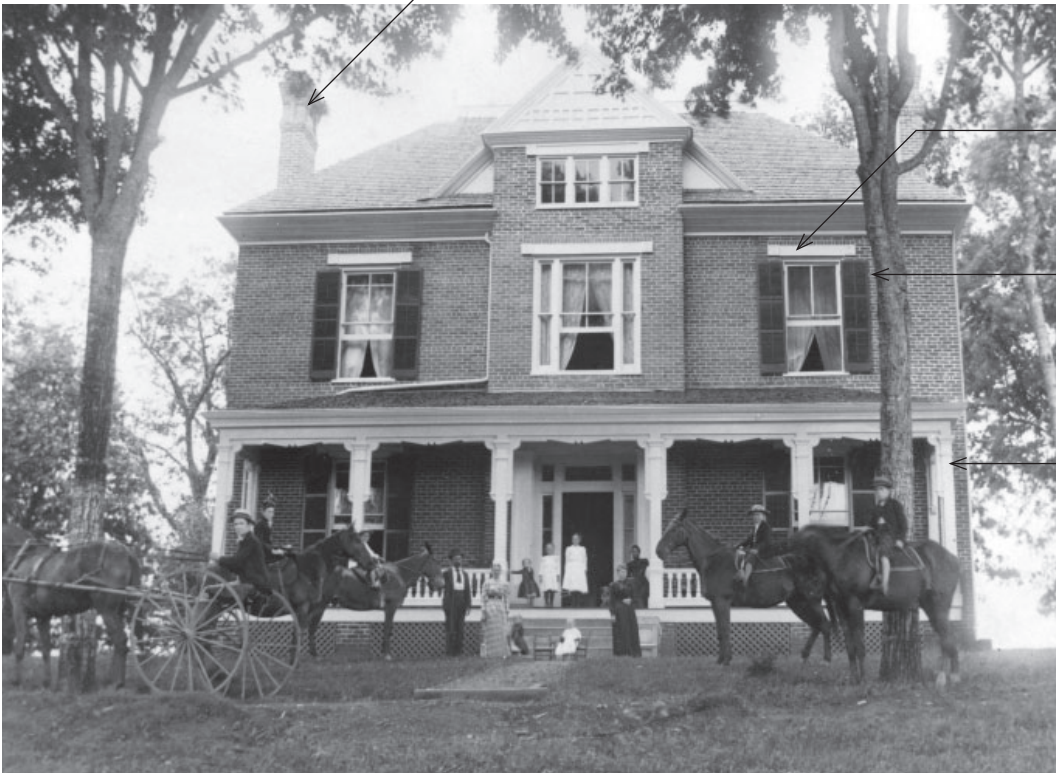
ORIGINAL 1851 CONSTRUCTION WITH 1919 PORCH

IN REBUILDING EACH CHIMNEY, WE ARE RETURNING SOME OF THESE DETAILS, WHILE MAINTAINING STRUCTURAL SOUNDNESS

ALL WOOD LINTELS AND ROSETTS HAVE ALWAYS BEEN PAINTED - WE WILL CONTINUE THIS THROUGHOUT ALL REPAIRS AND ADDITIONS

POST DETAILS MATCH EXISTING BACK PORCH POST DETAILING. WE SHALL MAINTAIN THIS 1919 VOCABULARY ON THE BACK PORCHES HONORING THESE 1919 DETAILS WHILE MAINTAINING THE LATER ADDED FRONT FACADE PORTICO (1930 - 1940). - REFER TO PAGE 5 OF THIS PACKET

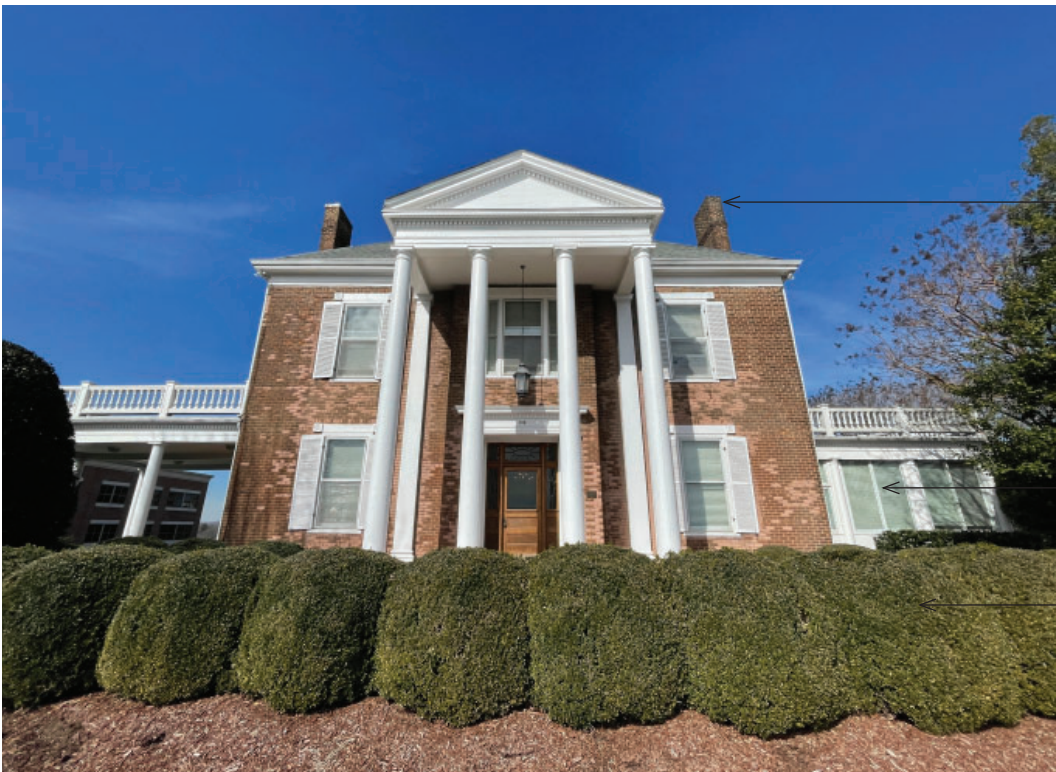
REBUILD AND RECAP ALL CHIMNEYS - REFER TO PAGE 9 OF THIS PACKET

REOPEN ORIGINAL EAST PORCH - REFER TO PAGE 10 OF THIS PACKET

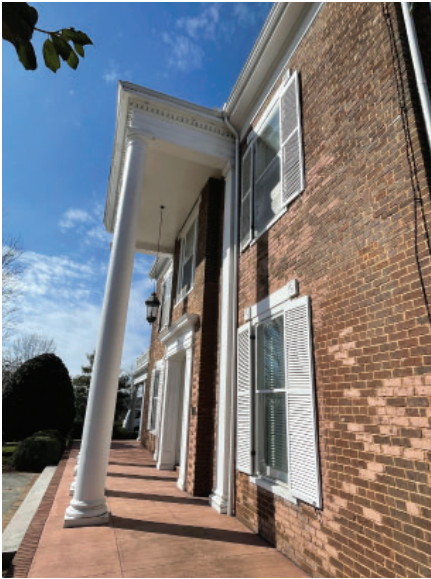
REMOVE PAINT OFF BRICK WALLS THROUGH DRY ICE BLASTING

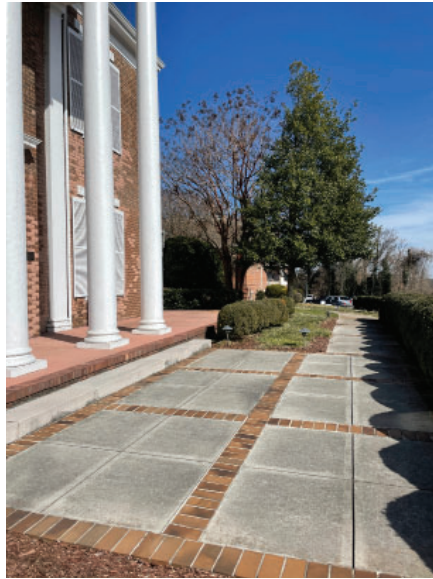
REMOVE EXISTING LOWER TERRACE HARDSCAPE IN LIEU OF A NEW FLAT GREEN LAWN - REFER TO PAGE # 1

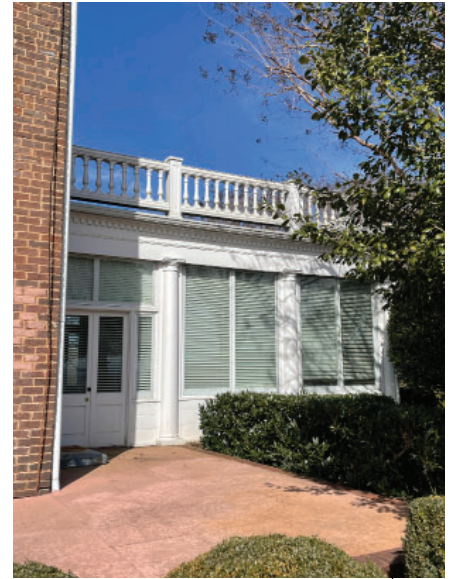
REMOVE ALL INTERIOR PARTITION WALLS, EXTERIOR ENVELOPE, AND REOPEN TO A COVERED PORCH WITH TENNESSEE MARBLE PAVERS - REFER TO PAGE # 17

RESURFACE CURRENT UPPER TERRACE WITH NEW TENNESSEE MARBLE PAVERS - REFER TO PAGE 1, 17 OF THIS PACKET

We propose the current east Sunroom to be reverted to the original open air porch. However, upon discovery, the current concrete planks, structural columns, & roof joists have all been severely over-compromised through years of construction changes rendering it 'unstable' by our structural engineer. This unsafe structure shall be fully replaced with sturdier applications throughout where hidden with all exposed elements shall match the existing historic appearance (1930+) & Porte Cochere. Refer to Structural Narrative attachment.

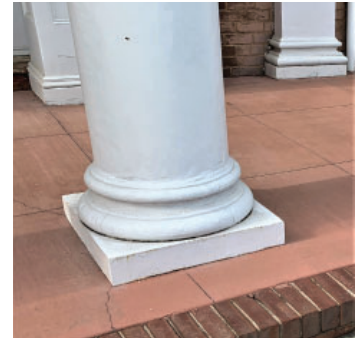
INCREASE PLINTH DEPTH 4" TO RAISE TORUS ABOVE NEW TENNESSEE MARBLE PAVERS ON EXISTING CONCRETE TERRACE

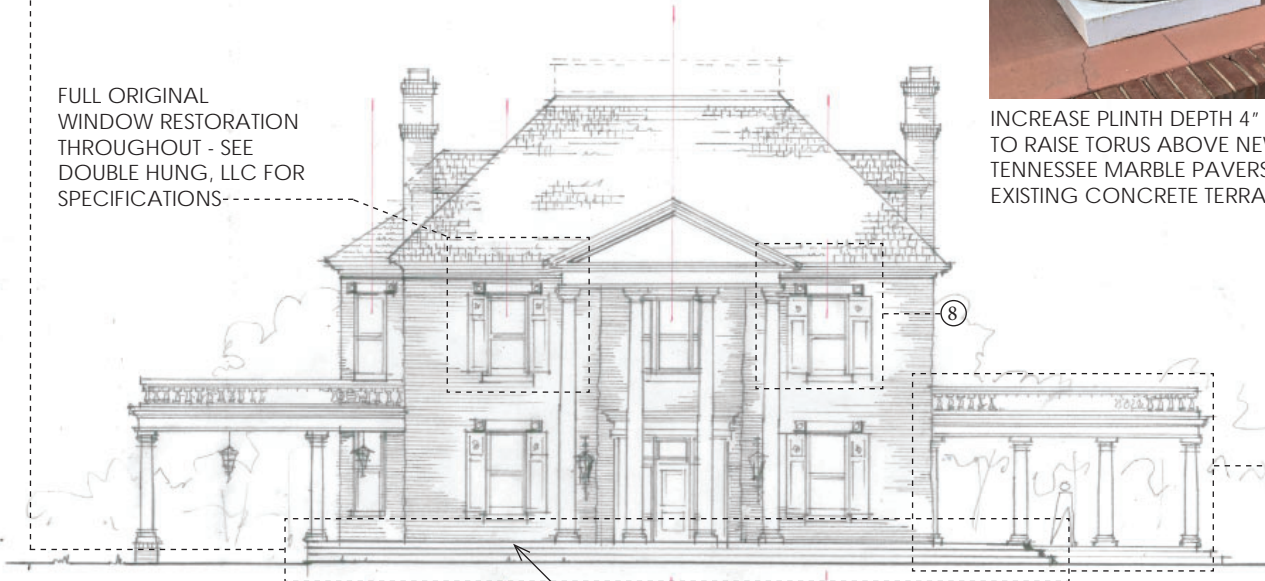
SOUTH ELEVATION: TOWARDS KINGSTON PIKE

NEW TENNESSEE MARBLE UPPER TERRACE - SEE PAGE # 17

We propose complementary dormers flanking the south (front) portico that would match the existing 1851 east and west dormers. There are no indications dormers were ever on the south elevation as evidenced by photos and on site discovery. But the addition would add much needed natural light as well as views from the newly engaged attic level that'll now be fully occupied. These new dormers shall match exactly that of the original, copper flashing, same window proportions & design, with slate on the roof of the dormer as well as the sides to match existing conditions.

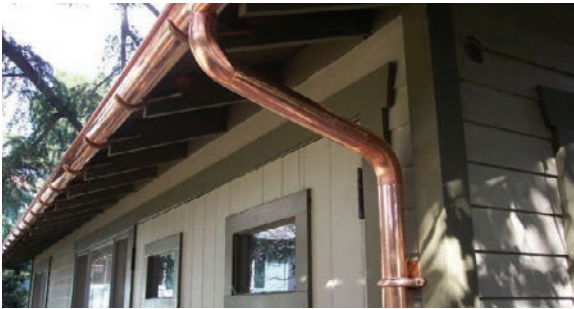
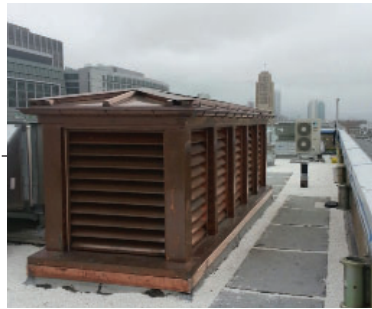
COPPER LOUVER LOOK INSPIRATION

Replace rotted wood louver in 1919 dormer in attic on west elevation with new all copper louver to match what is existing proportions, dimensions, & design.

Replace damaged louver over vent on north elevation with similar louver made of copper and allowed to age naturally.

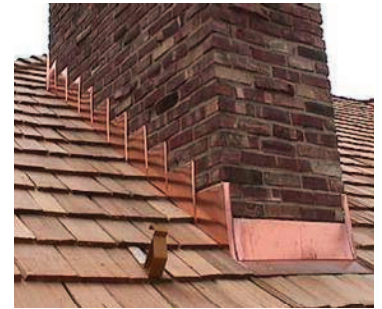
COPPER FLASHING INSPIRATION DETAIL

Replace all later added aluminum gutters and downspouts with all copper half round gutters, flashing and downspouts.
Refer to page 7 of this packet.

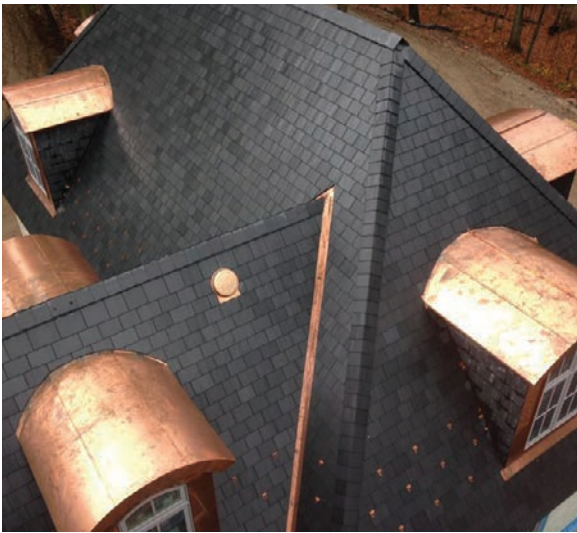
PROPOSED BLACK SLATE AND COPPER SNOW CLEATS

Currently covered in later-added asphalt shingles, we propose to return the entire roof to slate with copper flashing, round gutters, & downspouts. However, upon discovery our structural engineer advised a full rebuilding of the failing roof to hold up that re-added weight by restructuring all the minimally sized original, compromised roof joists with a full structural steel frame to support and straighten the entire roof of the original 1851 portion of the house. The entire house, shy lower slopes, shall be reclad in a black, natural slate roof to match the original historic design with snow guards. Refer to Structural Narrative attachment.

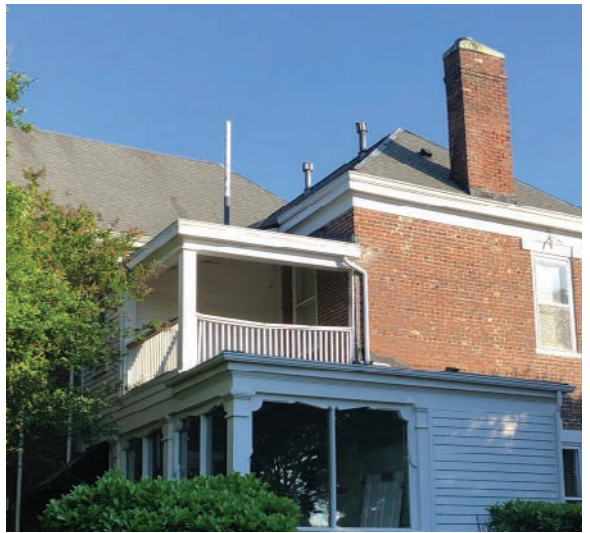
EXISTING BALCONY WALL WITHOUT ACCESS DOOR

Adding a means for full & safe access to the roof to tend to repairs or upkeep at any time. We suggest a simple and/or innocuous black iron railing that will meet safety codes paired with removable floor decking panels, to protect the new membrane roof, adding a spiral stair for direct access. The base of the mezzanine will be skirted with a copper cornice to match original skirt with natural slate roof restored.

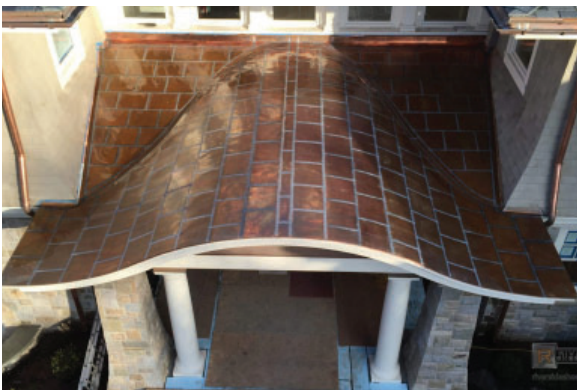
COPPER ROOF FOR LOW SLOPE APPLICATIONS

Replace low pitch TPO sunroom roof with copper roof left to patina.

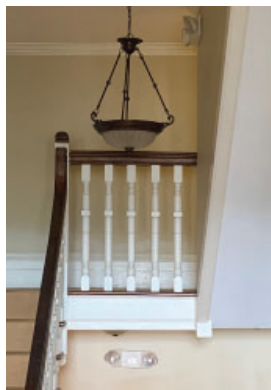
ORIGINAL INTERIOR VICTORIAN RAILING

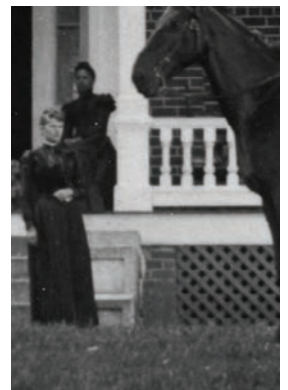
ORIGINAL EXTERIOR RAILING

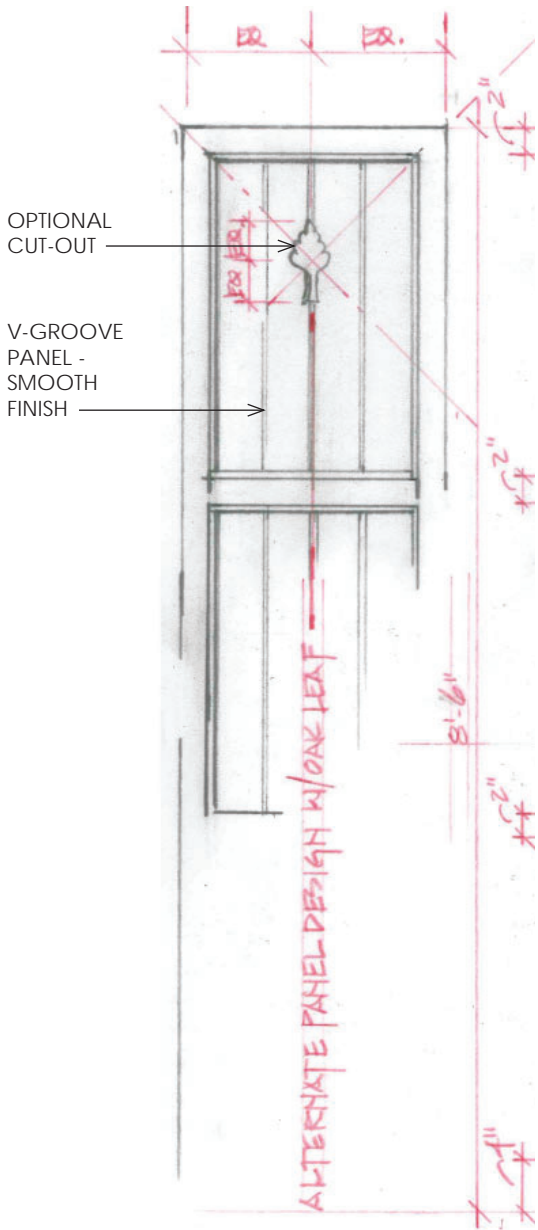
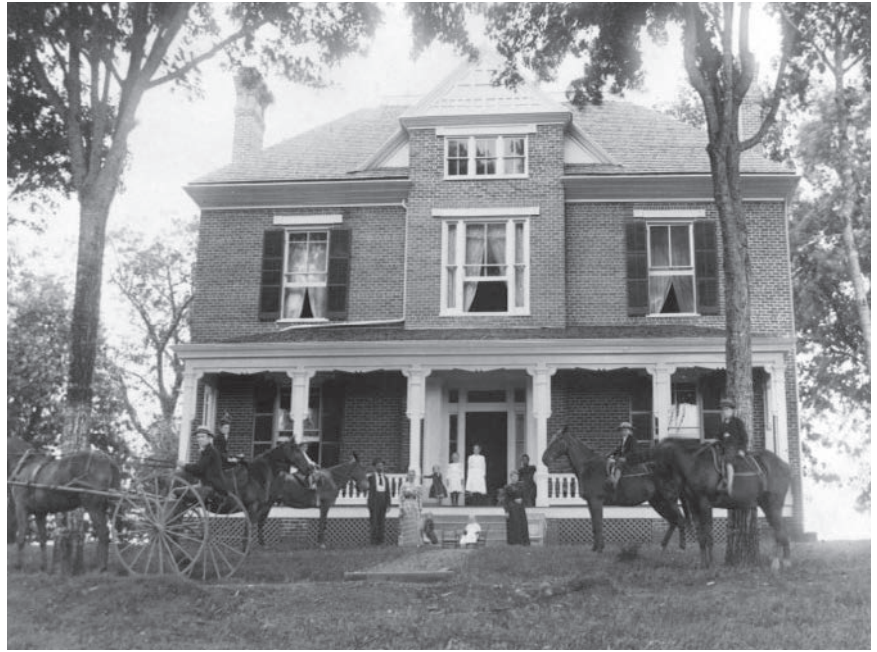
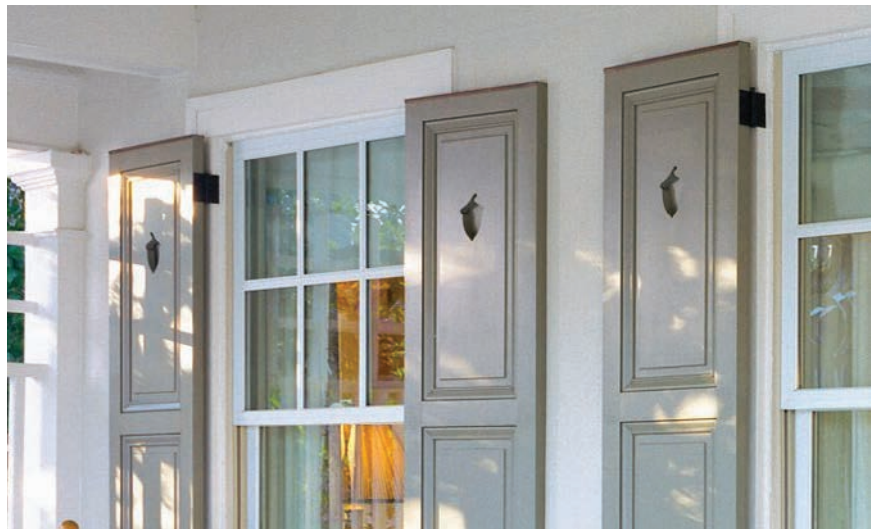
PROPOSED SHUTTER ALTERNATE MATERIAL FOR MAINTENACE LONGEVITY

Replace later added damaged shutters on the front facade with new custom made V groove panel design shutters. Boral material would be preferable to ensure the longevity and weather durability. Shutter dog selections shall match age appropriate design. Refer to Boral attachment.

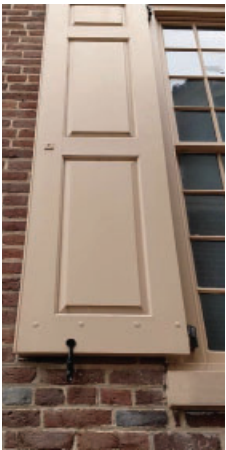
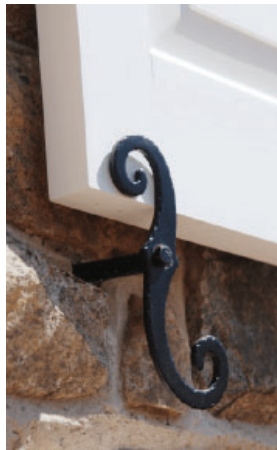
SHUTTER DOG SUGGESTIONS

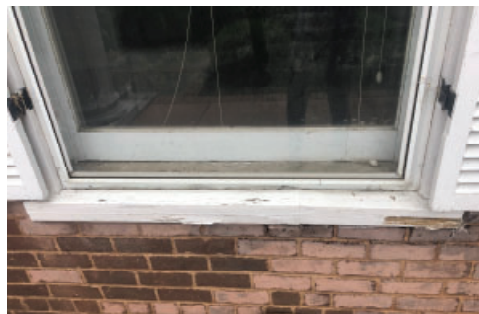
COMPROMISED WOOD (PINE) SILLS

Repair all wood lintels, sills and medallions. Replace any parts that have degraded beyond restoration with Sapele and paint-as needed. Sapele.

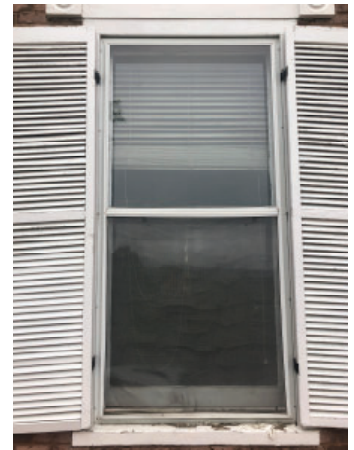
COMPROMISED WOOD (PINE) LOUVERED SHUTTERS

SHUTTERS: SOUTH ELEVATION ONLY

- Repair to existing wood lintels, sills, and decorative medallions, including replacement in-kind to those elements which are deteriorated.
- Removal of non-original wood louvered shutters on the façade (south elevation) and installation of new shutters. See application packet for materials and design of shutters and shutter dogs; applicant proposes custom-made, smooth-finished, V-groove panel shutters with a decorative cut-out (applicant notes the cut-out is optional) made of Boral composite material, featuring simple shutter dogs appropriate for era of house.

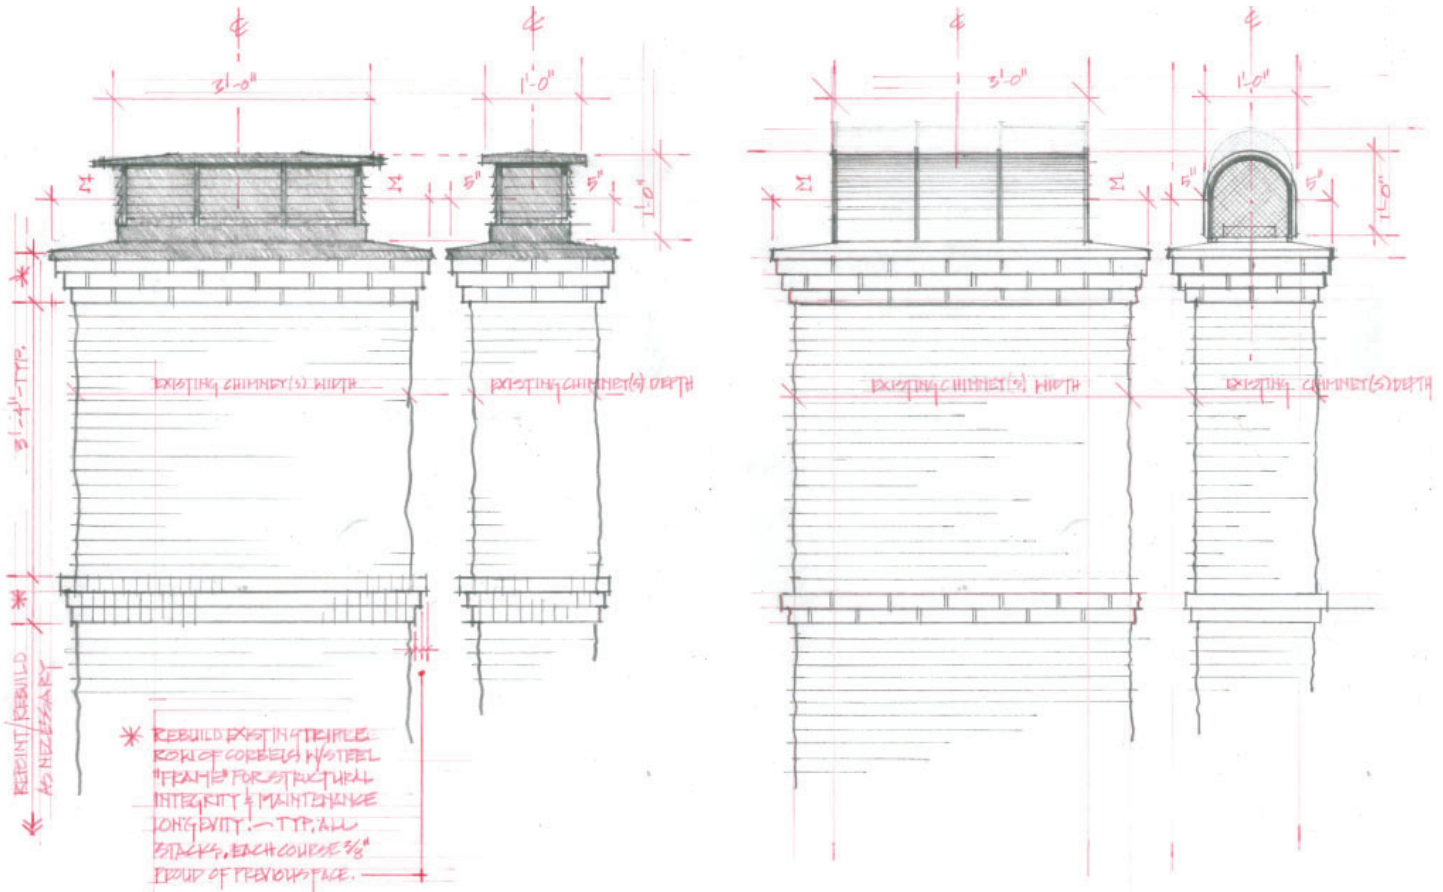
PROPOSED COPPER CHIMNEY CAP OPTIONS WITH RECONSTRUCTION AND CORBELLING EXTENTS

- New copper chimney flue caps (see two options in page 9 of application packet - louvered, flat copper chimney caps or half-barrel chimney caps).

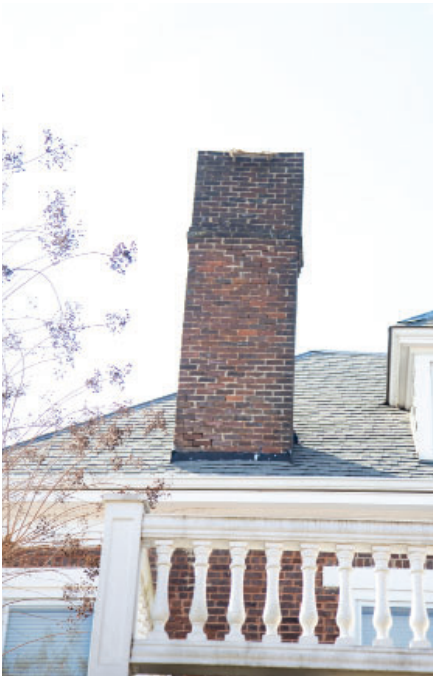
CHIMNEY (SE) - CURRENT

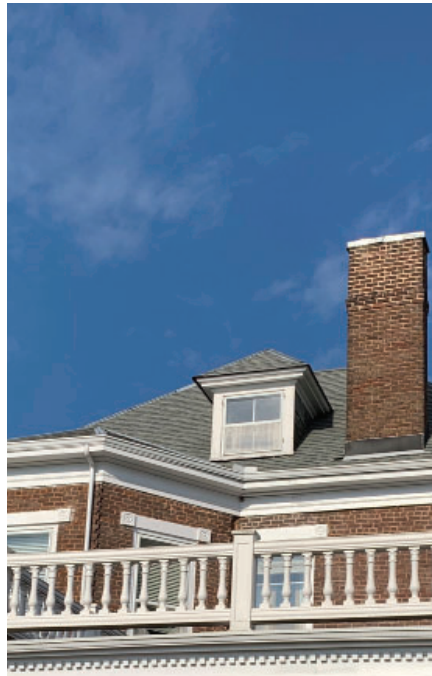
CHIMNEY (SW) - CURRENT

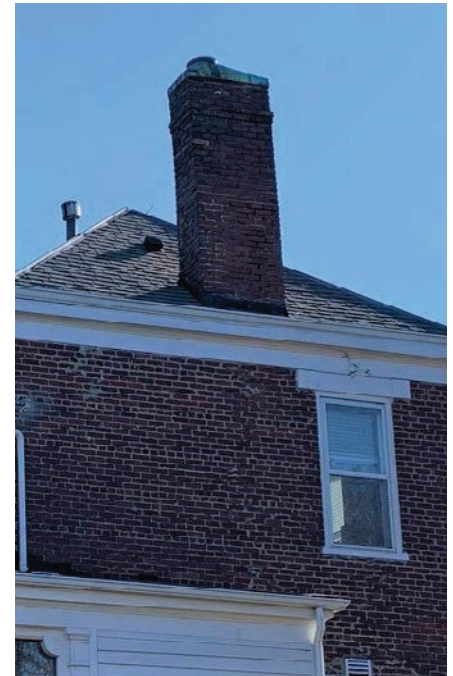
CHIMNEY (KITCHEN)

The north 1919 addition kitchen north chimney shall be repaired, repointed, and capped off with a secure copper lid.
Refer to page 7 of this packet.

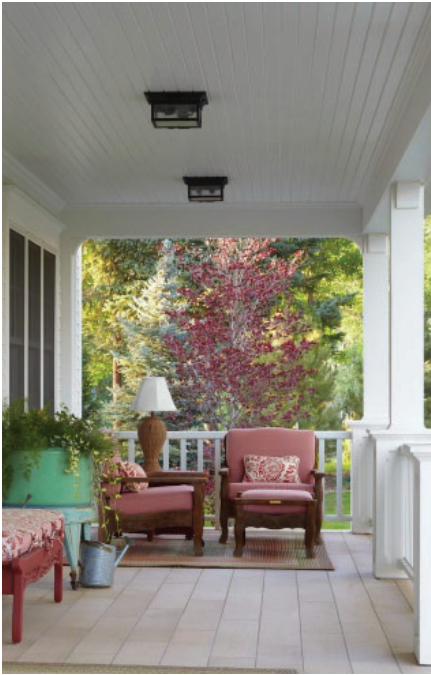
PROPOSED WOOD BEADBOARD CEILINGS
- TYPICAL ALL PORCHES AND SUNROOMS

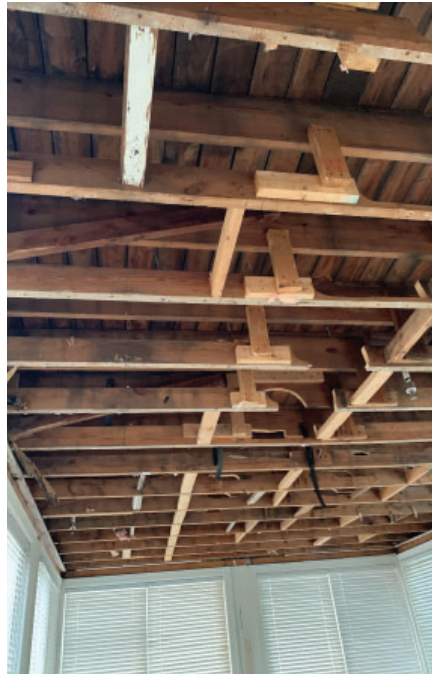
COMPROMISED PORCH STRUCTURE

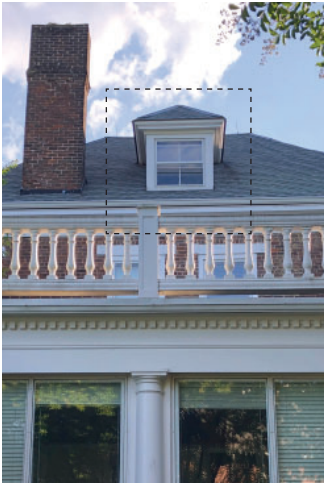
PROPOSED NEW DORMERS TO MATCH THESE EXISTING DORMERS

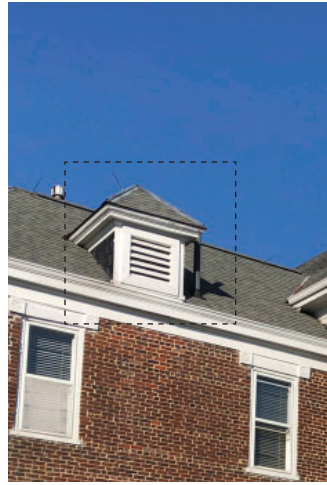
MATCH VERTICAL DORMER SLATE WITH NEW ROOF SLATE - TYPICAL

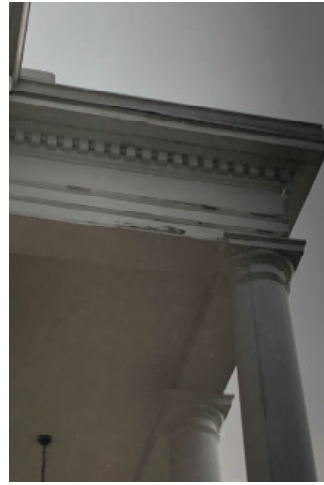
CORNICE REPAIRS - TYPICAL

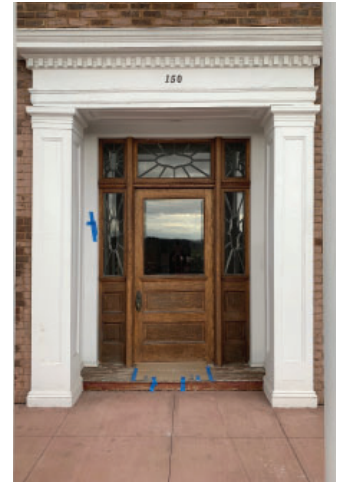
FULLY RESTORED 1919 FRONT DOOR

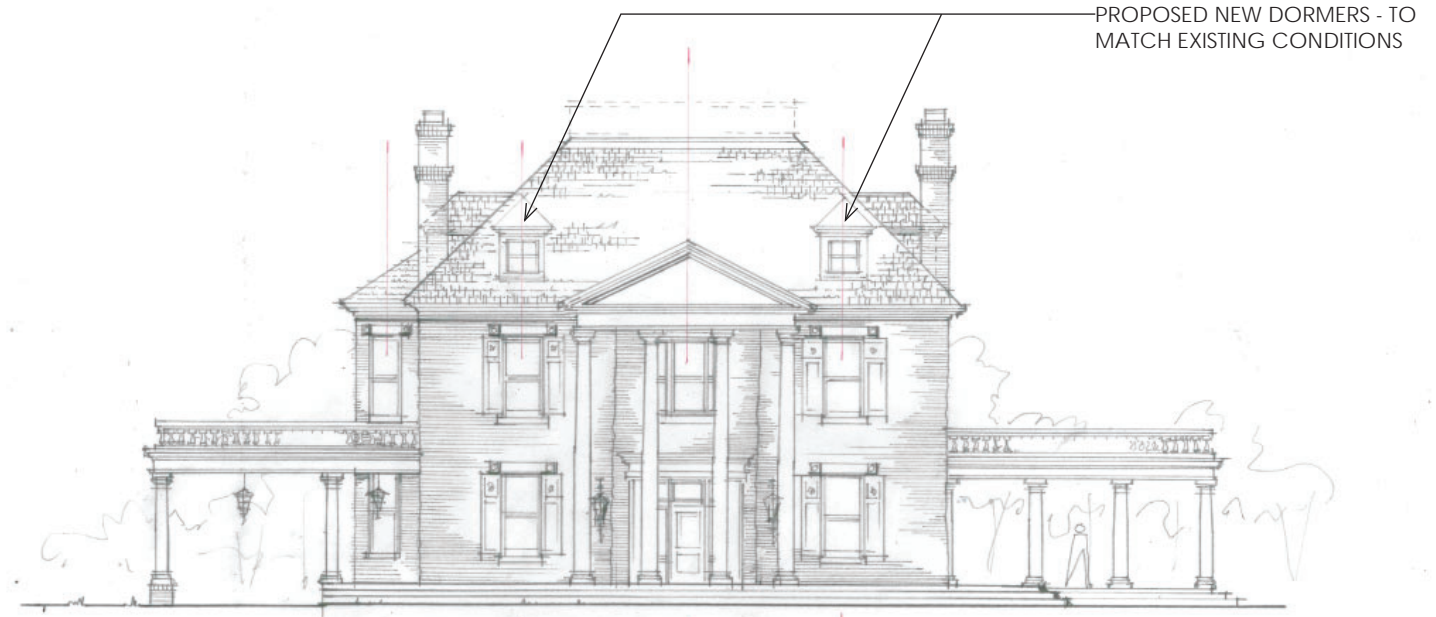
PROPOSED NEW DORMERS - TO MATCH EXISTING CONDITIONS

PROPOSED DORMERS: SOUTH ELEVATION ONLY

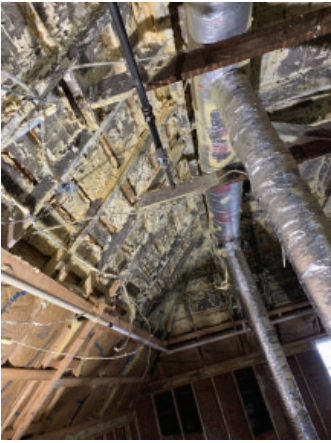
SEE STRUCTURAL NARRATIVE AT THE END OF PACKET

Since the desire for the design is install true slate shingles and a maintenance platform, there are several facets of the structure that will not meet modern standards for the support of such a heavy roof. It is our recommendation that the roof be restructured.

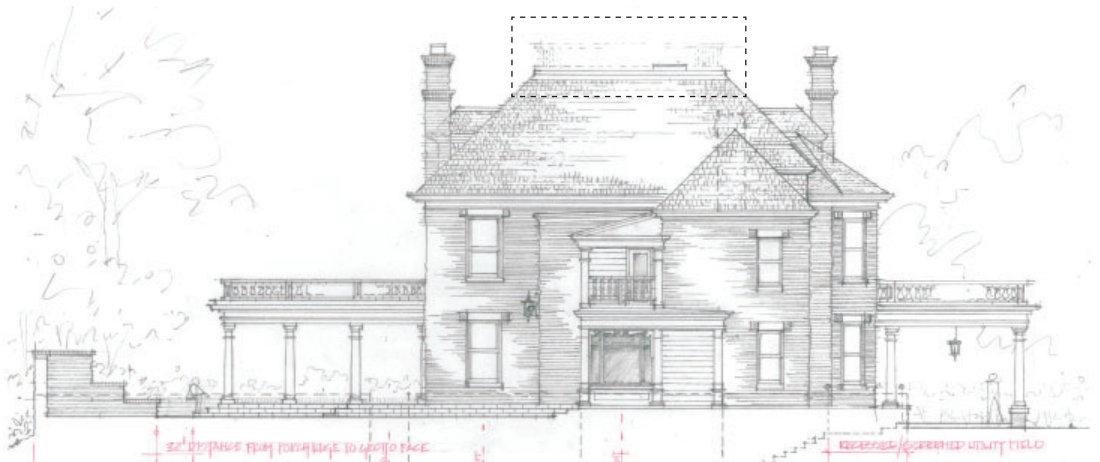
MAINTENANCE MEZZANINE

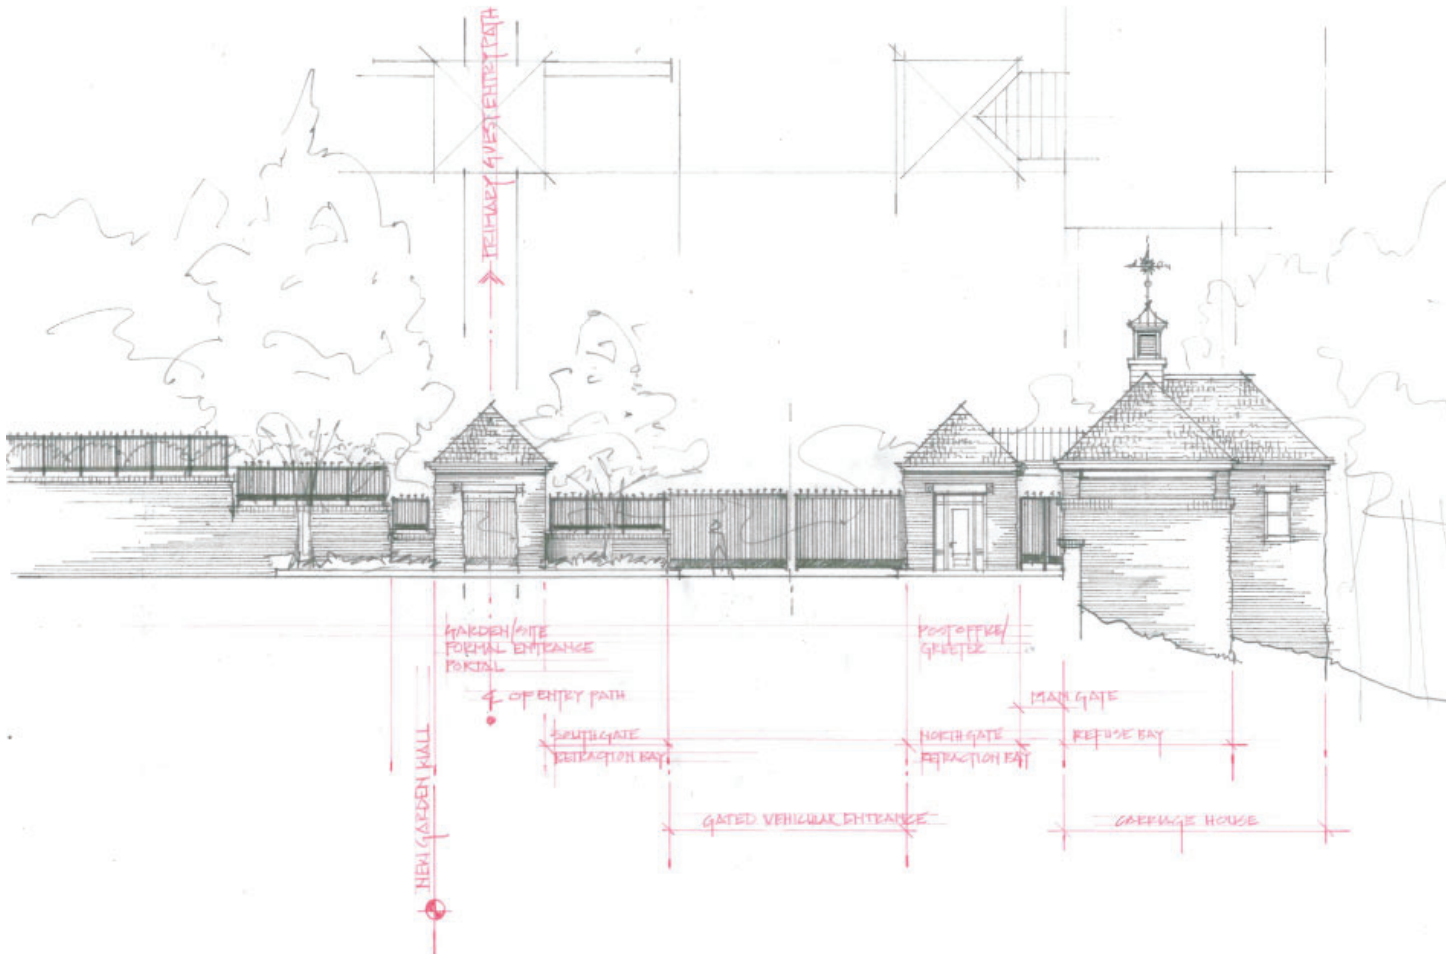
CARRIAGE HOUSE - EAST ELEVATION: FACING ENTRY DRIVE

SCALE: 1" = 20'

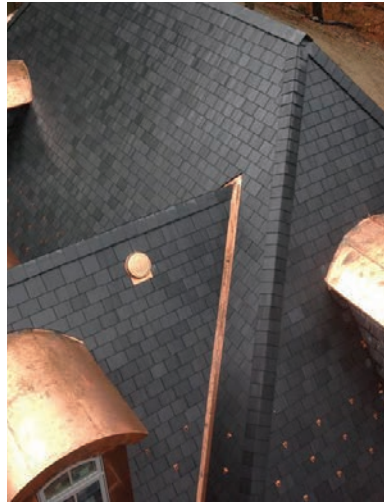
BLACK SLATE ROOF WITH COPPER TO BLEND WITH MAIN HOUSE

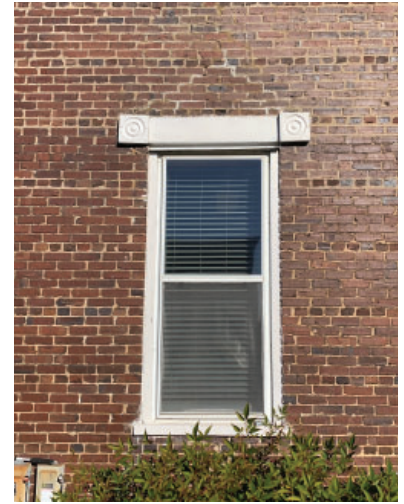
WINDOW HEADER, ROSETTE, AND SILL PROFILES TO MATCH EXISTING CONDITIONS

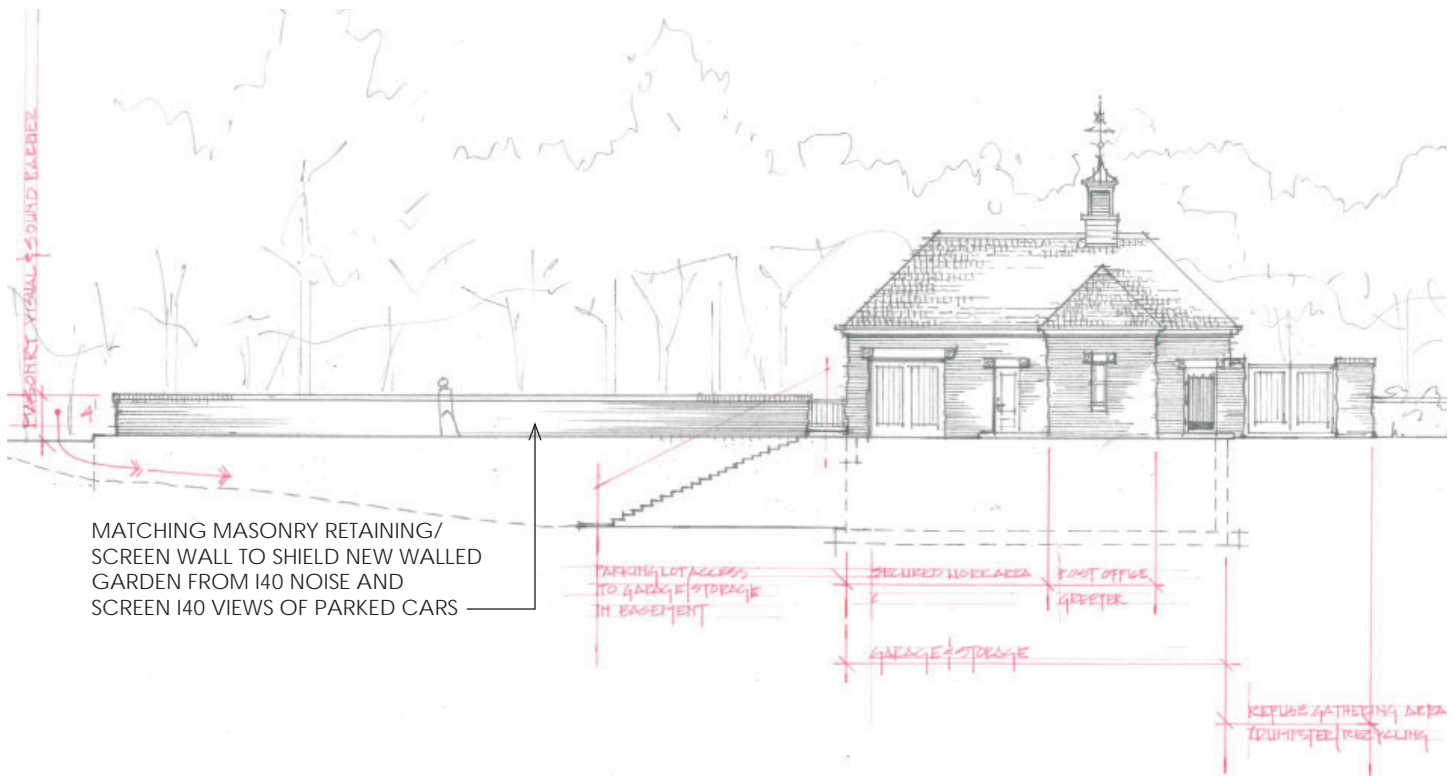
CARRIAGE HOUSE - SOUTH ELEVATION: FACING BACK OF HOUSE

SCALE: 1" = 20'

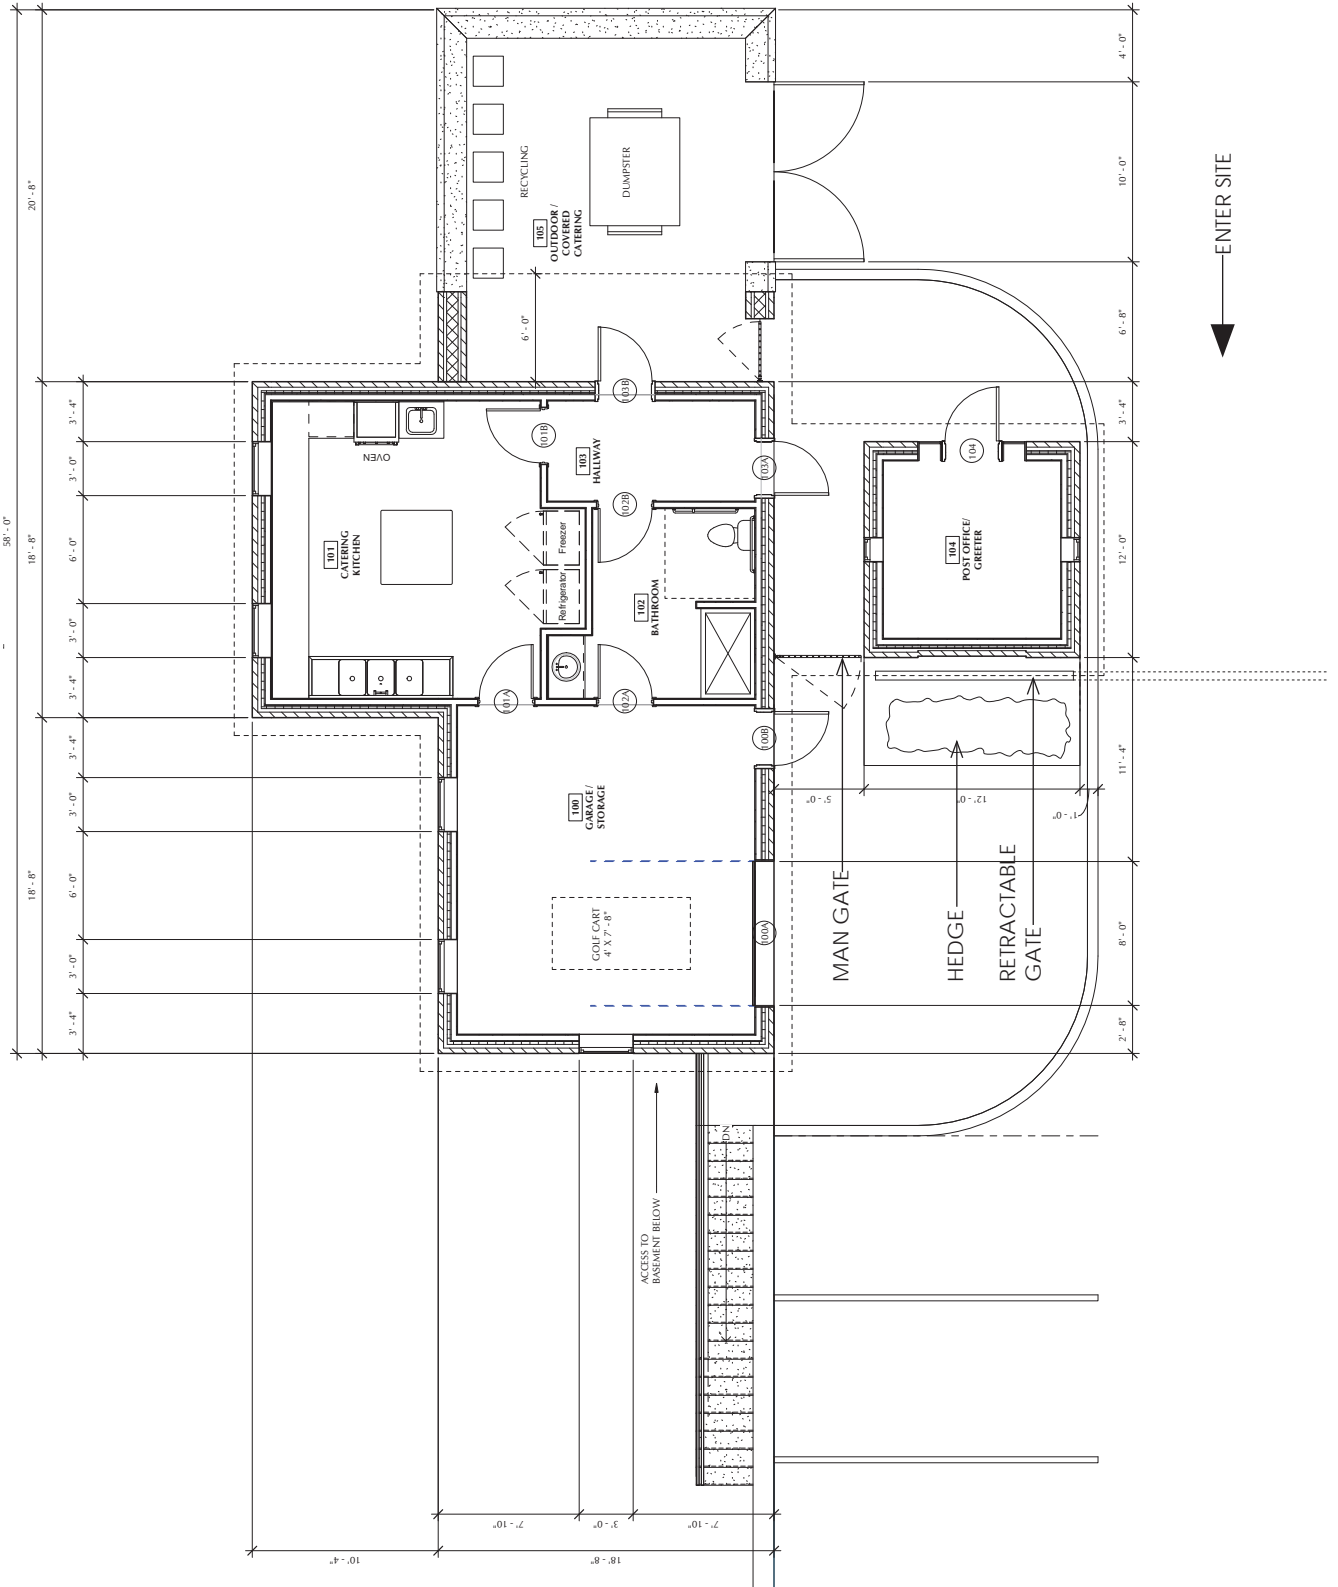
CARRIAGE HOUSE - PLAN

SCALE: 3/32" = 1'
