Meeting: 6/16/2022
Applicant: Brian Pittman Johnson Architecture, Inc
Owner: Knollwood Historic Preservation, LLC

Location: 150 Major Reynolds Place **Parcel ID** 121 A A 02807
District: Knollwood Individual H Landmark
Zoning: C-G (General Commercial)
Description: Neoclassical, c.1851 with modifications dating to 1890s and 1930s
See attached designation report and design guidelines for architectural description of house.

Comprehensive exterior rehabilitation, new secondary structure, and modifications to site design.

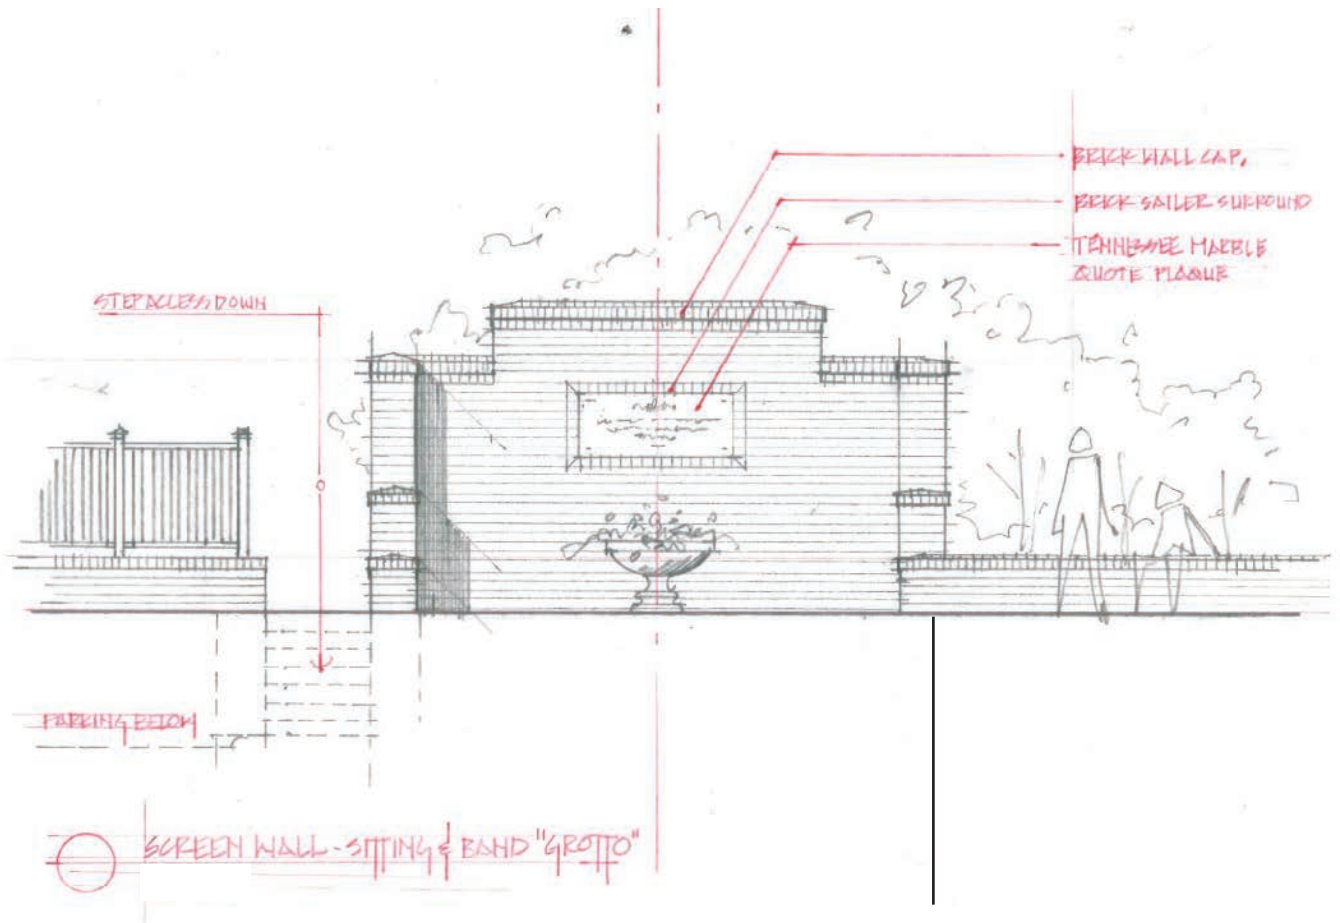
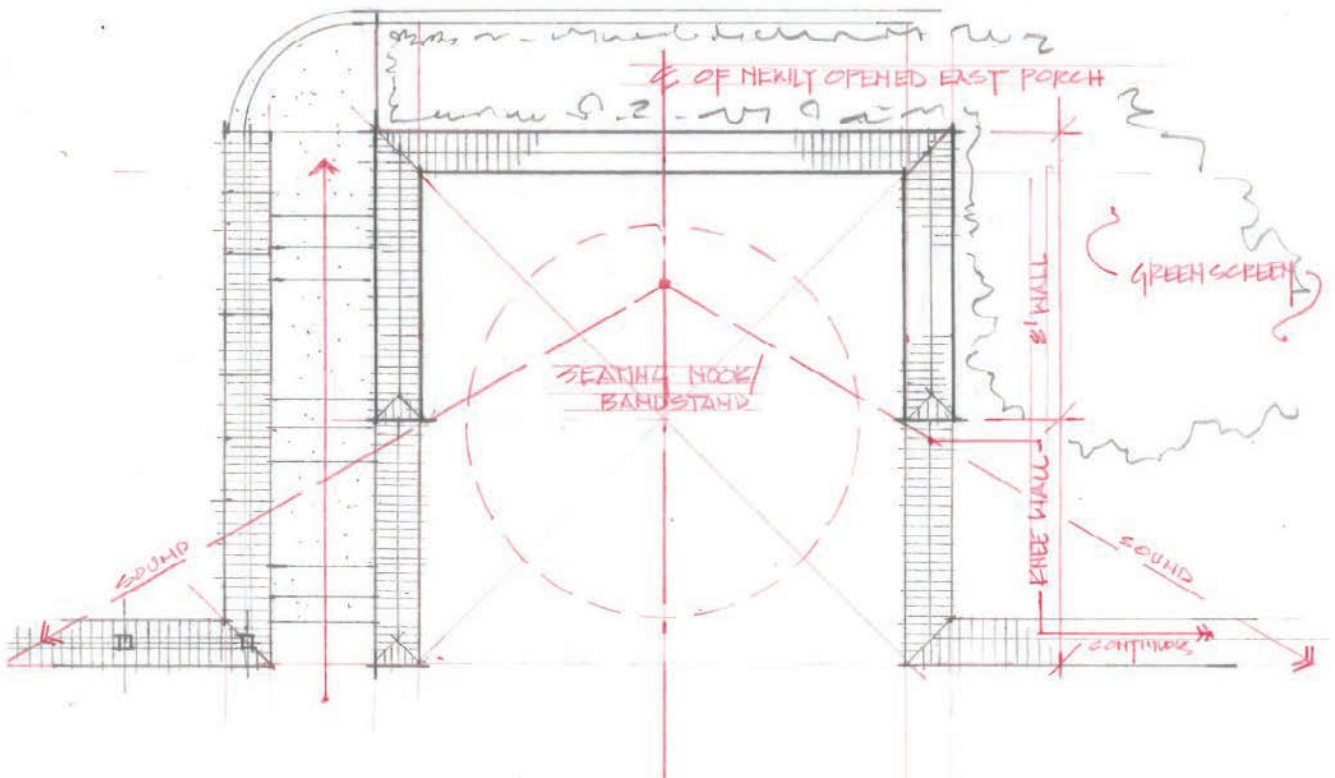
WALLED GARDEN GROTTTO

SCALE: 3/16" = 1'

LOWER TERRACES AND PATHS

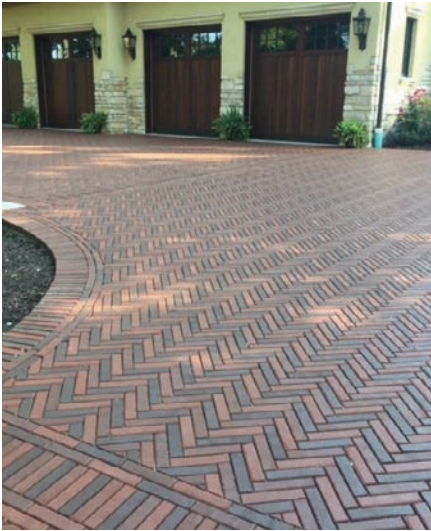
HERRINGBONE BRICK PAVERS - COLOR TBD

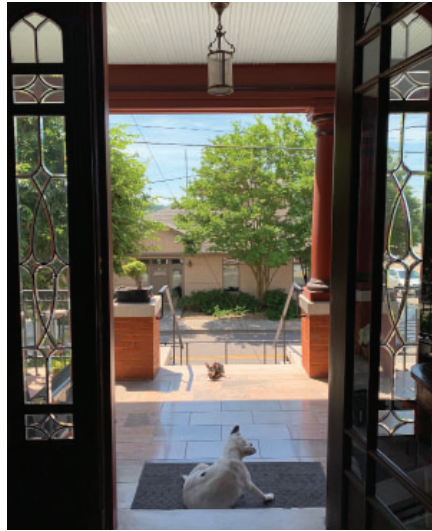
DAYTIME TENNESSEE MARBLE - 10 X 20
RUNNING BOND PATTERN

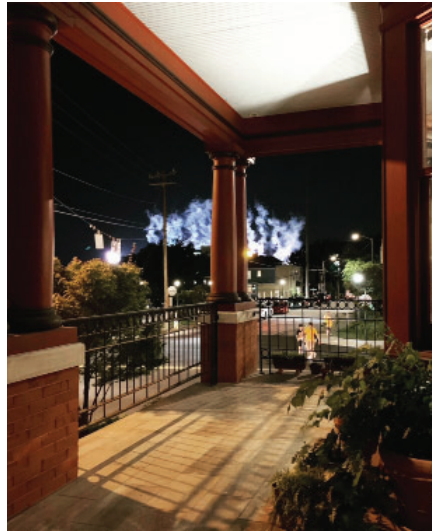
NIGHTTIME TENNESSEE MARBLE - 10 X 20
RUNNING BOND PATTERN

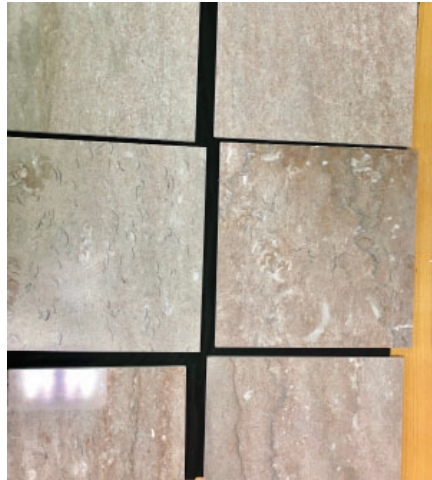
TENNESSEE MARBLE - 10X20 'RANGE FINISH'

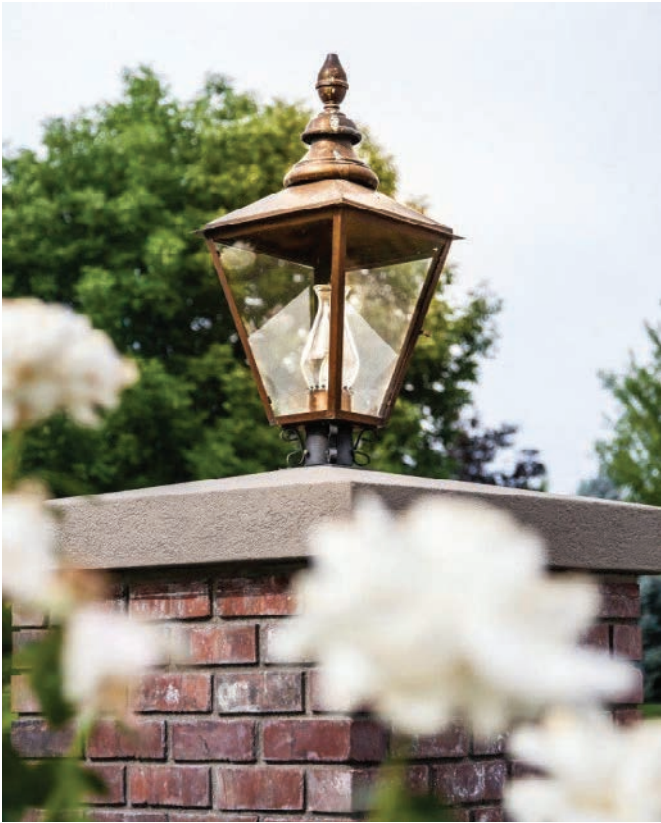
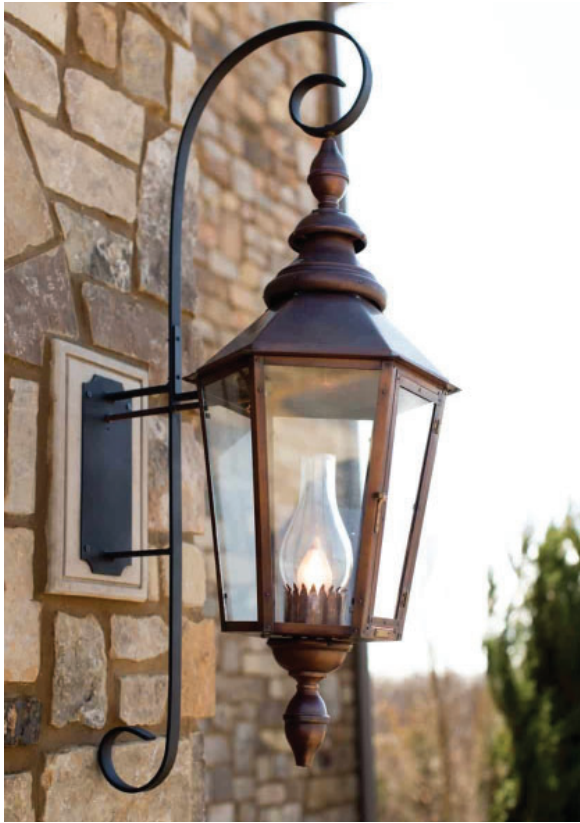
LANTERNS

SIZE:	31" 25" LS	35" 28" LS	43" 35" LS
A:	45"	47"	52 7/8"
B:	12 1/2"	14 1/2"	17 7/8"
C:	21 5/8"	23 3/4"	25 1/2"
D:	5"	5"	5"
E:	13"	13 3/4"	16 3/4"
F:	18 1/4"	22 1/4"	26 8/8"
G:	8"	9 1/2"	9 1/2"

BEVOLO GAS & ELECTRIC LIGHTS		DRW BY:	JJG	<small>COPYRIGHT 2019, BEVOLO GAS & ELECTRIC LIGHTS. THIS DRAWING AND ANY DESIGN OR DATA CONTAINED THEREIN ARE CONSIDERED PROPERTY OF BEVOLO GAS AND ELECTRIC LIGHTS. NEITHER THE DRAWING NOR ITS CONTENT MAY BE COPIED, REPRODUCED, OR EDITED TO A LIKENESS WITHOUT THE WRITTEN CONSENT OF BEVOLO GAS AND ELECTRIC LIGHTS.</small>
LIGHT:	LONDON STREET w/ LONDON BOTTOM	DATE:	JJG	
BRACKET:	RODIN BRACKET	5-8-19	REVISION: 2

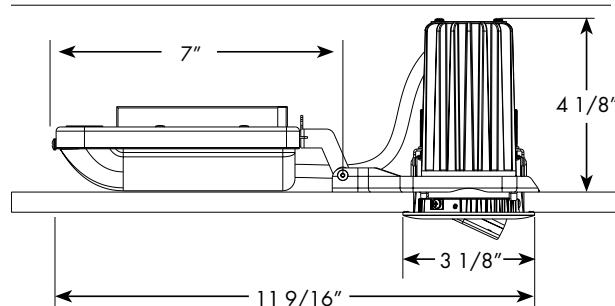
DIMENSIONS

2 5/8" CEILING CUTOUT

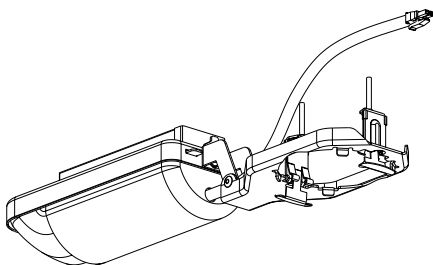
MOUNTING FRAME/DRIVER ASSEMBLY

Note: Driver assembly only intended for use with Gen2 LED trim modules. Not backward compatible with previous generation.

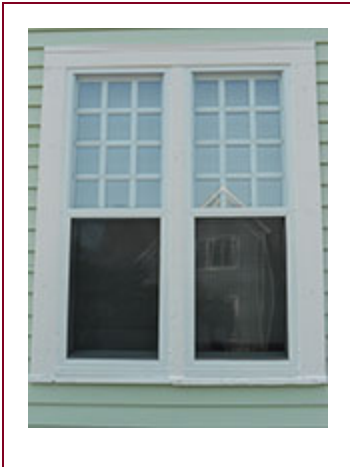
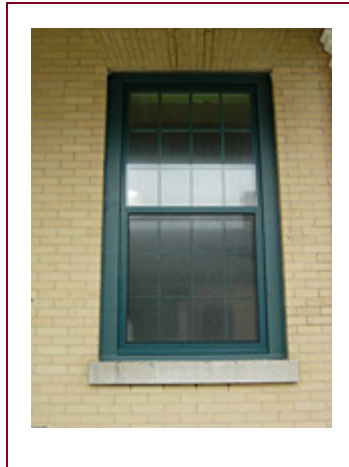
Item # HOL-OP, Operable Historic One Lite - (HOL-OP) - With Screen

The Operable Historic One Lite (HOL-OP) series has the same "invisible" appearance as the (HOL) units, but the bottom sash is operable and removable. It also has a year-round screen.

- Repair and restoration of existing double-hung, one-over-one windows. Window repair to meet Secretary of the Interiors Standards for window repair. Installation of new pre-finished aluminum storm windows, custom built to fit existing openings, with meeting rails to align with meeting rails of existing windows.

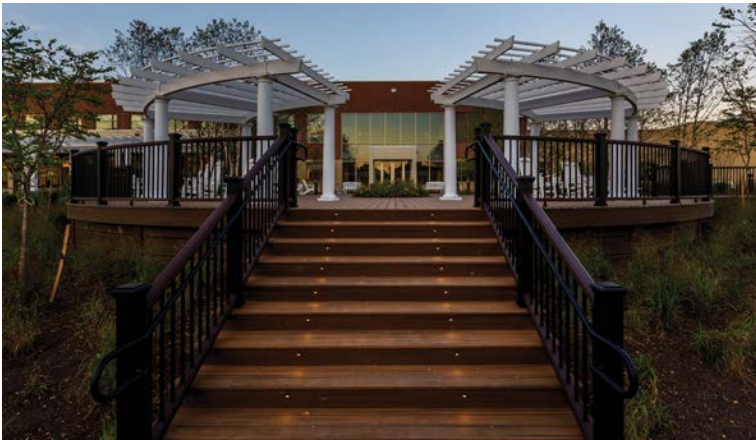
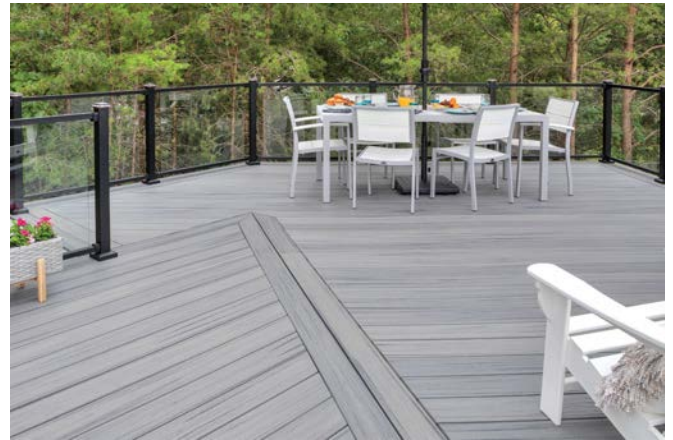
PREMIUM HIGH-PERFORMANCE DECKING & FASCIA

Trex Transcend® decking and Trex® Fascia are wood thermoplastic composite lumber (WTCL) boards with an integrated shell that covers the boards on the top surface and sides. The integrated shell consists of a proprietary surface formulation that produces a natural, wood-like grain pattern finish. An alternative to naturally durable hardwood lumber, Transcend Decking and Fascia are ICC-ES SAVE-certified to be a minimum of 95.4% recycled content of wood fiber and polyethylene by weight.

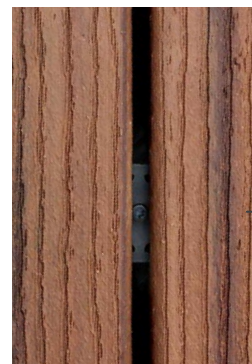
Trex Hideaway® Hidden Fastening System

Self-gapping, glass-filled nylon fastener with 304 grade stainless steel, sharp point screw for wood framing

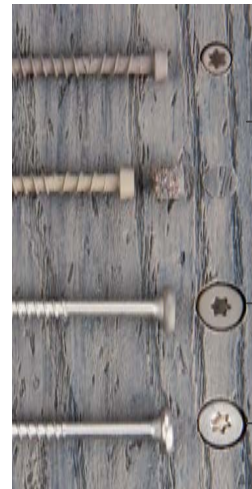
Other Approved Fasteners

Color-matched composite deck screw or matching composite plug
