**3-E-23-HZ**  
**APPLICATION FOR CERTIFICATE OF APPROPRIATENESS**

**523 E. Oklahoma Ave. 37917**  
**Old North Knoxville H**

**Proposed work for 523 E Oklahoma Ave.**

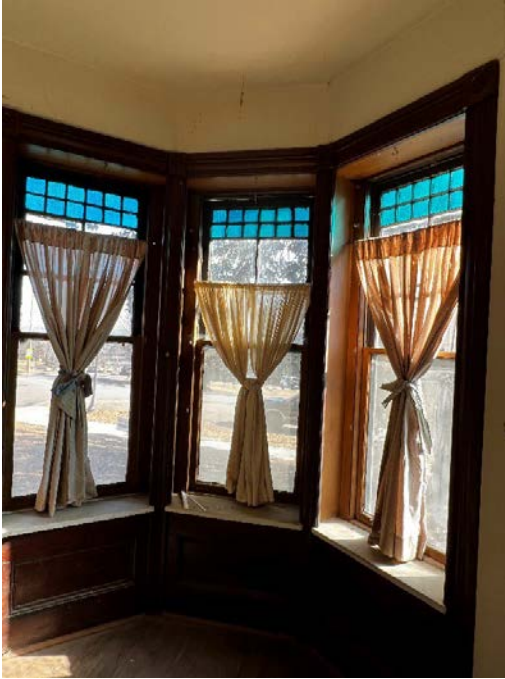
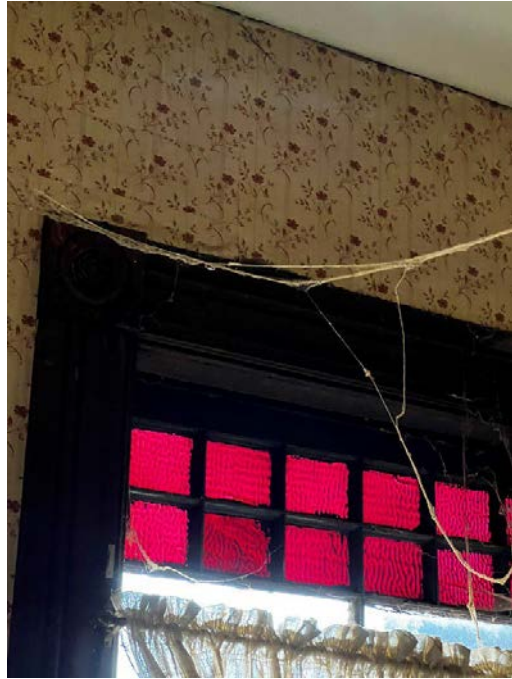
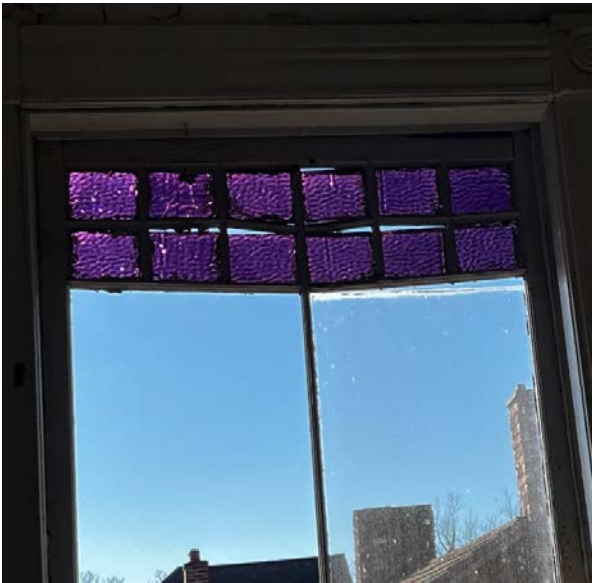
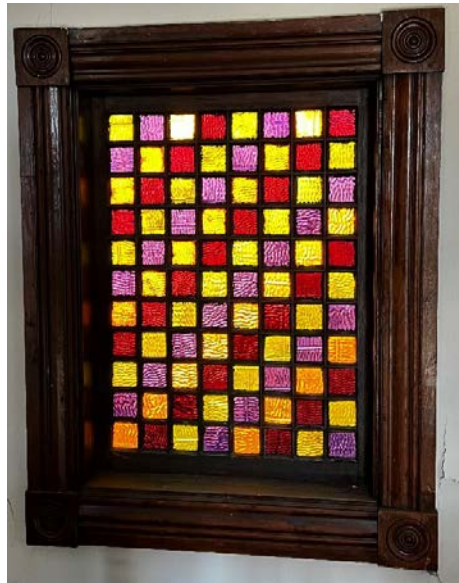
- 5) Repair or replicate all exterior windows. All replicated materials for the window frame will be wood.

5. While repair to the original windows is the preferred option, some windows may be too deteriorated to repair; in this case, replacement windows should be the same overall size, with the same pane division and muntin depth, width, and profile, and materials, with final specs submitted to staff for approval.

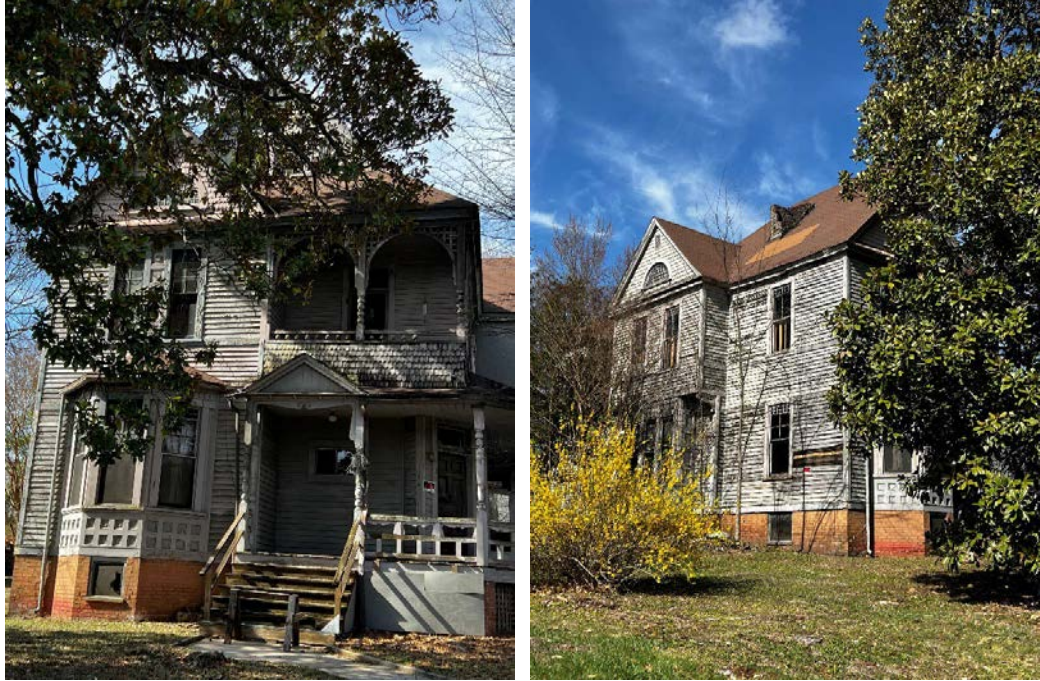
- 6) The applicants would like approval for ***both*** options for the chimney hole:
- a. To roof over the current chimney hole that was created ten years ago when a falling oak knocked it down.

3. The primary discussion point for the HZC is the removal of reconstruction of the left side chimney, which was demolished by a tree in 2013. The resulting hole has contributed to significant moisture damage in the attic and both levels of the house.

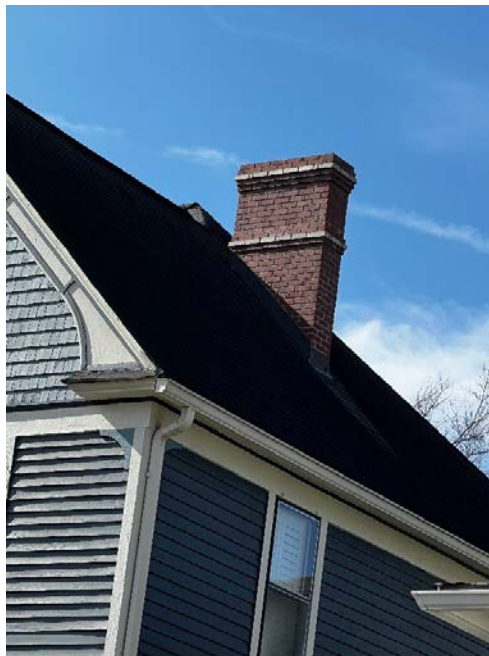
- b. To rebuild the chimney similar to the below photo of another chimney on E Oklahoma Ave. Dimensions to be approved by staff, but likely 5' x 2 1/2'.
