APPLICATION FOR CERTIFICATE OF APPROPRIATENESS

217 E. Scott Ave. 37917

File Number: 3-E-24-HZ

Historic Zoning Submittal March 4, 2024

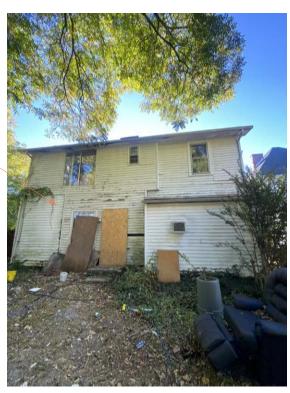
Hattar Residence - 217 E Scott Avenue Front Elevation

Remove old porch enclosure addition.

A new wrap around front porch will be built in the old footprint.
