APPLICATION FOR CERTIFICATE OF APPROPRIATENESS

1028 Luttrell St. 37917

Staff Report

File Number: 9-F-24-HZ

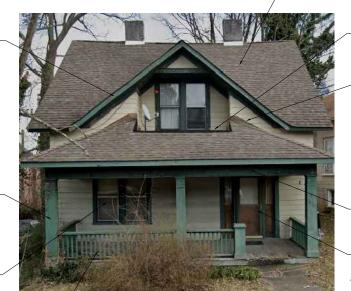
New EPDM (Rubber) Roof on flat roof with proper flashing and counter flashing.

> Repair and replace failing roof with proper flashing and new materials to match existing shape and slope.

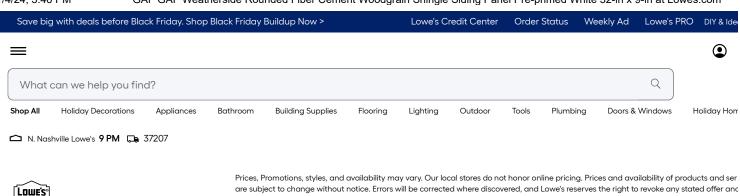
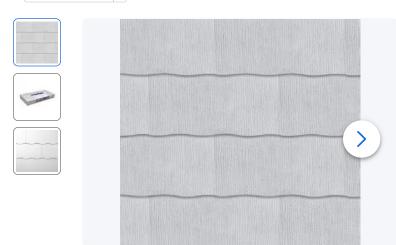
GAF GAF Weatherside Rounded Fiber Cement Woodgrain Shingle Siding Panel Pre-primed White 32-in x 9-in Item #805144 | Model #2214000WG

- Fire and freeze-thaw resistant replacement for asbestos siding
- Preprimed; ready to be painted to match existing wall color
- Wavy edged, textured surface shingle protected by 25-yr ltd. warranty

- Repair of the existing wood window trim on the diamond window on the right elevation. Installation of new glass into existing frame.
- Existing asbestos shingle siding to remain. In sections requiring patching, applicant proposes to patch with fiber cement shingle siding. Repair of existing siding with in-kind fiber cement shingle siding.
