Level II Major Repair or Replacement

**7-A-26-HZ**  
**APPLICATION FOR CERTIFICATE OF APPROPRIATENESS**

1726 Washington Ave. 37917  
 Edgewood-Park City H

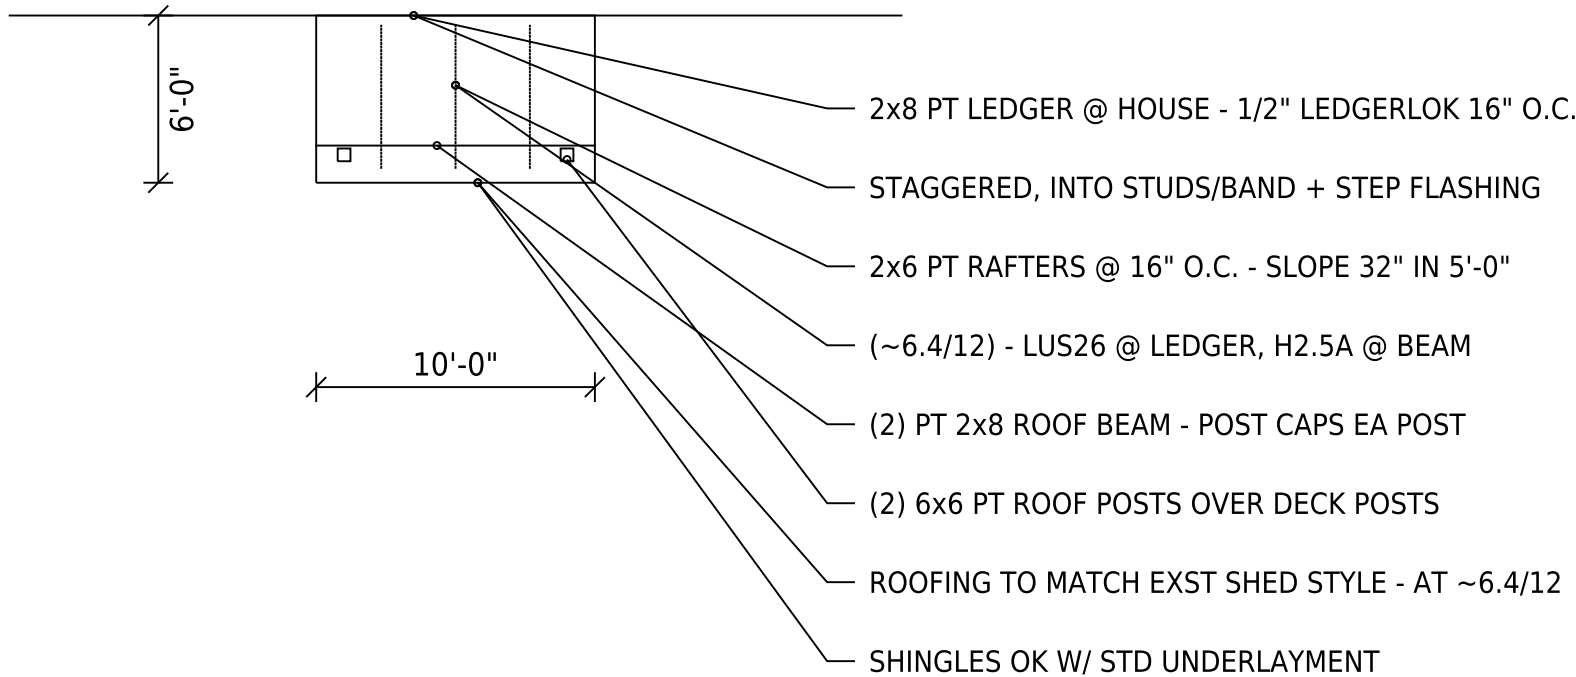
# ROOF FRAMING PLAN - SHED COVER (~6.4/12)

## ROOF NOTES

1. ROOF GEOMETRY PER OWNER PHOTO: 116" ABOVE DECK FLOOR @ HOUSE, 84" @ FRONT BEAM = 32" DROP / 5'-0" = ~6.4/12 PITCH. HEADROOM @ FRONT 7'-0" - OK.
2. 7/16" OSB OR 1x SKIP TO MATCH EXST, SYN FELT, DRIP EDGE ALL EDGES.
3. FLASH ROOF-TO-WALL W/ STEP + COUNTERFLASHING.
4. VERIFY LEDGER LANDS ON SOLID FRAMING BELOW 2ND FLOOR WINDOWS - ADJUST HT AS REQ'D (V.I.F.).
