**KNOXVILLE HISTORIC ZONING COMMISSION
STAFF REPORT - CERTIFICATE OF APPROPRIATENESS APPLICATION**

PROPERTY ADDRESS: 1206 Luttrell St 37917

FILE NO.: 1-B-14-HZ

DISTRICT: Fourth and Gill H-1

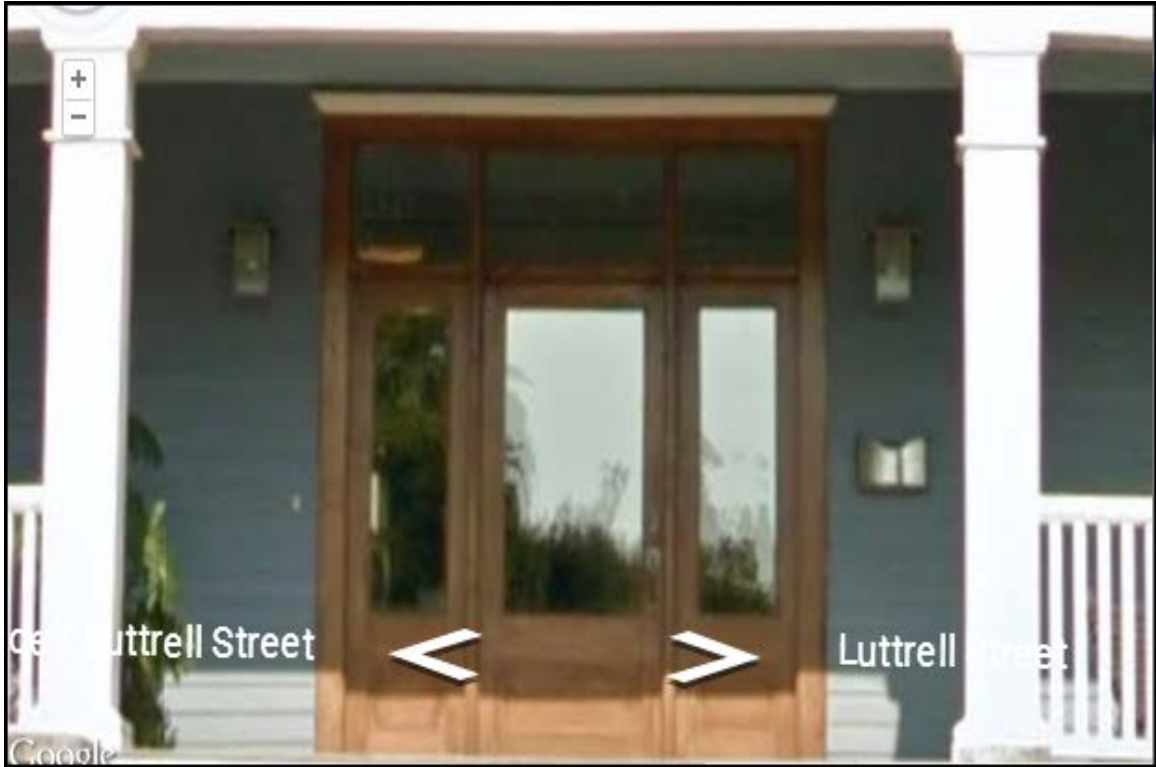
Square columns with trim at 1101 Luttrell proposed for 1206 Luttrell.
1-16-2014 HZC meeting submittal

- 3) The two proposed square wood columns with trim on the top and bottom are appropriate for the Neoclassical style of the house. The ionic volutes would not look as appropriate on the more recently existing "stoop" version of the porch as wood simple wood trim.

Approval of two square wood replacement columns to match those at 1101 Luttrell Street or with ionic volutes. Construct new brick steps if mock-up shows that the brick will match that existing on the foundation; otherwise the steps are to be of concrete. Construct fixed multi-light french door panel in center 2nd level. Install 2x2 square balustrade and handrail with molded top rail to meet building code.

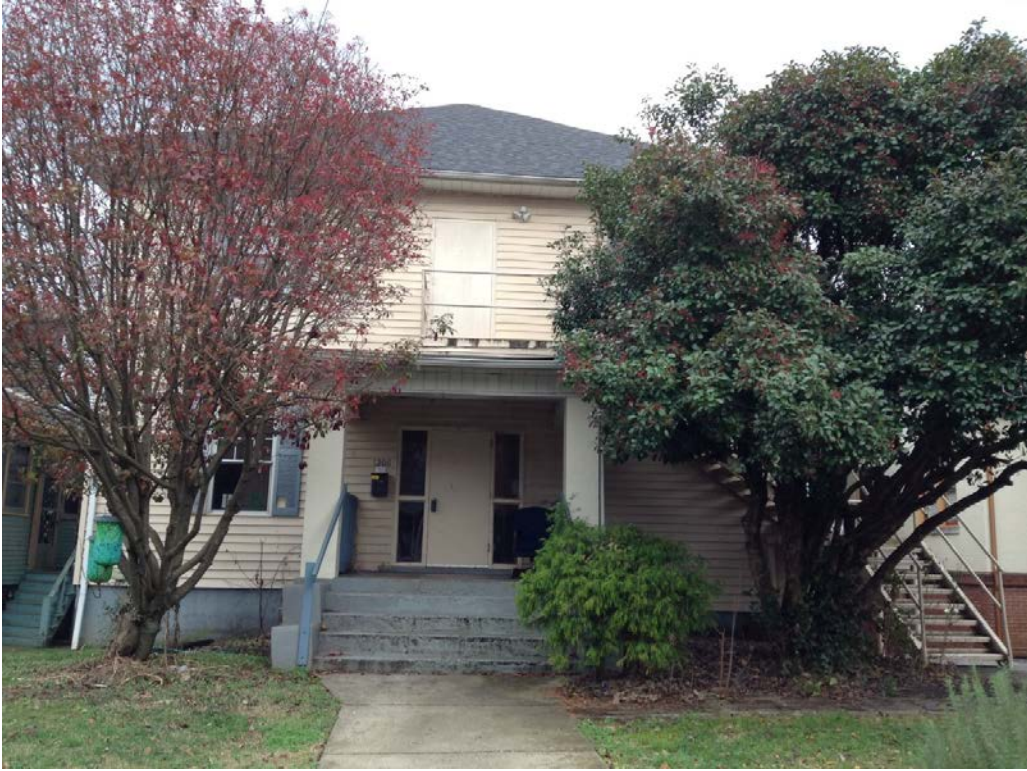
1206 Luttrell – Front

- 1) The house has been heavily altered overall prior to the establishment of the historic overlay. The windows, front door, and porch columns have been replaced or altered inappropriately. Metal stairs to the second-level have been added to the south front side in the more recent past, as well as a second-level door replacing a window to the porch roof. The original full-façade front porch has been reduced to a single-bay central porch, or stoop.

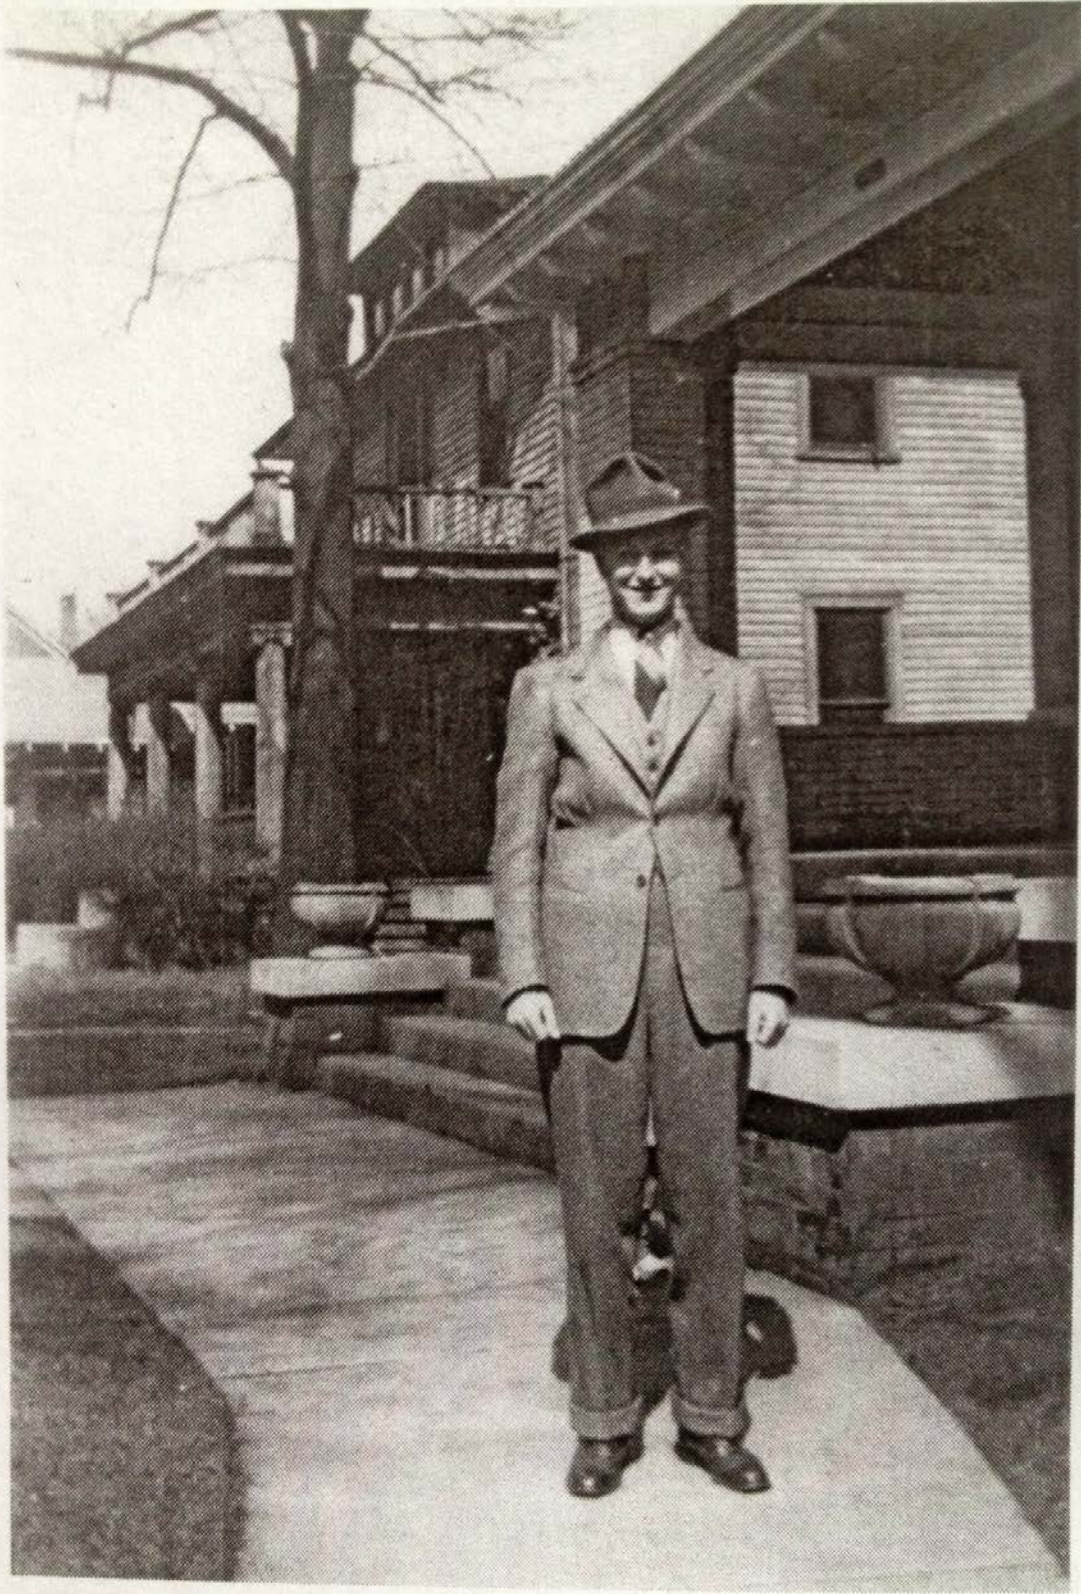
1206 Luttrell – Older photograph

- 2) Documentation on the original appearance of the house in the 1920s or 1930s has been submitted to indicate the design of the front porch and a portion of the front façade. One-over-one windows are shown and a central door on the 2nd level leading to a balustraded porch roof. The columns supporting a full-façade are square with ionic volutes. The photos do not show a balustrade on the historic porch does not
