Staff Report

Knox County Historic Zoning Commission

File Number: 5-C-22-HZ

Location: 10915 Lake Ridge Dr. **Parcel ID** 153 G B 005
District: Village of Concord HZ
Zoning: CA (General Business)
Description: Vernacular Commercial, c.1890

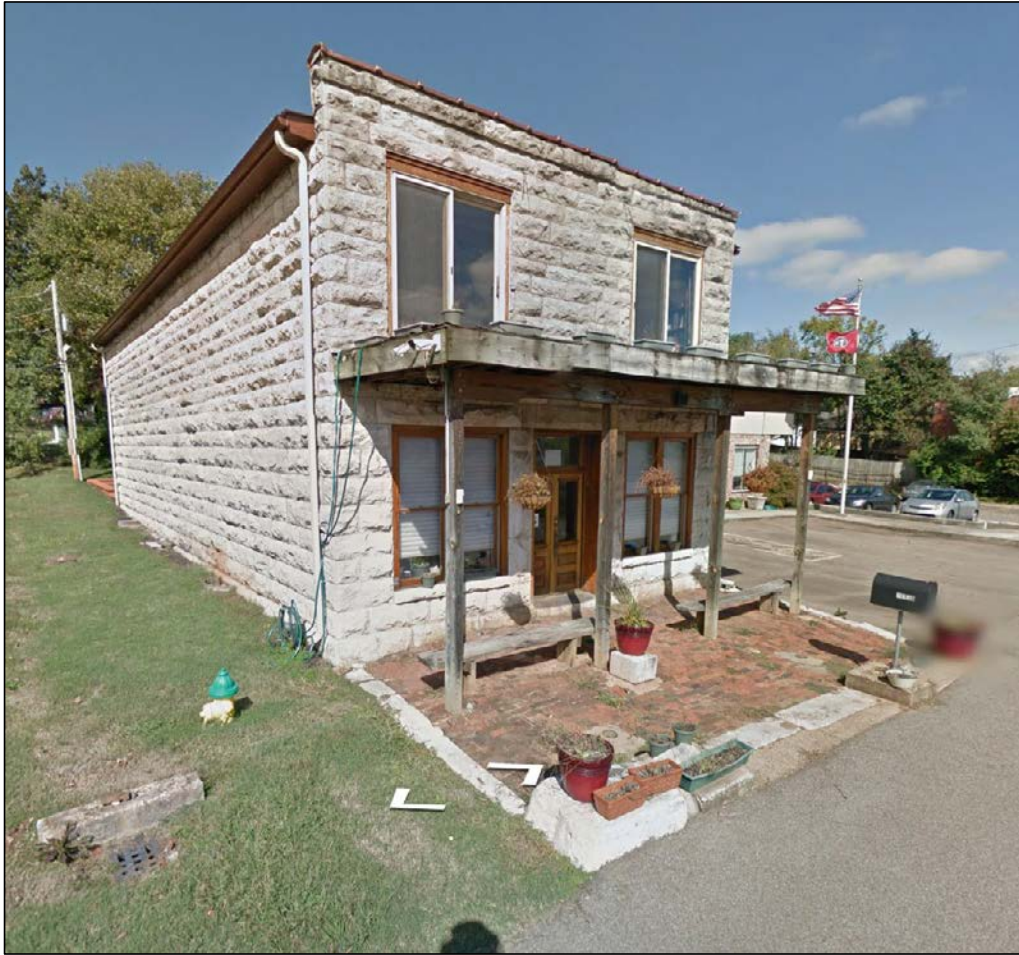
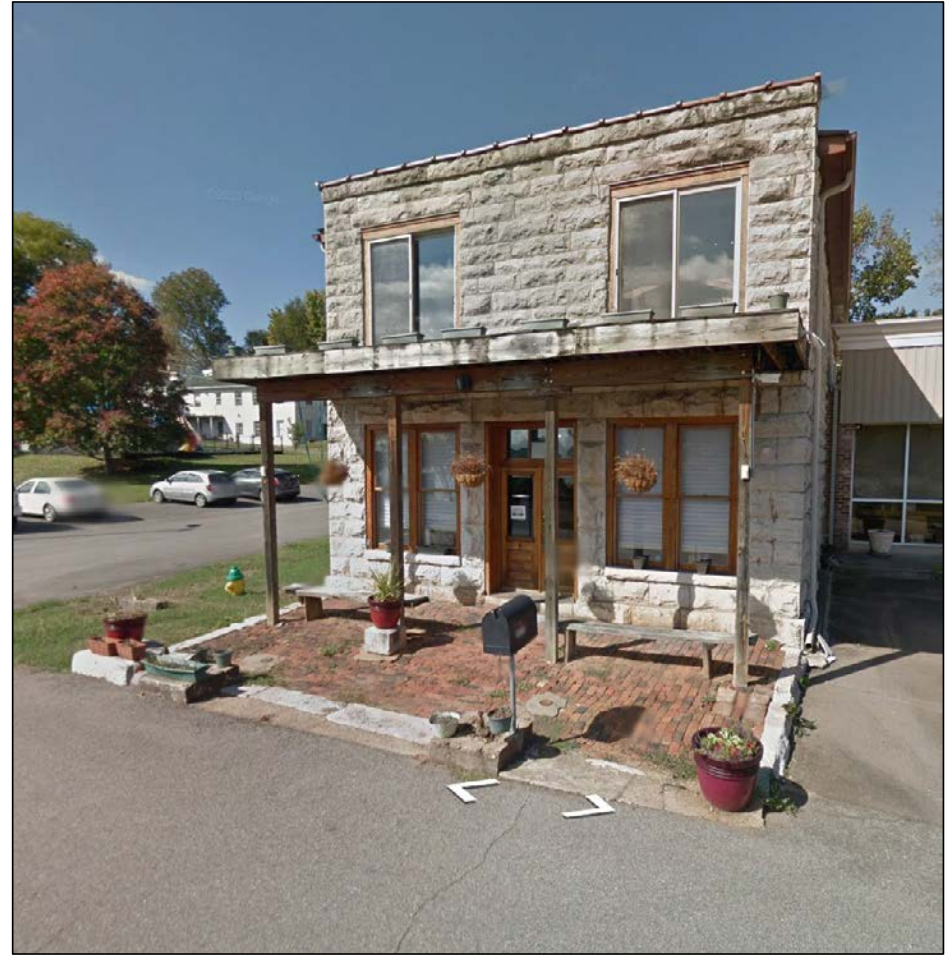
Google Streetview images of porch prior to work

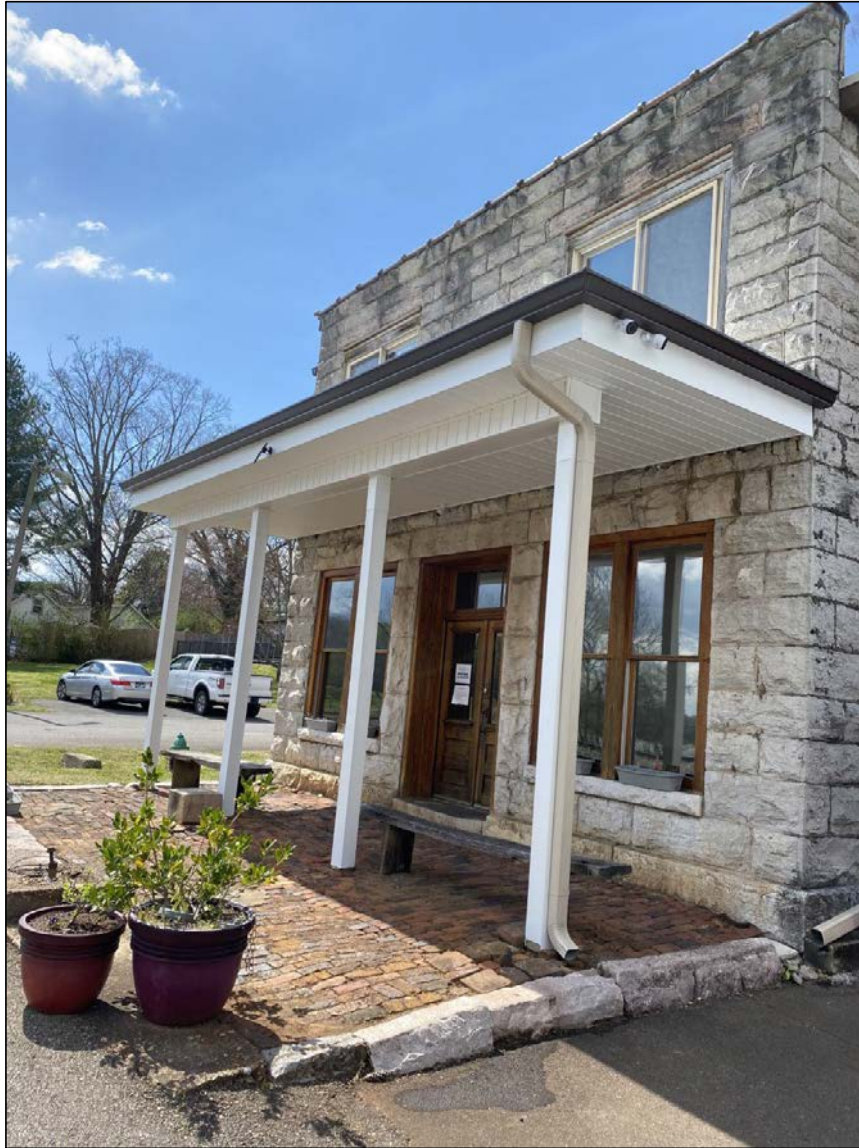
- **Removed exposed fastener metal roof on both buildings and installed new standing seam metal roof (same color) About 8,000sqft**
- **Removed existing EPDM membrane from porch roof. Replaced rotten wood as needed. Installed TPO membrane on roof. Installed aluminum around 4 wooden posts. Installed metal fascia trim and gutters. Installed vinyl soffit.**

Photo of work completed, submitted
by contractor

4. The front porch elements, while most likely not original to the building, did adhere to the design guidelines as using wood elements instead of synthetic materials. The design guidelines state "porches ... shall be repaired or replicated in size and design using wood materials for [...] posts and columns so that they duplicate the original size and design." Guidelines also state that reconstruction in order to achieve a uniform or 'improved' appearance is inappropriate, along with noting the "application of synthetic or substitute materials such as vinyl or aluminum over original wood siding is not appropriate." While these are porch elements and not siding, general preservation principles (and the Secretary of the Interiors Standards) discourage enclosing wood elements with synthetic materials for simply aesthetic purposes.
-

Staff recommends approval of the work as completed, with the condition that the applicant remove the vinyl and aluminum porch elements and provide a revised porch design which meets the guidelines, with approval by staff.
